NYC Department of Education
Building Condition Assessment Survey 2023 - 2024

Architectural Inspection

Asset: P.S. 257 - BROOKLYN, 60 COOK STREET, New York, 11206

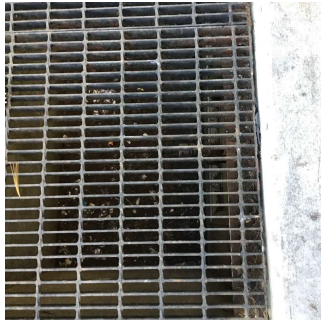
Question	Response
Architectural	
EXTERIOR	Inspected
AREAWAY	Inspected
Instance on AW1-AW3	Inspected
Instance Condition	5 - Poor
Instance Quantity	3
Instance Quantity Uom	EACH
Deficiency	AREAWAY STAIRS: DETERIORATED TREADS/RISERS/NOSINGS
Roof Plan reference	
Deficiency Quantity	80
Quantity Uom	S.F.
Potential Action	REPLACE
Urgency of Action	PRIORITY 4
Purpose of Action	LEVEL 2
Deficiency Photo1	
Violations	Areaway 2 No violations recorded.
Deficiency	AREAWAY GRATINGS: MAJOR RUSTING / OR BROKEN
Roof Plan reference	
Deficiency Quantity	50
Quantity Uom	S.F.
Potential Action	REPLACE

Question	Response
EXTERIOR	
AREAWAY	
Urgency of Action	PRIORITY 4
Purpose of Action	LEVEL 2
Deficiency Photo1

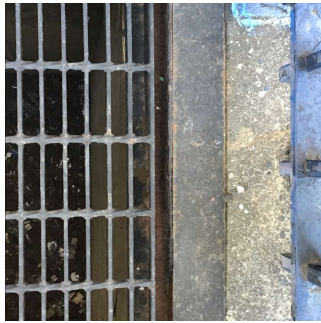
Violations	Areaway 1 No violations recorded.
Deficiency	AREAWAY GRATINGS: MAJOR RUSTING AND / OR BROKEN SUPPORTS
Roof Plan reference

Deficiency Quantity	10
Quantity Uom	L.F.
Potential Action	REPLACE
Urgency of Action	PRIORITY 4
Purpose of Action	LEVEL 2
Deficiency Photo1

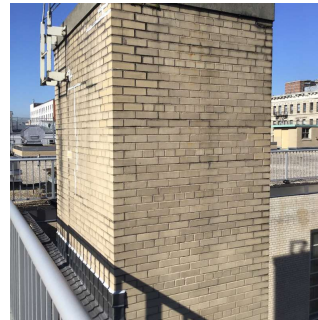
Chimney

Violations	Areaway 1 No violations recorded.
AWNINGS AND CANOPIES	Does not Exist
CHIMNEY	Inspected
Material Type(s)	Masonry
Condition	3 - Fair
Deficiency	BRICK: DETERIORATED JOINTS

100
S.F.
REPOINT
PRIORITY 3
LEVEL 2

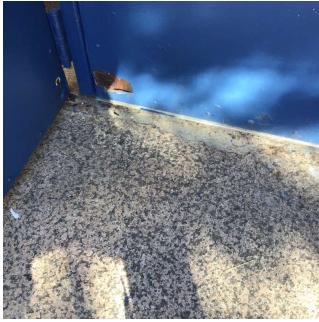
Question	Response
EXTERIOR	
CHIMNEY	
Deficiency Photo1	 
Violations	Chimney No violations recorded.
COPING	Does not Exist
CORNICE	Does not Exist
DOORS	Inspected
DOORS AND FRAMES	Inspected
Condition	5 - Poor
Deficiency	METAL CLAD: DETERIORATED DOOR AND FRAME - MINOR DETERIORATION
Roof Plan reference	 
Deficiency Quantity	1
Quantity Uom	EACH
Potential Action	MAINTENANCE
Urgency of Action	PRIORITY 3
Purpose of Action	LEVEL 2
Deficiency Photo1	 
Violations	Facade B North View No violations recorded.
Deficiency	METAL: DETERIORATED DOOR - MAJOR DETERIORATION

Violations	Facade A - South view No violations recorded.
DOOR HARDWARE	Inspected
Condition	3 - Fair
Deficiency	No deficiencies recorded
LINTELS	Inspected
Condition	2 - Between Good and Fair
Deficiency	No deficiencies recorded
TRANSOM/SIDE LIGHT	Inspected
Condition	2 - Between Good and Fair
Deficiency	No deficiencies recorded
EXTERIOR WALLS	Inspected
Material Type(s)	Masonry
Replacement Quantity	17,000
Replacement Uom	S.F.
Instance on All Facades	Inspected
Instance Condition	3 - Fair
Instance Quantity	17,000
Instance Quantity Uom	S.F.
Deficiency	BRICK: DETERIORATED MASONRY SILLS - MAJOR

Deficiency Quantity	5
Quantity Uom	EACH
Potential Action	REPLACE
Urgency of Action	PRIORITY 5
Purpose of Action	LEVEL 2
Deficiency Photo1

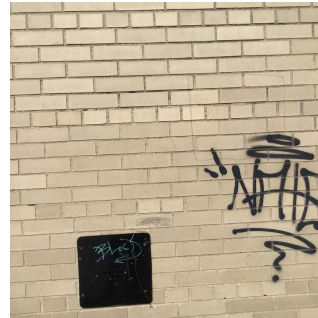
Facade A

BRICK: DETERIORATED JOINTS

PRIORITY 3
LEVEL 2

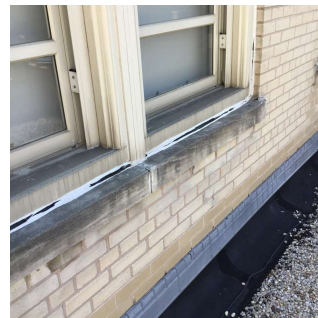
Facade G

BRICK: DETERIORATED MASONRY SILLS - MINOR

REPAIR

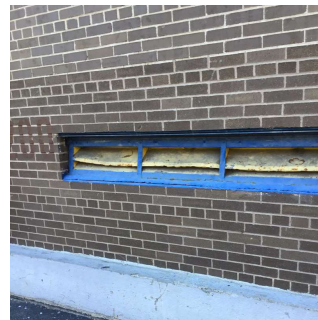
Facade C

Question	Response
EXTERIOR	
EXTERIOR WALLS	
Violations	No violations recorded.
Deficiency	BRICK: MINOR CRACKS AND SPALLING
Roof Plan reference	<p>K257 Varet Street</p>   <p align="right">N</p> <p align="right">Humboldt Street</p> <p align="center">Cook Street</p>
Elevation	 
Deficiency Quantity	100
Quantity Uom	S.F.
Potential Action	RESTITCH
Urgency of Action	PRIORITY 3
Purpose of Action	LEVEL 2
Deficiency Photo1	 
Violations	Facade G No violations recorded.
EXTERIOR SOFFITS	Does not Exist
LOADING DOCK	Does not Exist
LOUVER	Inspected
Condition	3 - Fair
Deficiency	BROKEN/ DENTED BLADES

REPLACE

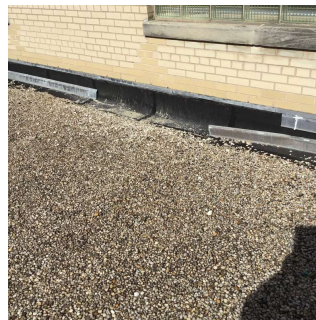
Roof 2

BUILT-UP: FLASHING: CAP FLASHING MISSING

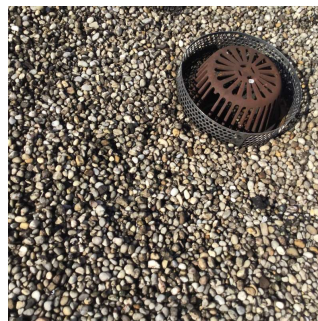
Roof 1 near Chimney

DETERIORATED

REPLACE

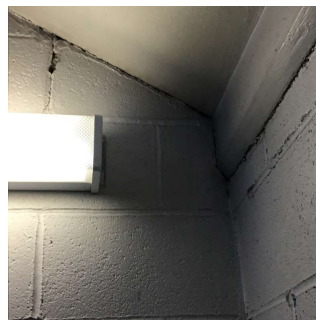
Bulk Head 1

BULKHEAD/PENTHOUSE WALLS/INTERIOR: CMU
CRACKS/SPALLING

20
S.F.
REPLACE
PRIORITY 3
LEVEL 2

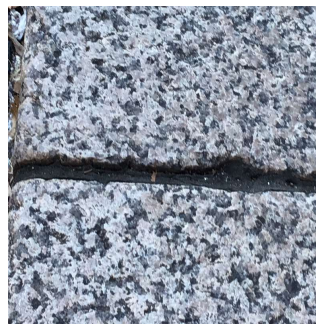
Facade C

Question	Response
EXTERIOR	
ROOF	Inspected
Specialties	Inspected
SKYLIGHT/ROOF VENT	Inspected
Condition	2 - Between Good and Fair
Deficiency	No deficiencies recorded
ROOF/GRAVITY TANK	Does not Exist
STAIRS/RAMPS: EXTERIOR	Inspected
BUILDING CHEEK/FLANK WALLS	Does not Exist
RAILINGS	Inspected
Condition	3 - Fair
Deficiency	MISSING RAILING
Roof Plan reference	
Deficiency Quantity	30
Quantity Uom	L.F.
Potential Action	REPLACE
Urgency of Action	PRIORITY 5
Purpose of Action	LEVEL 6
Deficiency Photo1	
Violations	Facade A - South view No violations recorded.
STAIRS/RAMPS	Inspected
Condition	5 - Poor
Deficiency	STONE: DETERIORATED JOINTS

30
L.F.
REPOINT
PRIORITY 3
LEVEL 2

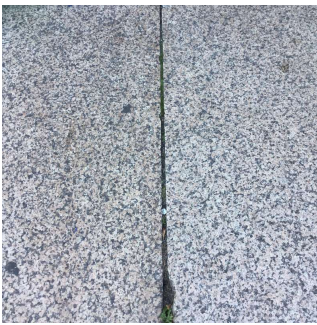
STONE: CRACKS/SPALLING - MAJOR

Violations	Facade C - East view No violations recorded.
WINDOWS	Inspected
Replacement Quantity	8,700
Replacement Uom	S.F.
EXTERIOR GUARDS	Inspected
Condition	2 - Between Good and Fair
Deficiency	No deficiencies recorded
LINTELS	Inspected
Condition	2 - Between Good and Fair
Deficiency	No deficiencies recorded
WINDOWS	Inspected
Material Type(s)	Aluminum
Instance on Aluminum - Double Hung: All Facades	Inspected
Instance Condition	3 - Fair
Instance Quantity	8,700
Instance Quantity Uom	S.F.
Are these windows insulated	No
Installation Year	1998
Source of Installation	Custodial Staff
Deficiency	No deficiencies recorded
INTERIOR	Inspected
POOLS	Does not Exist
STRUCTURAL	Inspected
COLUMNS/BEAMS/BEARING WALLS	Inspected
Condition	2 - Between Good and Fair
Deficiency	No deficiencies recorded
FLOOR STRUCTURE	Inspected
Condition	3 - Fair
Deficiency	CONCRETE: CRACKS/SPALLED/REINFORCEMENT EXPOSED

100
S.F.
REPLACE
PRIORITY 4
LEVEL 2

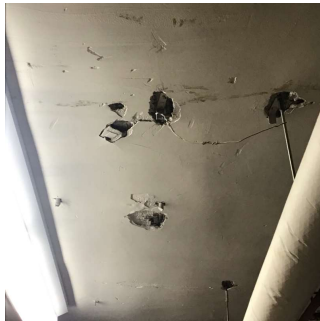
Deficiency Location/Instance	Basement ceiling Slab near Electrical Panel Room
Deficiency Quantity	20
Quantity Uom	S.F.
Potential Action	REPAIR
Urgency of Action	PRIORITY 3
Purpose of Action	LEVEL 5

Violations	Basement Ceiling Slab No violations recorded.
Deficiency	CONCRETE SLAB ON GRADE: THRU CRACKS
Deficiency Location/Instance	Basement School Supply Room, Gas Meter Room
Deficiency Quantity	20
Quantity Uom	S.F.
Potential Action	REPAIR
Urgency of Action	PRIORITY 3
Purpose of Action	LEVEL 5
Deficiency Photo1

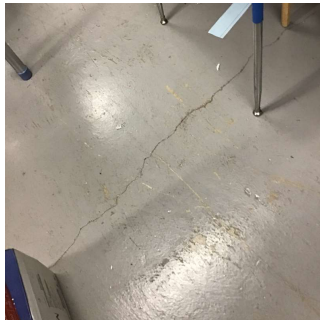
Violations	Basement School Supply Room No violations recorded.
FOUNDATION WALLS	Inspected
Material Type(s)	Concrete
Condition	2 - Between Good and Fair
Deficiency	No deficiencies recorded
ROOF STRUCTURE	Inspected
Condition	2 - Between Good and Fair
Deficiency	No deficiencies recorded
VAULTS-BUNKERS	Inspected
Foundation Walls	Inspected
Condition	2 - Between Good and Fair
Deficiency	No deficiencies recorded
Slab Structure	Inspected
Condition	2 - Between Good and Fair
Deficiency	No deficiencies recorded
Vault/Ash Hoist Doors and Framing	Inspected

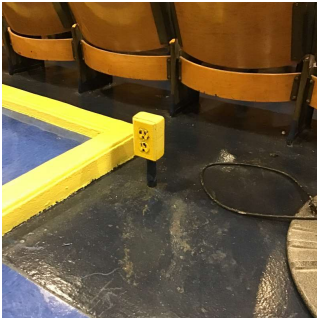
Question	Response
INTERIOR	
AUDITORIUM	
Fixed H/C Lift	
Instance on 1st Floor (400 Seats)	Inspected
Condition	1 - Good
Deficiency	No deficiencies recorded
Fixed Seating	
Instance on 1st Floor (400 Seats)	Inspected
Condition	3 - Fair
Deficiency	DAMAGED/BROKEN/INOPERABLE
Deficiency Location/Instance	Seat M/12
Deficiency Quantity	1
Quantity Uom	EACH
Potential Action	REPLACE
Urgency of Action	PRIORITY 5
Purpose of Action	LEVEL 6
Deficiency Photo1	 
Violations	Seat M/12 No violations recorded.
Deficiency	DAMAGED/BROKEN/INOPERABLE
Deficiency Location/Instance	Seat A/101, 106, 109, B/101, 103 and others
Deficiency Quantity	17
Quantity Uom	EACH
Potential Action	REPLACE
Urgency of Action	PRIORITY 3
Purpose of Action	LEVEL 2
Deficiency Photo1	 
Violations	Seat A/101 No violations recorded.
Floor Finish	
Instance on 1st Floor (400 Seats)	Inspected
Condition	2 - Between Good and Fair
Deficiency	CONCRETE: TRIPPING HAZARD - ELECTRICAL OUTLET

Deficiency Location/Instance	Near Entrance

Violations	Near Entrance No violations recorded.
Sliding-folding Partition	
Instance on 1st Floor (400 Seats)	Does not Exist
Stage	
Instance on 1st Floor (400 Seats)	Inspected
Stage	Inspected
Instance on 1st Floor (400 Seats)	Inspected
Condition	2 - Between Good and Fair
Deficiency	DAMAGED FLOOR
Deficiency Location/Instance	Right Side, Center
Deficiency Quantity	20
Quantity Uom	S.F.
Potential Action	REPLACE
Urgency of Action	PRIORITY 3
Purpose of Action	LEVEL 2
Deficiency Photo1

Question	Response
INTERIOR	
AUDITORIUM	
Floor Finish	
Deficiency Quantity	10
Quantity Uom	S.F.
Potential Action	REMOVE
Urgency of Action	PRIORITY 5
Purpose of Action	LEVEL 6
Deficiency Photo1

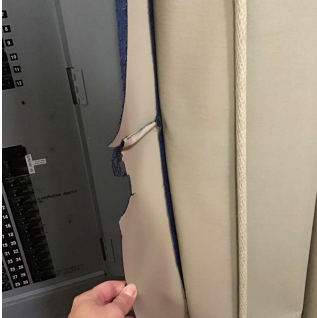
Question	Response
INTERIOR	
AUDITORIUM	
Stage	
Stage Curtains	
Condition	3 - Fair
Deficiency	WORN/DETERIORATED
Deficiency Location/Instance	Left Side
Deficiency Quantity	100
Quantity Uom	S.F.
Potential Action	REPLACE
Urgency of Action	PRIORITY 3
Purpose of Action	LEVEL 2
Deficiency Photo1

Violations	Left Side No violations recorded.
Walls	
Instance on 1st Floor (400 Seats)	Inspected
Condition	2 - Between Good and Fair
Deficiency	PLASTER: CRACKS/SPALLING
Deficiency Location/Instance	Left Side, Right Side near Stage
Deficiency Quantity	60
Quantity Uom	S.F.
Potential Action	REPLACE
Urgency of Action	PRIORITY 3
Purpose of Action	LEVEL 2
Deficiency Photo1

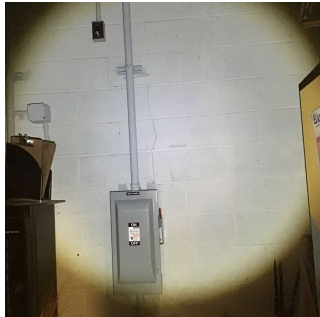
Violations	Left Side No violations recorded.
Deficiency	MASONRY: CRACKS/SPALLING
Deficiency Location/Instance	Storage Room
Deficiency Quantity	10
Quantity Uom	S.F.
Potential Action	REPLACE
Urgency of Action	PRIORITY 3

Storage Room
Violations	No violations recorded.
Window Curtains/Shades/Blinds	
Instance on 1st Floor (400 Seats)	Does not Exist
CAFETERIA	
	Inspected
Instance on 1st Floor - Staff (600 SF)	Inspected
Instance on 1st Floor - Students	Inspected
Ceiling	
Instance on 1st Floor - Students	Inspected
Condition	2 - Between Good and Fair
Deficiency	METAL PAN: DAMAGED/MISSING
Deficiency Location/Instance	Center, Near Entrance
Deficiency Quantity	20
Quantity Uom	S.F.
Potential Action	REPLACE
Urgency of Action	PRIORITY 3
Purpose of Action	LEVEL 2
Deficiency Photo1

Question	Response
INTERIOR	
AUDITORIUM	
Walls	
Purpose of Action	LEVEL 2
Deficiency Photo1

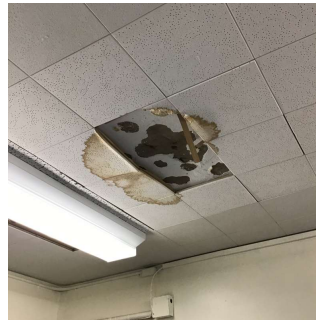
Near Entrance

ACOUSTIC TILES ON PLASTER: DAMAGED/MISSING - ACTIVE LEAK

REPLACE

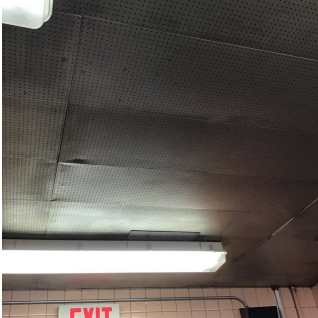
Question	Response
INTERIOR	
KITCHEN	
Ceiling	
Deficiency Location/Instance	Near Entrance, Left Side
Deficiency Quantity	20
Quantity Uom	S.F.
Potential Action	REPLACE
Urgency of Action	PRIORITY 3
Purpose of Action	LEVEL 2
Deficiency Photo1

Violations	Near Entrance No violations recorded.
Door(s)	
Instance on 1st Floor	Inspected
Condition	3 - Fair
Deficiency	WOOD: DETERIORATED DOOR
Deficiency Location/Instance	Storage Room
Deficiency Quantity	1
Quantity Uom	EACH
Potential Action	MAINTENANCE
Urgency of Action	PRIORITY 3
Purpose of Action	LEVEL 2
Deficiency Photo1

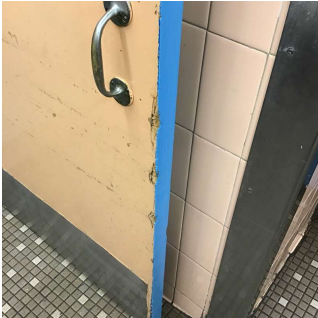
Violations	Storage Room No violations recorded.
Floor Finish	
Instance on 1st Floor	Inspected
Condition	3 - Fair
Deficiency	CERAMIC TILE: BROKEN/MISSING TILES
Deficiency Location/Instance	Main Entrance, prep area, Near hallway Entrance
Deficiency Quantity	50
Quantity Uom	S.F.
Potential Action	REPLACE
Urgency of Action	PRIORITY 3

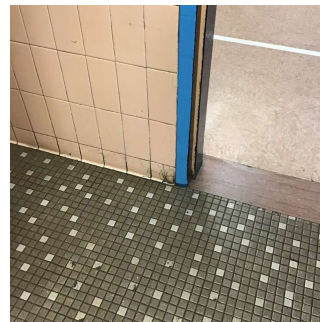
Deficiency	CERAMIC TILE: BROKEN/ MISSING
Deficiency Location/Instance	Near hallway Entrance, prep Area
Deficiency Quantity	20
Quantity Uom	S.F.
Potential Action	REPLACE
Urgency of Action	PRIORITY 3
Purpose of Action	LEVEL 2
Deficiency Photo1

Near hallway Entrance
No violations recorded.

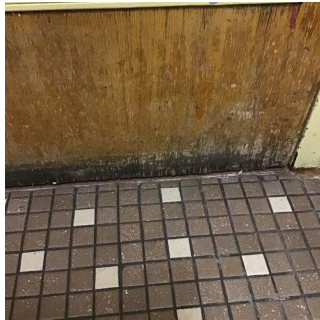
Room 323
Violations	No violations recorded.
Door(s)	
Condition	Inspected
	5 - Poor
Deficiency	WOOD: DETERIORATED DOOR
Deficiency Location/Instance	Room 225, Inside Room 136
Deficiency Quantity	2
Quantity Uom	EACH
Potential Action	MAINTENANCE
Urgency of Action	PRIORITY 3
Purpose of Action	LEVEL 2
Deficiency Photo1

Room 225
Violations	No violations recorded.
Floor Finish	
Condition	Inspected
	2 - Between Good and Fair
Deficiency	No deficiencies recorded
Stalls	
Condition	Inspected
	2 - Between Good and Fair
Deficiency	No deficiencies recorded
Walls	
Condition	Inspected
	2 - Between Good and Fair
Deficiency	CERAMIC TILE: BROKEN/ MISSING
Deficiency Location/Instance	Inside Gymnasium, Room 136
Deficiency Quantity	20
Quantity Uom	S.F.
Potential Action	REPLACE
Urgency of Action	PRIORITY 3
Purpose of Action	LEVEL 2

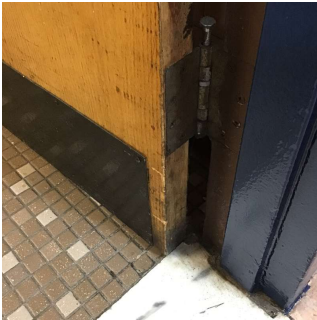
Violations	Room 129 No violations recorded.
Door(s)	Inspected
Condition	5 - Poor
Deficiency	WOOD: DETERIORATED DOOR
Deficiency Location/Instance	Rooms 321, 229, 142, 107
Deficiency Quantity	4
Quantity Uom	EACH
Potential Action	MAINTENANCE
Urgency of Action	PRIORITY 3
Purpose of Action	LEVEL 2
Deficiency Photo1

Violations	Room 142 No violations recorded.
Floor Finish	Inspected
Condition	2 - Between Good and Fair
Deficiency	CERAMIC TILE: DETERIORATED SUBSTRATE
Deficiency Location/Instance	Room 221
Deficiency Quantity	10
Quantity Uom	S.F.
Potential Action	REPLACE
Urgency of Action	PRIORITY 3
Purpose of Action	LEVEL 2
