**NYC Department of Education
Building Condition Assessment Survey 2023 - 2024**

Architectural Inspection

Asset: I.S. 259 - BROOKLYN, 7305 FT HAMILTON PKWY, New York, 11228

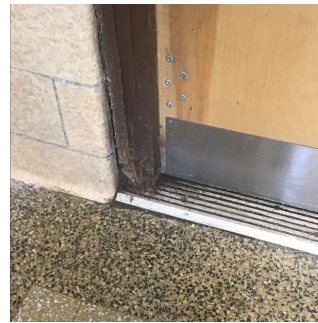
Facade A - Exit 4

METAL CLAD: DETERIORATED DOOR AND FRAME - MAJOR DETERIORATION

3
EACH
REPLACE
PRIORITY 4
LEVEL 2

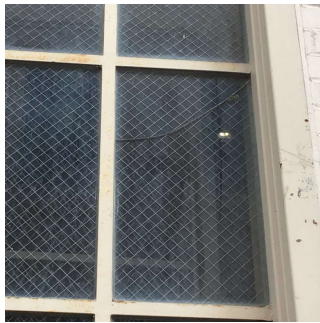
METAL: BROKEN GLASS

Violations	Facade C - Exit 13 No violations recorded.
EXTERIOR WALLS	Inspected
Material Type(s)	Concrete, Masonry
Replacement Quantity	60,000
Replacement Uom	S.F.
Instance on All Facades	Inspected
Instance Condition	3 - Fair
Instance Quantity	60,000
Instance Quantity Uom	S.F.
Deficiency	BRICK: DETERIORATED CONTROL/EXPANSION JOINTS
Roof Plan reference

10
 S.F.
 MAINTENANCE
 PRIORITY 3
 LEVEL 2

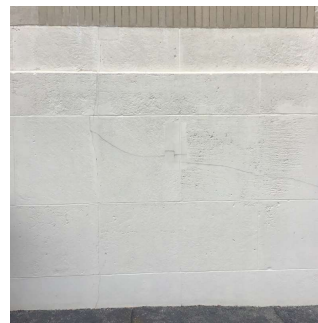
Facade F

CAST IN PLACE / PRE-CAST CONCRETE: MINOR CRACKS/SPALLING

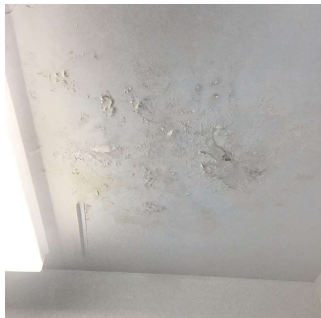
Question	Response
EXTERIOR	
ROOF	
Roofing	
ROOFING	
	Roof 2
Instance Quantity	25,300
Instance Quantity Uom	S.F.
Does the roof have major mechanical equipment sitting on Dunnage Steel less than 18" above the Roofing?	No
Does this roof instance have a Sustainable Roof System?	Yes
Sustainable Roof Type	White Roof
Sustainable Roof Location (Roof Number)	Roofs 1-3, 5-8
Do solar panels exist on these roofs?	No
Is/Are the roof(s) suitable for Solar Panel installation?	Yes
Installation Year	2017
Source of Installation	Custodial Staff
Deficiency	MODIFIED BITUMEN: ROOFING: MAJOR ACTIVE ROOF LEAKS IN INSTRUCTIONAL SPACE
Roof Plan reference

Violations	Roof 1 - Room 426 shown, Roof 2 - 4th Floor Gymnasium No violations recorded.
Deficiency	MODIFIED BITUMEN: ROOFING: DELAMINATION

Deficiency Quantity	200
Quantity Uom	S.F.
Potential Action	REPLACE ROOFING WITHOUT MAJOR EQUIPMENT REMOVAL
Urgency of Action	PRIORITY 5
Purpose of Action	LEVEL 2
Deficiency Photo1

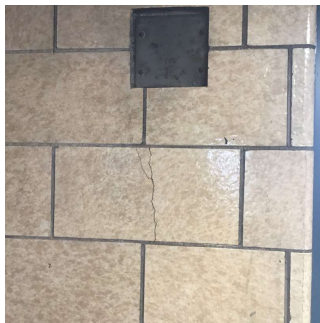
Violations	PH No violations recorded.
Deficiency	BULKHEAD/PENTHOUSE WALLS/INTERIOR: GLAZED BLOCK CRACKS/SPALLING
Roof Plan reference

Deficiency Quantity	20
Quantity Uom	S.F.
Potential Action	REPLACE
Urgency of Action	PRIORITY 3
Purpose of Action	LEVEL 2
Deficiency Photo1

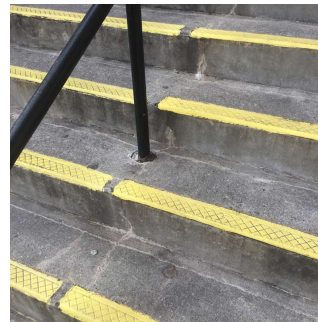
Facade C

CONCRETE: CRACKS/SPALLING - MINOR

REPAIR

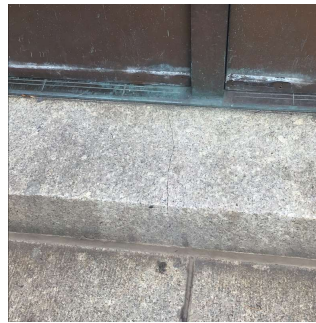
Facade G - Near Exit 8

STONE: CRACKS/SPALLING - MINOR

REPAIR

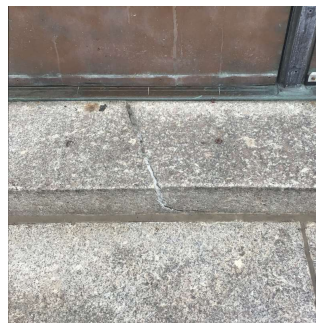
Facade H - Exit 6

STONE: CRACKS/SPALLING - MAJOR

REPLACE

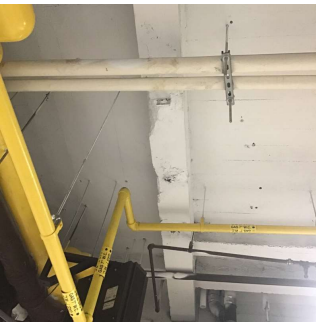
Yes	Potential Falling Debris	Deteriorated concrete fireproofing is a potential falling debris hazard.	INTERIOR STRUCTURAL COLUMNS/BEARING WALLS	Basement - Boiler Room, Room B04	Shawn Cavanagh	Custodian

Question	Response
INTERIOR	
STRUCTURAL	
COLUMNS/BEAMS/BEARING WALLS	
Deficiency Photo1

Boiler Room	Boiler Room
Violations	No violations recorded.
Deficiency	STEEL COLUMNS/BEAMS: DETERIORATED CONCRETE FIREPROOFING
Deficiency Location/Instance	Basement - Boiler Room, Room B04
Deficiency Quantity	40
Quantity Uom	S.F.
Potential Action	REPLACE
Urgency of Action	PRIORITY 5
Purpose of Action	LEVEL 6
Deficiency Photo1

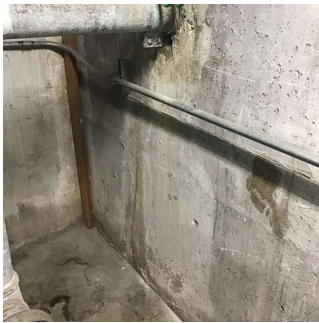
Violations	Basement - Mechanical Equipment Room South No violations recorded.
ROOF STRUCTURE	
Condition	Inspected
Deficiency	2 - Between Good and Fair
VAULTS-BUNKERS	
Foundation Walls	Inspected
Condition	2 - Between Good and Fair
Deficiency	No deficiencies recorded
Slab Structure	Inspected
Condition	2 - Between Good and Fair
Deficiency	No deficiencies recorded
Vault/Ash Hoist Doors and Framing	Inspected
Condition	1 - Good
Deficiency	No deficiencies recorded
AUDITORIUM	
Instance on 1st Floor (525 Seats)	Inspected
Ceiling	
Instance on 1st Floor (525 Seats)	Inspected
Condition	2 - Between Good and Fair
Deficiency	No deficiencies recorded
Door(s)	
Instance on 1st Floor (525 Seats)	Inspected
Condition	3 - Fair
Deficiency	WOOD: DETERIORATED DOOR
Deficiency Location/Instance	Main Entrance
Deficiency Quantity	2
Quantity Uom	EACH
Potential Action	MAINTENANCE

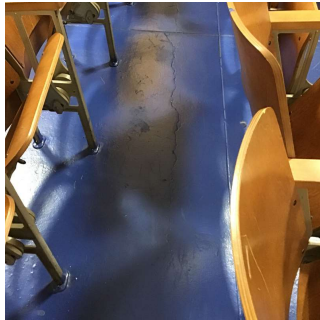
Question	Response
INTERIOR	
AUDITORIUM	
Floor Finish	
Condition	2 - Between Good and Fair
Deficiency	CONCRETE: CRACKS
Deficiency Location/Instance	Near Rows F, G, M
Deficiency Quantity	60
Quantity Uom	S.F.
Potential Action	REPLACE
Urgency of Action	PRIORITY 3
Purpose of Action	LEVEL 2
Deficiency Photo1

Violations	Near Row M No violations recorded.
Deficiency	VINYL TILES: BROKEN/DETERIORATED/MISSING TILES
Deficiency Location/Instance	Left Side
Deficiency Quantity	10
Quantity Uom	S.F.
Potential Action	REPLACE
Urgency of Action	PRIORITY 3
Purpose of Action	LEVEL 2
Deficiency Photo1

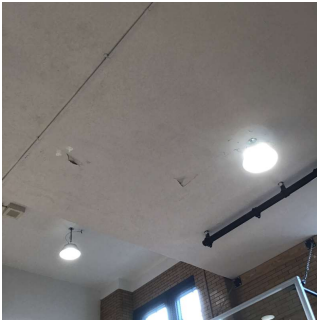
Question	Response
INTERIOR	
GYMNASIUM	
Ceiling	
Deficiency Photo1

Near Main Entrance
Violations	No violations recorded.
Door(s)	
Instance on 3rd Floor	Inspected
Condition	5 - Poor
Deficiency	WOOD: DETERIORATED DOOR AND FRAME
Deficiency Location/Instance	Office Room
Deficiency Quantity	1
Quantity Uom	EACH
Potential Action	MAINTENANCE
Urgency of Action	PRIORITY 3
Purpose of Action	LEVEL 2
Deficiency Photo1

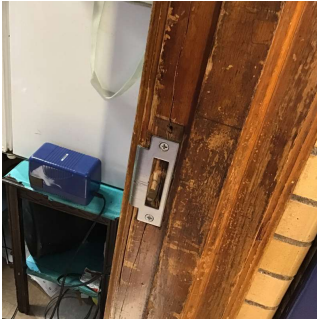
Office Room
Violations	No violations recorded.
Deficiency	WOOD: DETERIORATED DOOR
Deficiency Location/Instance	Main Entrance, Room 301R
Deficiency Quantity	2
Quantity Uom	EACH
Potential Action	MAINTENANCE
Urgency of Action	PRIORITY 3
Purpose of Action	LEVEL 2

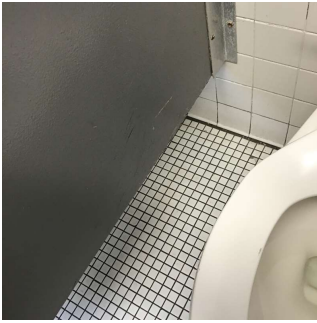
Question	Response
INTERIOR	
TOILET ROOMS - STAFF	
Stalls	
Deficiency Photo1

Violations	Room 218 No violations recorded.
Walls	Inspected
Condition	2 - Between Good and Fair
Deficiency	CERAMIC TILE: BROKEN/ MISSING
Deficiency Location/Instance	Rooms 314,104
Deficiency Quantity	20
Quantity Uom	S.F.
Potential Action	REPLACE
Urgency of Action	PRIORITY 3
Purpose of Action	LEVEL 2
Deficiency Photo1	 
Violations	Room 314 No violations recorded.
TOILET ROOMS - STUDENTS	
Ceiling	Inspected
Condition	2 - Between Good and Fair
Deficiency	No deficiencies recorded
Door(s)	Inspected
Condition	5 - Poor
Deficiency	WOOD: DETERIORATED DOOR
Deficiency Location/Instance	Room 418, Girls Toilet Room - 1st Floor
Deficiency Quantity	2
Quantity Uom	EACH
Potential Action	MAINTENANCE
Urgency of Action	PRIORITY 3
Purpose of Action	LEVEL 2

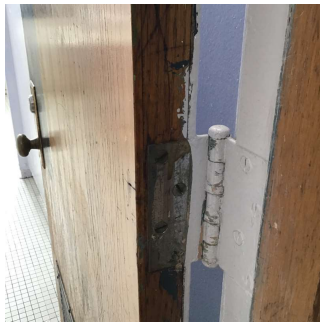
Question	Response
INTERIOR	
TOILET ROOMS - STUDENTS	
Door(s)	
Deficiency Photo1

Violations	Room 418 No violations recorded.
Floor Finish	Inspected
Condition	2 - Between Good and Fair
Deficiency	CERAMIC TILE: DETERIORATED SUBSTRATE
Deficiency Location/Instance	Room 418
Deficiency Quantity	20
Quantity Uom	S.F.
Potential Action	REPLACE
Urgency of Action	PRIORITY 3
Purpose of Action	LEVEL 2
Deficiency Photo1

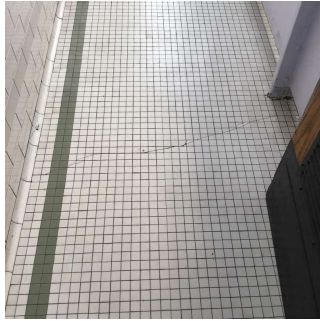
Violations	Room 418 No violations recorded.
Stalls	Inspected
Condition	2 - Between Good and Fair
Deficiency	No deficiencies recorded
Walls	Inspected
Condition	2 - Between Good and Fair
Deficiency	CERAMIC TILE: BROKEN/ MISSING
Deficiency Location/Instance	Room 418, Boys Toilet Room- 1st Floor
Deficiency Quantity	20
Quantity Uom	S.F.
Potential Action	REPLACE
Urgency of Action	PRIORITY 3
Purpose of Action	LEVEL 2

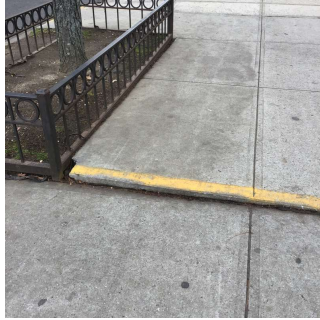
Question	Response
SITE	
PAVING	
DOT Sidewalk	
Concrete	
Urgency of Action	PRIORITY 3
Purpose of Action	LEVEL 2
Deficiency Photo1

74th Street
Violations	No violations recorded.
Deficiency	DAMAGED/DETERIORATED/MISSING SECTIONS
Deficiency Location/Instance	73rd Street, 74th Street, Fort Hamilton Parkway
Deficiency Quantity	600
Quantity Uom	S.F.
Potential Action	REPLACE
Urgency of Action	PRIORITY 3
Purpose of Action	LEVEL 2
Deficiency Photo1

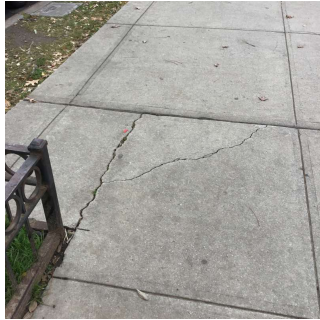
74th Street
Violations	No violations recorded.
Deficiency	DAMAGED CURBS
Deficiency Location/Instance	73rd Street, 74th Street, Fort Hamilton Parkway
Deficiency Quantity	80
Quantity Uom	L.F.
Potential Action	REPLACE
Urgency of Action	PRIORITY 3
Purpose of Action	LEVEL 2
