NYC Department of Education
Building Condition Assessment Survey 2023 - 2024

Architectural Inspection

Asset: P.S./I.S. 323 - BROOKLYN, 210 CHESTER STREET, New York, 11212

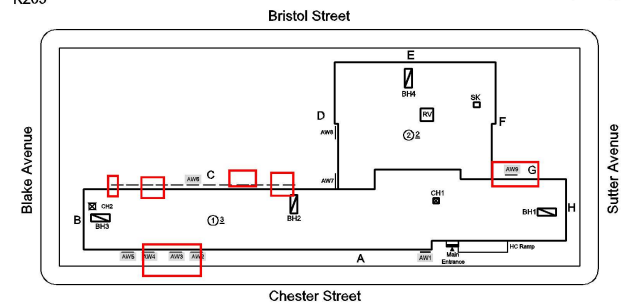
AW4, AW5
No violations recorded.

AREAWAY WALLS: CRACKS AND SPALLING

16
S.F.
REPAIR
PRIORITY 3
LEVEL 2

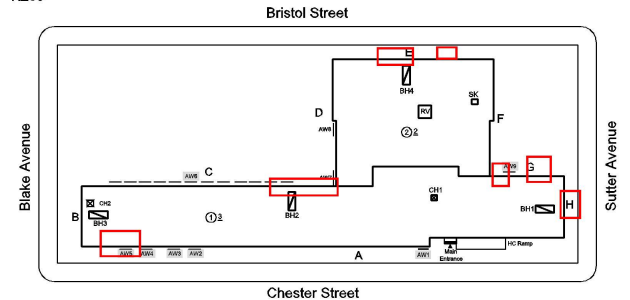
Main Entrance Canopy
No violations recorded.

CONCRETE: MAJOR CRACKS/SPALLING

20
S.F.
REPAIR
PRIORITY 4
LEVEL 2

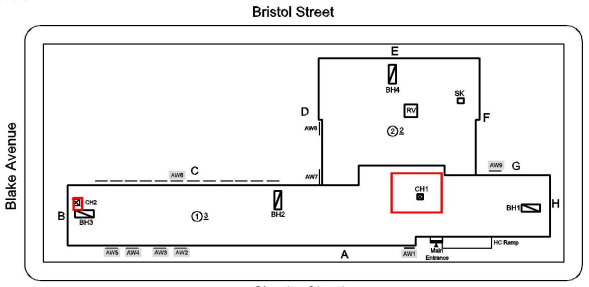
Facade A - South No violations recorded.
CHIMNEY	
Material Type(s)	Masonry
Condition	3 - Fair
Deficiency	BRICK: MAJOR / THRU CRACKS
Roof Plan reference	K263

Deficiency Quantity	15
Quantity Uom	S.F.
Potential Action	REMOVE AND REBUILD
Urgency of Action	PRIORITY 4
Purpose of Action	LEVEL 4
Deficiency Photo1

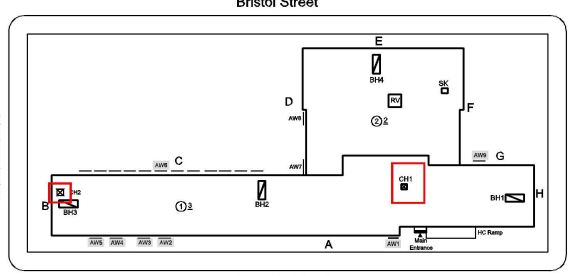
Violations	Chimney 35674680L
Deficiency	BRICK: DETERIORATED JOINTS

Deficiency Quantity	150
Quantity Uom	S.F.
Potential Action	REPOINT
Urgency of Action	PRIORITY 3
Purpose of Action	LEVEL 2
Deficiency Photo1

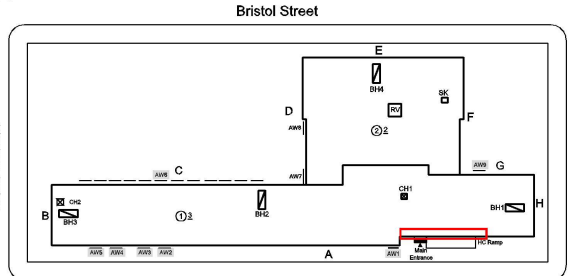
COPING	Inspected
Condition	3 - Fair
Deficiency	METAL: DETERIORATED JOINTS
Roof Plan reference	K263

Deficiency Quantity	25
Quantity Uom	L.F.
Potential Action	REPAIR
Urgency of Action	PRIORITY 3
Purpose of Action	LEVEL 2

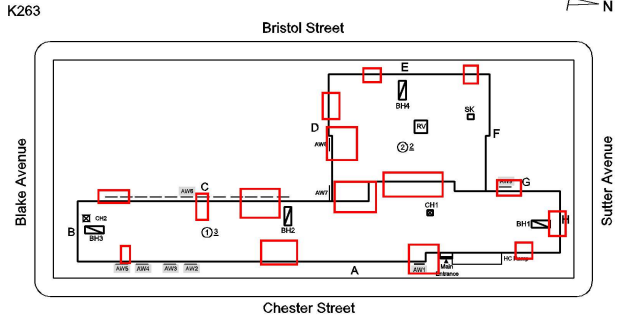
Violations	Facade A - Above Main Entry No violations recorded.
Deficiency	CAST STONE: DETERIORATED TRANSVERSE JOINTS
Roof Plan reference	K263

Deficiency Quantity	70
Quantity Uom	L.F.
Potential Action	MAINTENANCE
Urgency of Action	PRIORITY 3
Purpose of Action	LEVEL 2
Deficiency Photo1

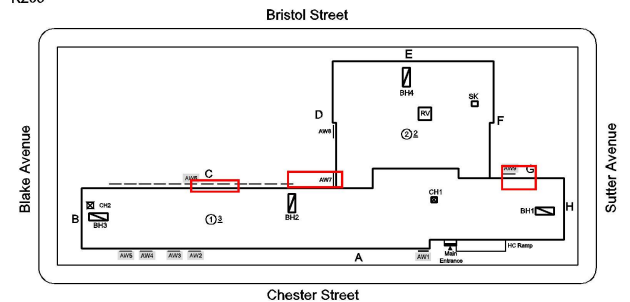
BRICK: MASONRY SILLS - DETERIORATED JOINTS

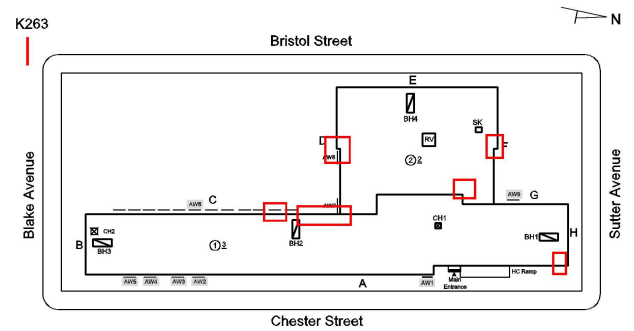
BRICK: MAJOR / THRU CRACKS

100
S.F.
REMOVE AND REBUILD
PRIORITY 4
LEVEL 4

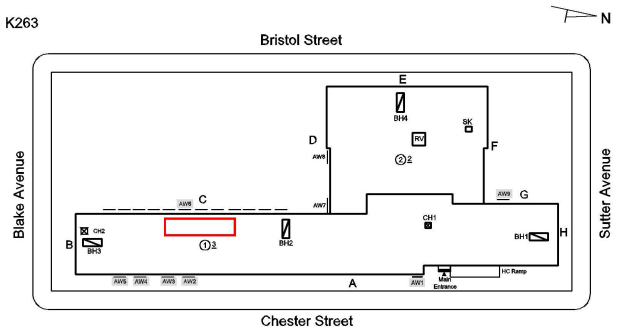
Deficiency IRMA: ROOFING: MAJOR ACTIVE ROOF LEAKS IN INSTRUCTIONAL SPACE

Deficiency Quantity	200
Quantity Uom	S.F.
Potential Action	REPLACE ROOFING WITHOUT MAJOR EQUIPMENT REMOVAL
Urgency of Action	PRIORITY 5
Purpose of Action	LEVEL 2
Deficiency Photo1

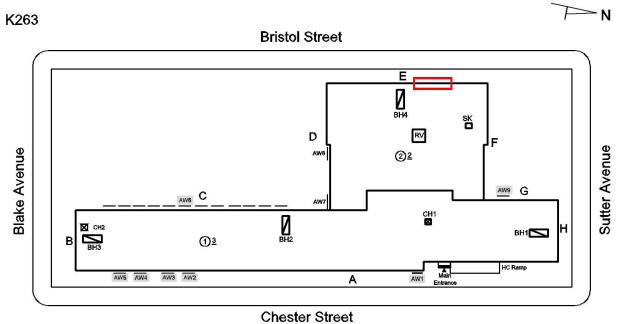
Deficiency IRMA: FLASHING: CAP FLASHING DAMAGED

Deficiency Quantity	10
Quantity Uom	L.F.

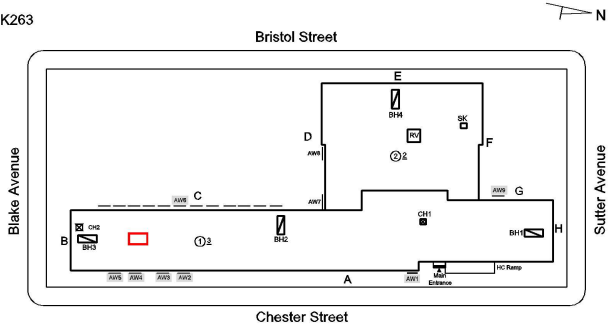
Violations	Roof 2 - Facade E No violations recorded.
Deficiency	IRMA: ROOFING: DAMAGED INSULATION
Roof Plan reference	K263

Deficiency Quantity	10
Quantity Uom	S.F.
Potential Action	REPLACE
Urgency of Action	PRIORITY 4
Purpose of Action	LEVEL 2
Deficiency Photo1

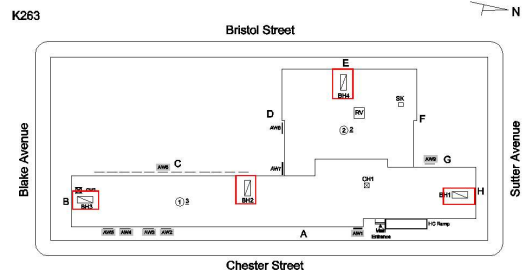
BULKHEAD/PENTHOUSE WALLS/EXTERIOR: WATER INFILTRATION

REPAIR

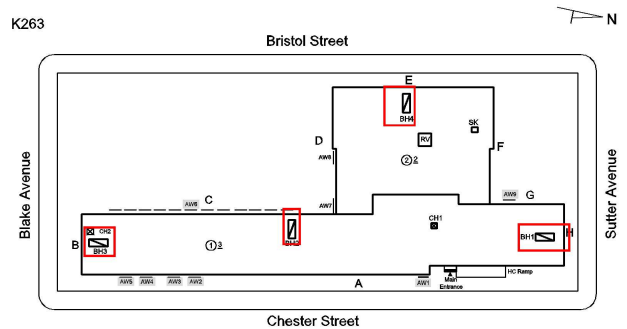
BULKHEAD/PENTHOUSE WALLS/INTERIOR: PLASTER CRACKS/SPALLING

REPLACE

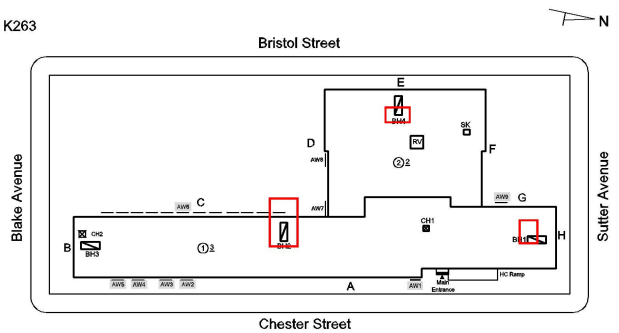
BULKHEAD/PENTHOUSE ROOF: DETERIORATED

REPAIR

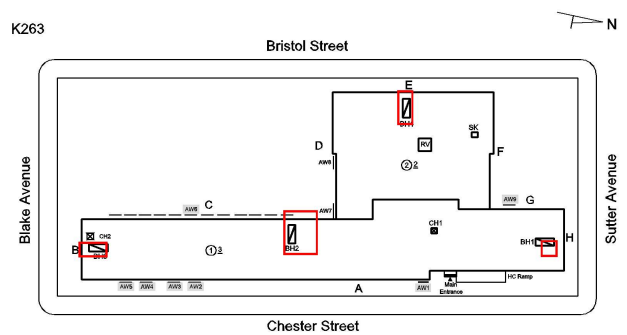
**BULKHEAD/PENTHOUSE WALLS/EXTERIOR:
CRACKS/SPALLING - MAJOR**

50
S.F.
REPLACE
PRIORITY 4
LEVEL 2

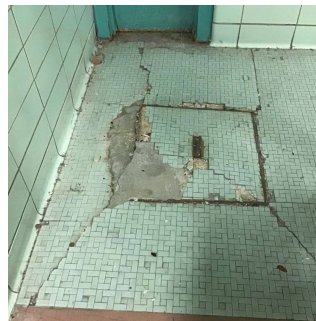
Deficiency	CERAMIC TILE: DETERIORATED SUBSTRATE
Deficiency Location/Instance	Left Side
Deficiency Quantity	25
Quantity Uom	S.F.
Potential Action	REPLACE
Urgency of Action	PRIORITY 5
Purpose of Action	LEVEL 6
Deficiency Photo1

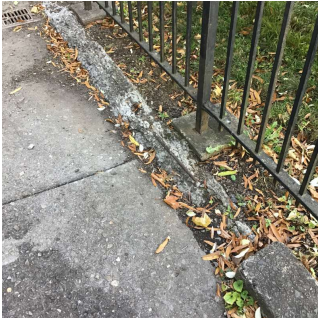
Deficiency	CONCRETE CURB: DAMAGED/DETERIORATED
Deficiency Location/Instance	Near Exit 9
Deficiency Quantity	100
Quantity Uom	S.F.
Potential Action	REPLACE
Urgency of Action	PRIORITY 4
Purpose of Action	LEVEL 4
Deficiency Photo1

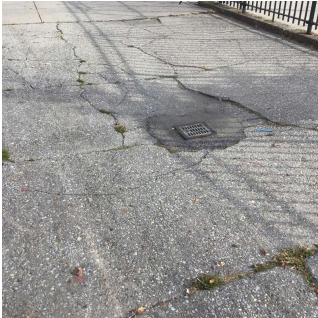
Priority Condition Exist Last Year?	Priority Category	Condition Description	Component Affected	Location Description	Person(s) Notified	Person(s) Title	PhotoImage
Yes	Tripping Hazard	Severely damaged and heaving concrete is a potential tripping hazard.	SITE PAVING Site Sidewalks & Walkways Concrete	Blake Avenue Near Exit 3	Anthony Mark	Fireman

Question	Response
SITE	
PAVING	
Site Sidewalks & Walkways	
Concrete	
Deficiency Location/Instance	Blake Avenue Near Exit 3
Deficiency Quantity	400
Quantity Uom	S.F.
Potential Action	REPLACE
Urgency of Action	PRIORITY 5
Purpose of Action	LEVEL 6
Deficiency Photo1
