**NYC Department of Education**  
**Building Condition Assessment Survey 2023 - 2024**

Architectural Inspection

**Asset: I.S. 265 - BROOKLYN, 101 PARK AVENUE, New York, 11205**

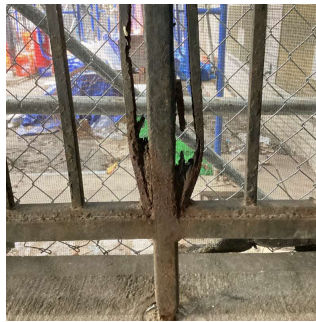
Facade C - Exit 5

Question	Response
<b>EXTERIOR</b>	
<b>ROOF</b>	Inspected
<b>Specialties</b>	Inspected
<b>SKYLIGHT/ROOF VENT</b>	Does not Exist
<b>ROOF/GRAVITY TANK</b>	Does not Exist
<b>STAIRS/RAMPS: EXTERIOR</b>	Inspected
<b>BUILDING CHEEK/FLANK WALLS</b>	Inaccessible
<b>RAILINGS</b>	Inspected
Condition	5 - Poor

Deficiency RUST - MAJOR

40  
L.F.  
REPLACE  
PRIORITY 4  
LEVEL 2

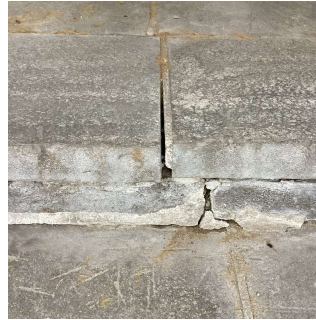
Facade A

<b>STAIRS/RAMPS</b>	Inspected
Condition	5 - Poor

STONE: DETERIORATED JOINTS

L.F.  
REPOINT  
PRIORITY 4  
LEVEL 2

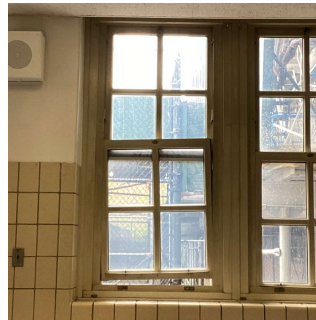
Facade D - Cafeteria

ALUMINUM - DOUBLE HUNG: INOPERABLE BALANCE

150  
EACH  
REPLACE BALANCES  
PRIORITY 3  
LEVEL 2

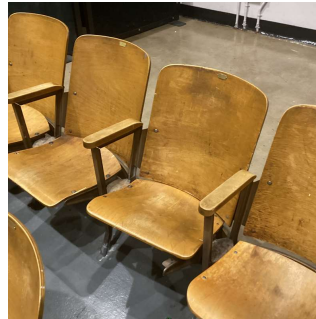
Seat S/112

Condition	5 - Poor
-----------	----------

Deficiency	DAMAGED/BROKEN/INOPERABLE
------------	---------------------------

Deficiency Location/Instance	Seats B/101 S/112
------------------------------	-------------------

Potential Action	REPLACE
------------------	---------

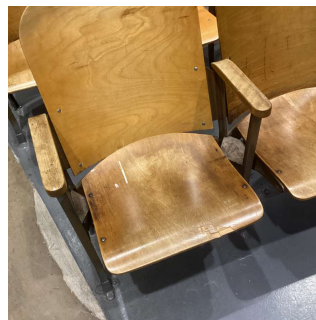
Seat B/1

Deficiency	DAMAGED/BROKEN/INOPERABLE
------------	---------------------------

Deficiency Location/Instance	Seats B/1,3,7, E/9,11 and others
------------------------------	----------------------------------

Potential Action	REPLACE
------------------	---------

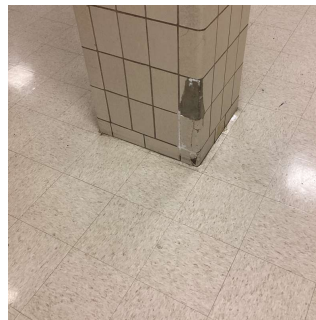
Column

GLAZED BLOCK: CRACKS/SPALLING

REPLACE

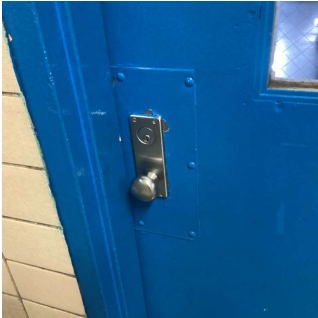
Violations	Main Lobby No violations recorded.
<b>Door(s)</b>	
Condition	5 - Poor
Deficiency	WOOD: DETERIORATED DOOR
Deficiency Location/Instance	Rooms 112, 135, 210, 212, 218 and others
Deficiency Quantity	7
Quantity Uom	EACH
Potential Action	MAINTENANCE
Urgency of Action	PRIORITY 3
Purpose of Action	LEVEL 2
Deficiency Photo1

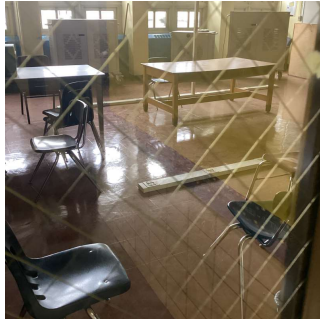
Question	Response
<b>INTERIOR</b>	
<b>CLASSROOMS/CORRIDORS/ADMIN SPACES</b>	
<b>Floor Finish</b>	
Condition	2 - Between Good and Fair
Deficiency	VINYL TILES: TRIPPING HAZARD - ELECTRICAL OUTLET
Deficiency Location/Instance	Room 220
Deficiency Quantity	20
Quantity Uom	S.F.
Potential Action	REMOVE
Urgency of Action	PRIORITY 5
Purpose of Action	LEVEL 6
Deficiency Photo1

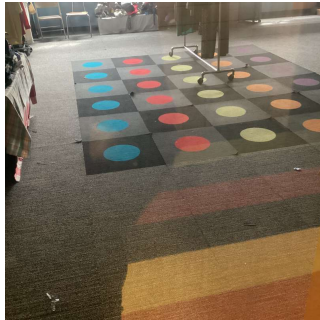
Room 220
Violations	No violations recorded.
Deficiency	CARPET: WORN/DETERIORATED
Deficiency Location/Instance	Rooms 308, 306, 305
Deficiency Quantity	30
Quantity Uom	S.F.
Potential Action	REPLACE
Urgency of Action	PRIORITY 3
Purpose of Action	LEVEL 2
Deficiency Photo1

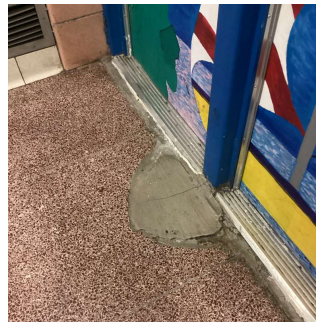
Room 308
Violations	No violations recorded.
Deficiency	TERRAZZO: CRACKS
Deficiency Location/Instance	Main Vestibule
Deficiency Quantity	15
Quantity Uom	S.F.
Potential Action	REPLACE
Urgency of Action	PRIORITY 3
Purpose of Action	LEVEL 2

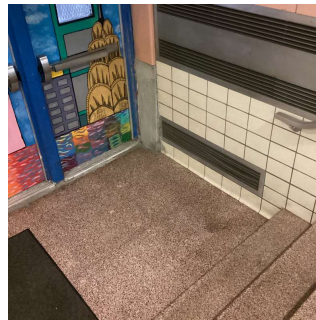
Main Vestibule

STONE: CRACKS/SPALLING

REPLACE

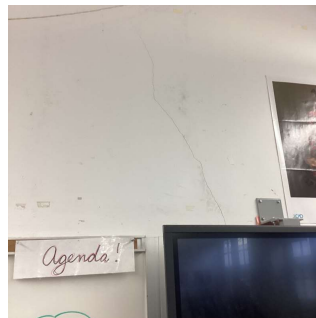
PLASTER: CRACKS/SPALLING

REPLACE

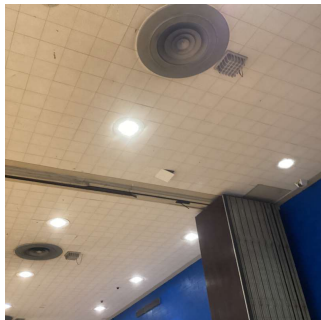
Deficiency	ACOUSTIC TILES ON PLASTER: DAMAGED/MISSING
------------	--

Deficiency Location/Instance	Center
------------------------------	--------

Potential Action	REPLACE
------------------	---------

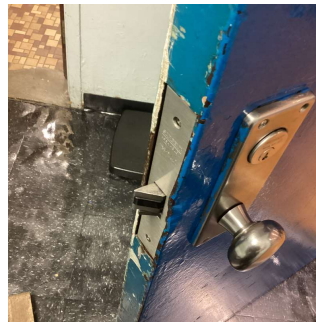
Office	Office
Violations	No violations recorded.

Instance on 1st Floor	Inspected
Condition	4 - Between Fair and Poor
Deficiency	METAL: DETERIORATED DOOR
Deficiency Location/Instance	Offices
Deficiency Quantity	2
Quantity Uom	EACH
Potential Action	MAINTENANCE
Urgency of Action	PRIORITY 3
Purpose of Action	LEVEL 2
Deficiency Photo1

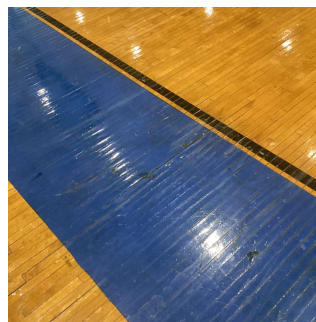
Instance on 1st Floor	Inspected
Condition	2 - Between Good and Fair
Deficiency	WOOD: DAMAGED/DETERIORATED
Deficiency Location/Instance	Near Office
Deficiency Quantity	20
Quantity Uom	S.F.
Potential Action	REPLACE
Urgency of Action	PRIORITY 3
Purpose of Action	LEVEL 2
Deficiency Photo1

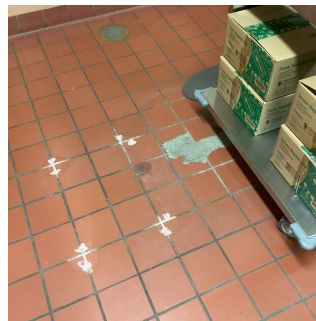
Deficiency	QUARRY TILE: BROKEN/MISSING TILES
Deficiency Location/Instance	Servery
Deficiency Quantity	10
Quantity Uom	S.F.
Potential Action	REPLACE
Urgency of Action	PRIORITY 3
Purpose of Action	LEVEL 2
Deficiency Photo1

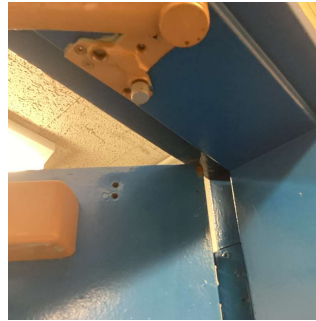
Condition	3 - Fair
Deficiency	METAL: DETERIORATED DOOR
Deficiency Location/Instance	Entrance
Deficiency Quantity	1
Quantity Uom	EACH
Potential Action	MAINTENANCE
Urgency of Action	PRIORITY 3
Purpose of Action	LEVEL 2

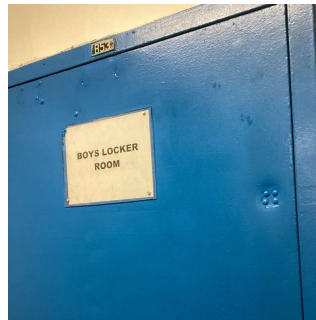
Entrance

METAL: DETERIORATED DOOR

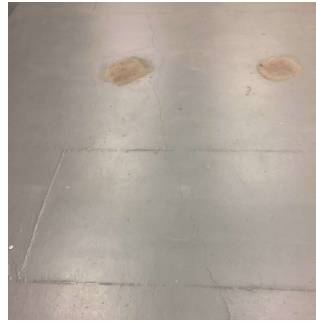
Center

CONCRETE: CRACKS

REPLACE

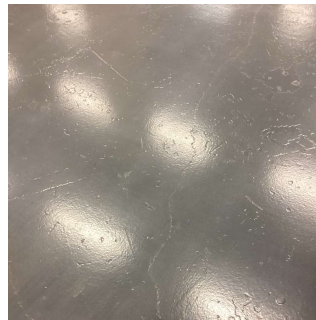
Center

CONCRETE: CRACKS

REPLACE

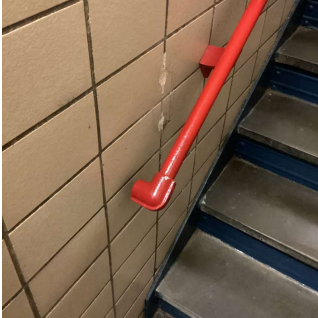
Question	Response
<b>INTERIOR</b>	
<b>STAIRS/RAMPS: INTERIOR</b>	
<b>Railings</b>	Inspected
Condition	3 - Fair
Deficiency	METAL: BROKEN BRACKET
Deficiency Location/Instance	Stair G/Basement
Deficiency Quantity	1
Quantity Uom	EACH
Potential Action	REPLACE
Urgency of Action	PRIORITY 3
Purpose of Action	LEVEL 2
Deficiency Photo1

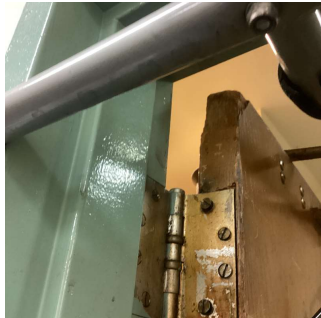
Room B40

Condition	5 - Poor
-----------	----------

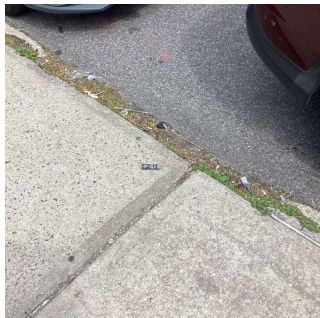
Violations	Along Exit 4 No violations recorded.
<b>Pavers</b>	Does not Exist
<b>DOT Sidewalk</b>	Inspected
<b>Asphalt</b>	Does not Exist
<b>Concrete</b>	Inspected
Condition	4 - Between Fair and Poor
Deficiency	DAMAGED CURBS
Deficiency Location/Instance	N. Oxford Street, Park Avenue
Deficiency Quantity	125
Quantity Uom	L.F.
Potential Action	REPLACE
Urgency of Action	PRIORITY 3
Purpose of Action	LEVEL 2
Deficiency Photo1
