**NYC Department of Education
Building Condition Assessment Survey 2023 - 2024**

Architectural Inspection

Asset: P.S. 269 - BROOKLYN, 1957 NOSTRAND AVENUE, New York, 11210

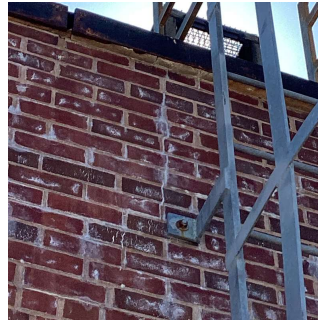
CH

BRICK: MINOR CRACKS AND SPALLING

20
S.F.
RESTITCH
PRIORITY 3
LEVEL 2

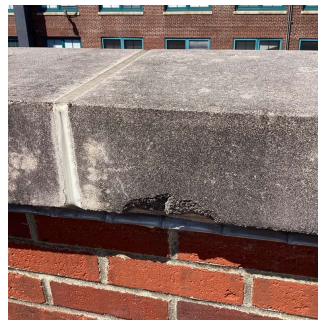
Roof 6 - Facade J

CAST STONE: CRACKED/BROKEN PIECES

REPLACE-IN-KIND

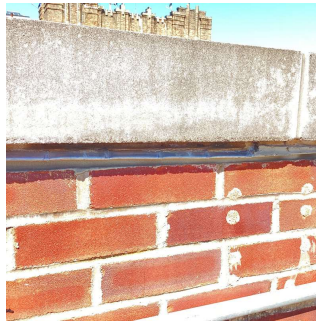
Roof 1 - Facade A

CAST STONE: DETERIORATED BED JOINT

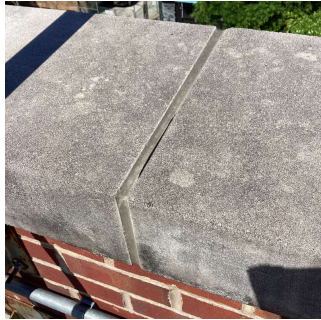
CAST STONE: DETERIORATED TRANSVERSE JOINTS

Violations	Roof 1 - Facade A No violations recorded.
CORNICE	Does not Exist
DOORS	Inspected
DOORS AND FRAMES	Inspected
Condition	5 - Poor
Deficiency	METAL: DETERIORATED DOOR AND FRAME - MAJOR DETERIORATION
Roof Plan reference

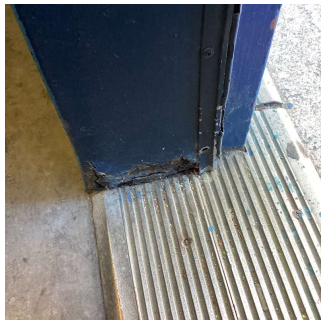
Deficiency Quantity	8
Quantity Uom	EACH
Potential Action	REPLACE
Urgency of Action	PRIORITY 4
Purpose of Action	LEVEL 2
Deficiency Photo1

Violations	Facade A - Main Entrance No violations recorded.
DOOR HARDWARE	Inspected
Condition	3 - Fair
Deficiency	No deficiencies recorded
LINTELS	Inspected
Condition	2 - Between Good and Fair

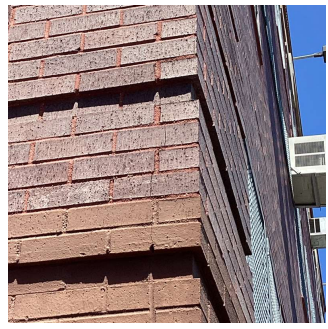
Facade L

Deficiency Quantity: 20
 Quantity Uom: S.F.
 Potential Action: RESTITCH
 Urgency of Action: PRIORITY 3
 Purpose of Action: LEVEL 2
 Deficiency Photo1

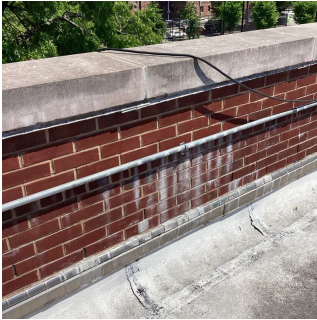
Question	Response
EXTERIOR	
PARAPETS	
Deficiency Photo1

Violations	Roof 7 - Facade F No violations recorded.
Deficiency	BRICK: DETERIORATED JOINTS
Roof Plan reference

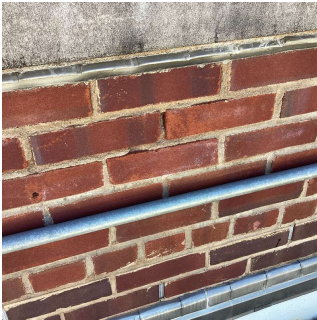
Deficiency Quantity	60
Quantity Uom	S.F.
Potential Action	REPOINT
Urgency of Action	PRIORITY 3
Purpose of Action	LEVEL 2
Deficiency Photo1

Violations	Roof 1 - Facade C No violations recorded.
PLAZA DECK	Does not Exist
ROOF	Inspected
Roofing	Inspected
Replacement Quantity	38,000
Replacement Uom	S.F.
ROOF HATCH/SMOKE HATCH	Inspected
Condition	2 - Between Good and Fair
Deficiency	No deficiencies recorded
LEADERS, GUTTERS, DOWNSPOUTS, SCUPPERS	Inspected
Condition	2 - Between Good and Fair

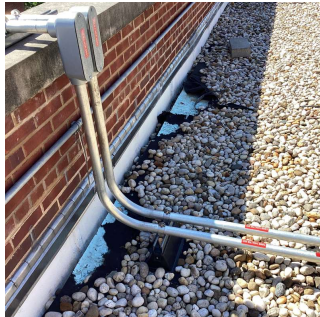
Roof 1
Instance Quantity	14,500
Instance Quantity Uom	S.F.
Does the roof have major mechanical equipment sitting on Dunnage Steel less than 18" above the Roofing?	Yes
Does this roof instance have a Sustainable Roof System?	No
Do solar panels exist on these roofs?	Yes
Solar Panel Location (Roof Number)	Roof 1
Installation Year	2016
Source of Installation	Custodial Staff
Deficiency	IRMA: ROOFING: DAMAGED INSULATION
Roof Plan reference

Deficiency Quantity	60
Quantity Uom	S.F.
Potential Action	REPLACE
Urgency of Action	PRIORITY 4
Purpose of Action	LEVEL 2

Roof 1 - Near CH
Violations	No violations recorded.
Instance on Modified Bitumen: Roofs 2 - 7	Inspected
Instance Condition	2 - Between Good and Fair
Instance Photo

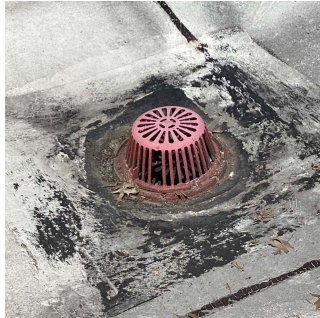
Roof 2a
Instance Quantity	23,500
Instance Quantity Uom	S.F.
Does the roof have major mechanical equipment sitting on Dunnage Steel less than 18" above the Roofing?	No
Does this roof instance have a Sustainable Roof System?	Yes
Sustainable Roof Type	White Roof
Sustainable Roof Location (Roof Number)	Roofs 2 - 7
Do solar panels exist on these roofs?	Yes
Solar Panel Location (Roof Number)	Roofs 2a, 4a, 6, 7
Installation Year	2016
Source of Installation	Custodial Staff
Deficiency	No deficiencies recorded
ROOFING DRAINS	Inspected
Condition	3 - Fair
Deficiency	DETERIORATED
Roof Plan reference

Deficiency Quantity	1
Quantity Uom	EACH
Potential Action	REPLACE

Question	Response
EXTERIOR	
ROOF	
Roofing	
ROOFING DRAINS	
Urgency of Action	PRIORITY 4
Purpose of Action	LEVEL 2
Deficiency Photo1

Violations	Roof 7 No violations recorded.
Specialties	Inspected
BULKHEAD/PENTHOUSE	Inspected
Condition	3 - Fair
Deficiency	BULKHEAD/PENTHOUSE WALLS/EXTERIOR: EFFLORESCENCE
Roof Plan reference

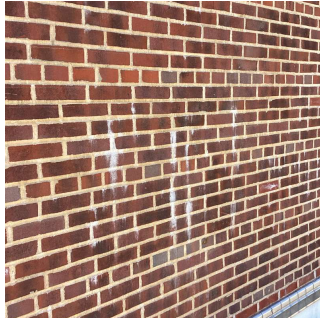
Deficiency Quantity	30
Quantity Uom	S.F.
Potential Action	MAINTENANCE
Urgency of Action	PRIORITY 3
Purpose of Action	LEVEL 2
Deficiency Photo1

Violations	BH2 No violations recorded.
Deficiency	BULKHEAD/PENTHOUSE WALLS/INTERIOR: PLASTER CRACKS/SPALLING

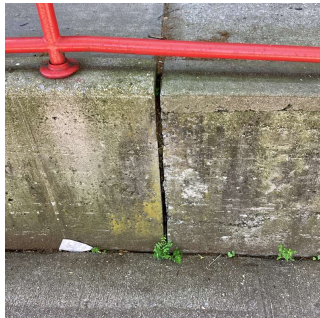
Violations	Roof 1 No violations recorded.
SKYLIGHT/ROOF VENT	Does not Exist
ROOF/GRAVITY TANK	Does not Exist
STAIRS/RAMPS: EXTERIOR	Inspected
BUILDING CHEEK/FLANK WALLS	Inspected
Condition	3 - Fair
Deficiency	CAST IN PLACE CONCRETE: DETERIORATED CONTROL/EXPANSION JOINT
Roof Plan reference

<p>K269</p> <p>10 L.F. REPLACE PRIORITY 3 LEVEL 2</p>
Deficiency Quantity	
Quantity Uom	
Potential Action	
Urgency of Action	
Purpose of Action	
Deficiency Photo1

Violations	Facade B - HC Ramp No violations recorded.
Deficiency	CAST IN PLACE CONCRETE: CRACKS/SPALLING - MAJOR

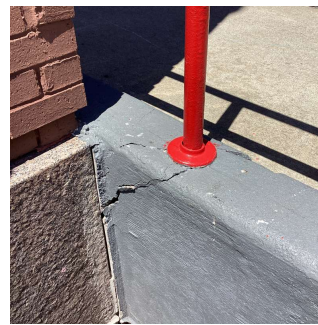
Facade L - HC Ramp
No violations recorded.

15
S.F.
REPLACE
PRIORITY 4
LEVEL 2

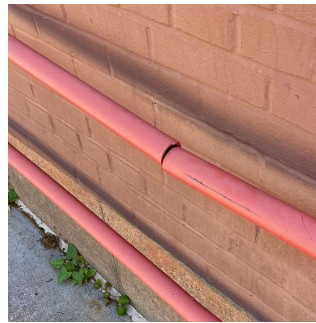
Facade A - HC Ramp

DAMAGED

10
L.F.
REPLACE
PRIORITY 4
LEVEL 2

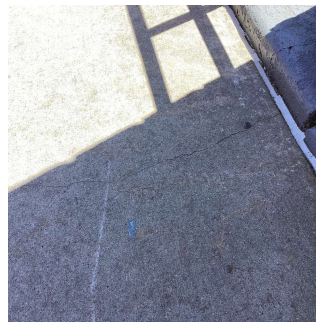
Facade L - HC Ramp

CONCRETE: CRACKS/SPALLING - MINOR

REPAIR

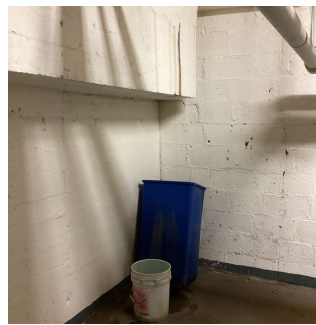
Facade G - Basement- Mechanical Equipment Room
 No violations recorded.

STONE: WATER INFILTRATION IN NON-INSTRUCTIONAL SPACE BELOW

100
 S.F.
 INSTALL NEW
 PRIORITY 5
 LEVEL 2

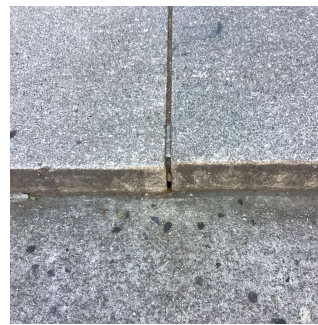
Facade A - Main Entrance
 No violations recorded.

STONE: DETERIORATED JOINTS

20
 L.F.
 REPOINT
 PRIORITY 3
 LEVEL 2

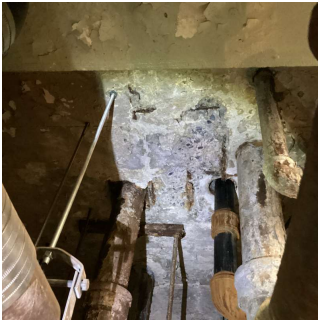
Violations	Electrical Panel Room No violations recorded.
Deficiency	CONCRETE: CRACKS/SPALLED/REINFORCEMENT EXPOSED
Deficiency Location/Instance	Basement - Boiler Room
Deficiency Quantity	20
Quantity Uom	S.F.
Potential Action	REPAIR
Urgency of Action	PRIORITY 4
Purpose of Action	LEVEL 5
Deficiency Photo1

Violations	Boiler Room No violations recorded.
FOUNDATION WALLS	Inspected
Material Type(s)	Concrete, Masonry
Condition	2 - Between Good and Fair

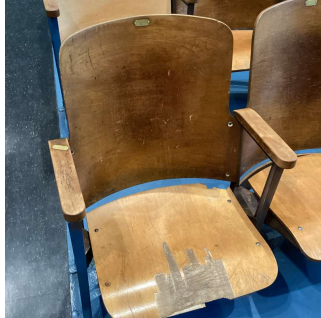
Seat G/101

Deficiency	DAMAGED/BROKEN/INOPERABLE
Deficiency Location/Instance	Seats F/6, G/101, H/101, J/2, K/10 and others
Deficiency Quantity	52
Quantity Uom	EACH
Potential Action	REPLACE
Urgency of Action	PRIORITY 3
Purpose of Action	LEVEL 2
Deficiency Photo1

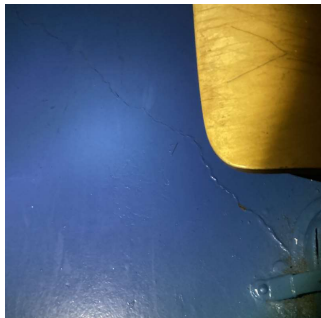
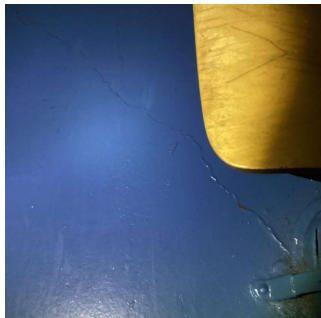
Near Row L

Instance on 1st Floor (412 Seats)	Inspected
Condition	2 - Between Good and Fair
Deficiency	CONCRETE: CRACKS
Deficiency Location/Instance	Near Rows C and L
Deficiency Quantity	20
Quantity Uom	S.F.
Potential Action	REPLACE
Urgency of Action	PRIORITY 3
Purpose of Action	LEVEL 2
Deficiency Photo1

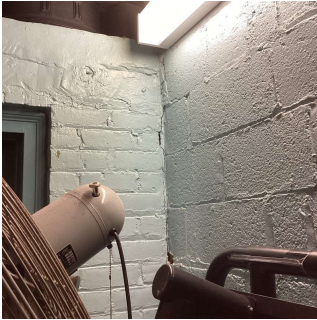
Violations	Near Stair I No violations recorded.
Deficiency	MASONRY: CRACKS/SPALLING
Deficiency Location/Instance	Right and Left Side Backstage
Deficiency Quantity	30
Quantity Uom	S.F.
Potential Action	REPLACE
Urgency of Action	PRIORITY 3
Purpose of Action	LEVEL 2
Deficiency Photo1

Violations	Right Side Backstage No violations recorded.
Window Curtains/Shades/Blinds	
Instance on 1st Floor (412 Seats)	Inspected
Condition	5 - Poor
Deficiency	INOPERABLE CURTAINS
Deficiency Location/Instance	Near Right and Left Side
Deficiency Quantity	6
Quantity Uom	EACH
Potential Action	MAINTENANCE
Urgency of Action	PRIORITY 3
Purpose of Action	LEVEL 2
Deficiency Photo1	No photo recorded
Violations	No violations recorded.
CAFETERIA	
Instance on 1st Floor - Staff(600 SF)	Inspected
Instance on 1st Floor - Students	Inspected
Ceiling	
Instance on 1st Floor - Staff(600 SF)	Inspected

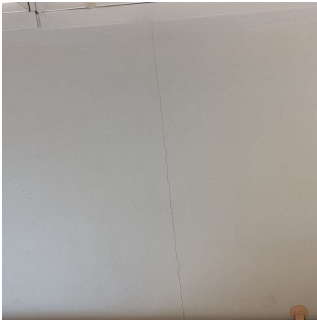
Question	Response
INTERIOR	
CAFETERIA	
Ceiling	
Condition	4 - Between Fair and Poor
Deficiency	PLASTER: CRACKS/SPALLING
Deficiency Location/Instance	Near Windows, by Entrance, close to Servery
Deficiency Quantity	50
Quantity Uom	S.F.
Potential Action	REPLACE
Urgency of Action	PRIORITY 3
Purpose of Action	LEVEL 2
Deficiency Photo1

Violations	Near Windows No violations recorded.
Door(s)	
Instance on 1st Floor - Staff(600 SF)	Inspected
Condition	3 - Fair
Deficiency	METAL: DETERIORATED DOOR
Deficiency Location/Instance	Entrance
Deficiency Quantity	1
Quantity Uom	EACH
Potential Action	MAINTENANCE
Urgency of Action	PRIORITY 3
Purpose of Action	LEVEL 2
Deficiency Photo1

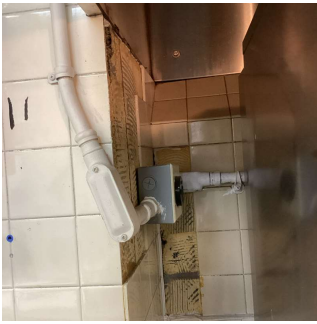
Violations	Sinks Room No violations recorded.
Walls	
Instance on 1st Floor	Inspected
Condition	3 - Fair
Deficiency	CERAMIC TILE: BROKEN/ MISSING
Deficiency Location/Instance	Servery, by Windows, near Sink, next to Ovens, close to Exit and others
Deficiency Quantity	50
Quantity Uom	S.F.
Potential Action	REPLACE
Urgency of Action	PRIORITY 3
Purpose of Action	LEVEL 2
Deficiency Photo1

Violations	Next to Ovens No violations recorded.
LIBRARY	
Instance on Room 113/117	Inspected
Built-in Furnishing	
Instance on Room 113/117	Inspected
Condition	2 - Between Good and Fair
Deficiency	No deficiencies recorded
Ceiling	
Instance on Room 113/117	Inspected
Condition	2 - Between Good and Fair
Deficiency	No deficiencies recorded
Door(s)	
Instance on Room 113/117	Inspected
Condition	2 - Between Good and Fair
Deficiency	No deficiencies recorded
