NYC Department of Education
Building Condition Assessment Survey 2023 - 2024

Architectural Inspection

Asset: P.S. 270 - BROOKLYN, 241 EMERSON PLACE, New York, 11205

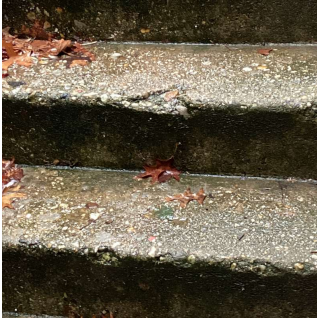
Question	Response
EXTERIOR	
AREAWAY	
Instance Quantity	1
Instance Quantity Uom	EACH
Deficiency	AREAWAY STAIRS: DETERIORATED TREADS/RISERS/NOSINGS
Roof Plan reference	
Deficiency Quantity	20
Quantity Uom	S.F.
Potential Action	REPAIR
Urgency of Action	PRIORITY 3
Purpose of Action	LEVEL 2
Deficiency Photo1	
Violations	No violations recorded.
Deficiency	AREAWAY STAIRS: DETERIORATED TREADS/RISERS/NOSINGS
Roof Plan reference	
Deficiency Quantity	15
Quantity Uom	S.F.
Potential Action	REPLACE
Urgency of Action	PRIORITY 4
Purpose of Action	LEVEL 2

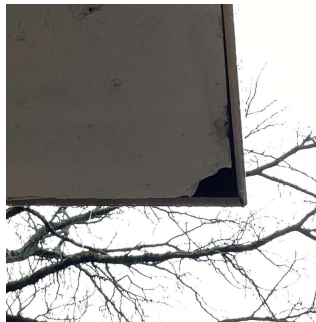
Facade A
No violations recorded.

Violations	AW1 No violations recorded.
Instance on AW2	Inspected
Instance Condition	1 - Good
Instance Quantity	1
Instance Quantity Uom	EACH
Deficiency	No deficiencies recorded
AWNINGS AND CANOPIES	
Condition	Inspected 3 - Fair
Deficiency	CONCRETE: MAJOR CRACKS/SPALLING

35
S.F.
REPAIR
PRIORITY 4
LEVEL 2

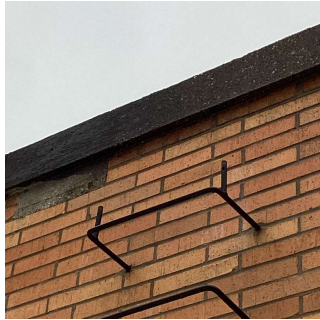
BRICK: DETERIORATED LADDER

1
EACH
REPLACE
PRIORITY 3
LEVEL 2

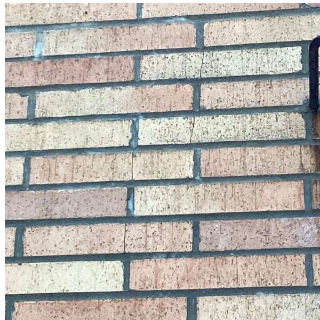
Violations	Chimney No violations recorded.
Deficiency	BRICK: MINOR CRACKS AND SPALLING
Roof Plan reference

Deficiency Quantity	40
Quantity Uom	S.F.
Potential Action	RESTITCH
Urgency of Action	PRIORITY 3
Purpose of Action	LEVEL 2
Deficiency Photo1

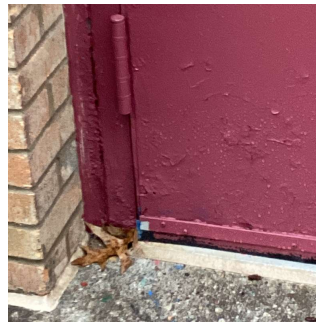
Facade A

Violations	Chimney No violations recorded.
COPING	Inspected
Condition	1 - Good
Deficiency	No deficiencies recorded
CORNICE	Does not Exist
DOORS	Inspected
DOORS AND FRAMES	Inspected
Condition	5 - Poor
Deficiency	METAL CLAD: DETERIORATED DOOR AND FRAME - MAJOR DETERIORATION

5
EACH
REPLACE
PRIORITY 4
LEVEL 2

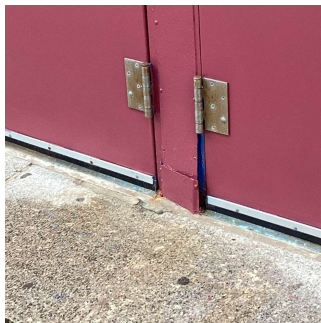
METAL: DETERIORATED DOOR AND FRAME - MINOR DETERIORATION

1
EACH
MAINTENANCE
PRIORITY 3
LEVEL 2

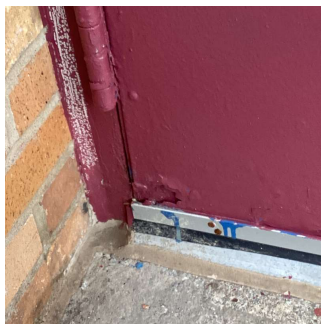
Violations	Facade A No violations recorded.
Deficiency	METAL CLAD: DETERIORATED DOOR - MAJOR DETERIORATION
Roof Plan reference

Deficiency Quantity	2
Quantity Uom	EACH
Potential Action	REPLACE
Urgency of Action	PRIORITY 4
Purpose of Action	LEVEL 2
Deficiency Photo1

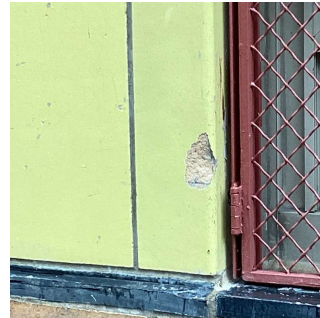
Facade C

TERRA COTTA: CHIPPED/SPALLED/BROKEN PIECES - MAJOR

REPLACE

PRIORITY 4
LEVEL 2

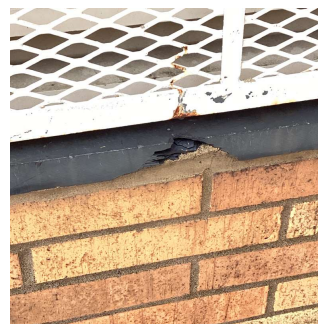
Roof 5

BRICK: DETERIORATED MASONRY SILLS - MAJOR

REMOVE AND REPLACE

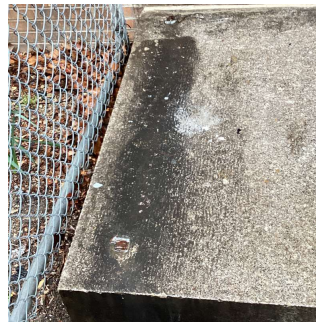
Facade A

MISSING RAILING

10
L.F.
REPLACE
PRIORITY 5
LEVEL 6

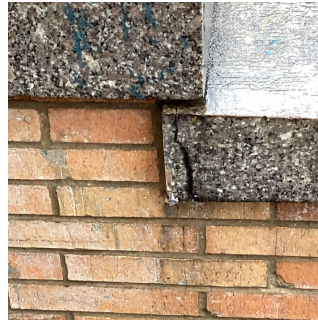
Facade F

STONE: CRACKS/SPALLING - MAJOR

15
S.F.
REPLACE
PRIORITY 4
LEVEL 2

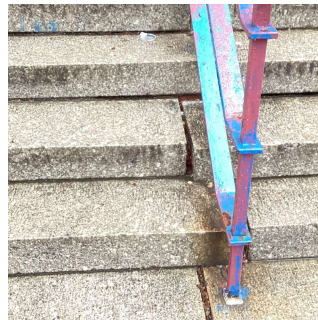
Facade F

STONE: DETERIORATED SUBSTRATE

REPLACE SUBSTRATE AND RESET

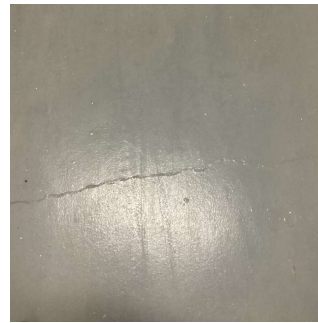
Question	Response
EXTERIOR	
WINDOWS	
WINDOWS	
Instance Quantity Uom	S.F.
Are these windows insulated	No
Installation Year	1999
Source of Installation	Custodial Staff
Deficiency	No deficiencies recorded
INTERIOR	Inspected
POOLS	Does not Exist
STRUCTURAL	Inspected
COLUMNS/BEAMS/BEARING WALLS	Inspected
Condition	2 - Between Good and Fair
Deficiency	No deficiencies recorded
FLOOR STRUCTURE	Inspected
Condition	4 - Between Fair and Poor
Deficiency	CONCRETE SLAB ON GRADE: WATER INFILTRATION IN NON-INSTRUCTIONAL SPACE
Deficiency Location/Instance	Basement
Deficiency Quantity	100
Quantity Uom	S.F.
Potential Action	INSTALL WATERPROOFING
Urgency of Action	PRIORITY 5
Purpose of Action	LEVEL 5
Deficiency Photo1	 
Violations	Basement Corridor No violations recorded.
Deficiency	CONCRETE SLAB ON GRADE: THRU CRACKS
Deficiency Location/Instance	Basement
Deficiency Quantity	25
Quantity Uom	S.F.
Potential Action	REPAIR
Urgency of Action	PRIORITY 3

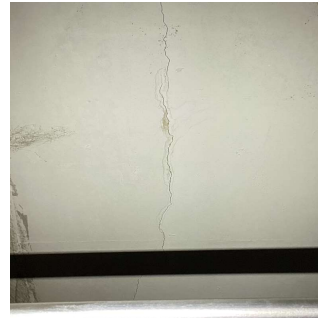
Room B6 (Basement Corridor, Boiler Room similar)

CONCRETE: CRACKS/SPALLED/REINFORCEMENT EXPOSED

REPAIR

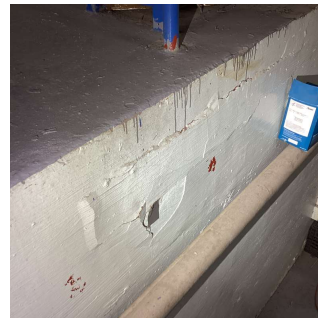
Boiler Room (Basement Stair Vestibule similar)

CONCRETE SLAB ON GRADE: THRU CRACKS

REPLACE

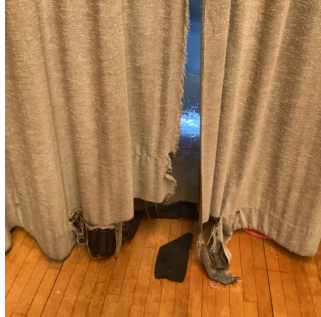
Left Side	
-----------	--

Condition	4 - Between Fair and Poor
-----------	---------------------------

Deficiency	WORN/DETERIORATED
------------	-------------------

Deficiency Location/Instance	Left Side, Right Side, Rear
------------------------------	-----------------------------

Potential Action	REPLACE
------------------	---------

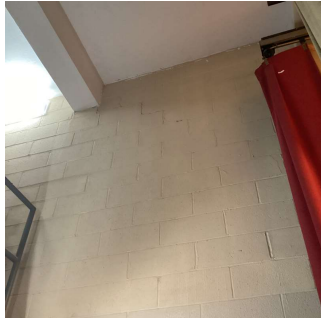
Left Side of Stage	
--------------------	--

Deficiency	MASONRY: CRACKS/SPALLING
------------	--------------------------

Deficiency Location/Instance	Left Side of Stage
------------------------------	--------------------

Potential Action	REPLACE
------------------	---------

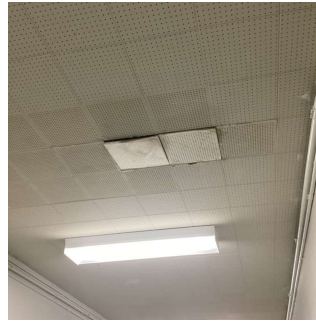
Priority Condition Exist Last Year?	Priority Category	Condition Description	Component Affected	Location Description	Person(s) Notified	Person(s) Title	PhotoImage
Yes	Potential Falling Debris	Damages acoustic tile on plaster resulting in potential safety hazard	INTERIOR CLASSROOMS /CORRIDORS/ ADMIN SPACES Ceiling	Corridor near Room 303	Rahkeim Williams	Fireman

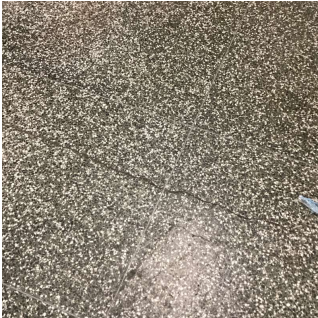
Question	Response
INTERIOR	
KITCHEN	Inspected
Floor Finish	
Deficiency	TERRAZZO: CRACKS
Deficiency Location/Instance	Vestibule
Deficiency Quantity	20
Quantity Uom	S.F.
Potential Action	REPLACE
Urgency of Action	PRIORITY 3
Purpose of Action	LEVEL 2
Deficiency Photo1

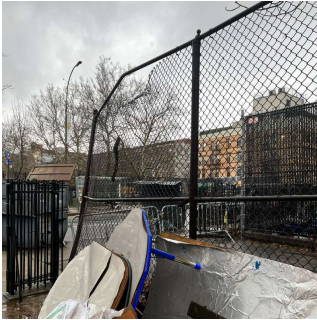
Question	Response
SITE	
DRINKING FOUNTAINS	
Deficiency	INOPERABLE
Deficiency Location/Instance	Schoolyard
Deficiency Quantity	1
Quantity Uom	EACH
Potential Action	MAINTENANCE
Urgency of Action	PRIORITY 3
Purpose of Action	LEVEL 2
Deficiency Photo1	No photo recorded
Violations	No violations recorded.
FENCES	
Condition	Inspected
Deficiency	4 - Between Fair and Poor
Deficiency	CHAIN LINK: DAMAGED POST/RAIL
Deficiency Location/Instance	Exit 3
Deficiency Quantity	30
Quantity Uom	L.F.
Potential Action	REPLACE
Urgency of Action	PRIORITY 3
Purpose of Action	LEVEL 2
Deficiency Photo1

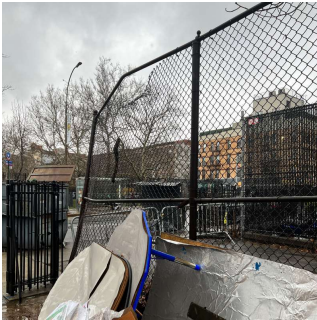
Violations	Exit 3 No violations recorded.
Deficiency	CHAIN LINK: DAMAGED/DETERIORATED
Deficiency Location/Instance	Exit 3
Deficiency Quantity	100
Quantity Uom	S.F.
Potential Action	REPLACE
Urgency of Action	PRIORITY 3
Purpose of Action	LEVEL 2
Deficiency Photo1
