NYC Department of Education
Building Condition Assessment Survey 2023 - 2024

Architectural Inspection

Asset: I.S. 271 - BROOKLYN, 1137 HERKIMER STREET, New York, 11212

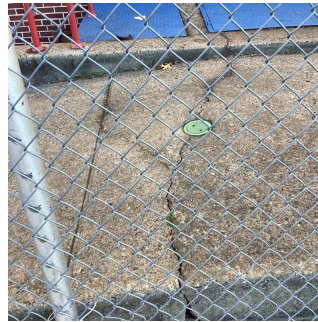
AW2
No violations recorded.

Question	Response
Architectural	
EXTERIOR	Inspected
AREAWAY	Inspected
Instance on AW1 - AW2	Inspected
Instance Condition	3 - Fair
Instance Quantity	2
Instance Quantity Uom	EACH
Deficiency	AREAWAY SLAB: CRACKS AND SPALLING

25
S.F.
REPLACE
PRIORITY 4
LEVEL 2

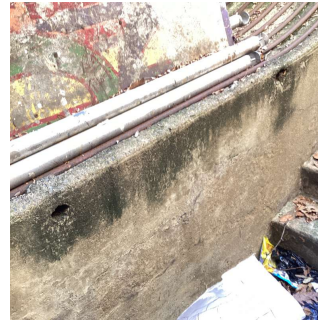
AW2

AREAWAY WALLS: CRACKS AND SPALLING
K271

30
S.F.
REPAIR
PRIORITY 3
LEVEL 2

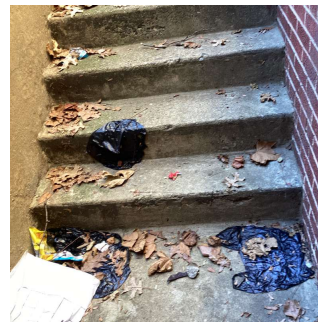
AW2

AREAWAY STAIRS: DETERIORATED
TREADS/RISERS/NOSINGS

REPAIR

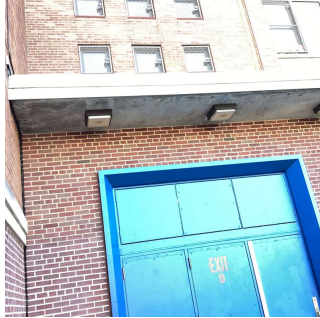
Question	Response
EXTERIOR	
AWNINGS AND CANOPIES	
Deficiency Quantity	10
Quantity Uom	S.F.
Potential Action	REPAIR
Urgency of Action	PRIORITY 3
Purpose of Action	LEVEL 2
Deficiency Photo1

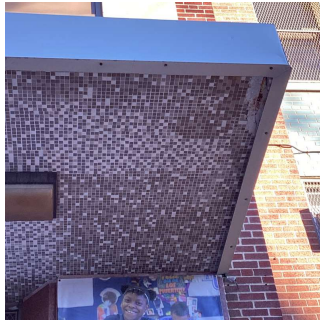
Violations	Facade E No violations recorded.
Deficiency	CONCRETE: DETERIORATED
Roof Plan reference	K271

Deficiency Quantity	10
Quantity Uom	S.F.
Potential Action	REPLACE
Urgency of Action	PRIORITY 4
Purpose of Action	LEVEL 2
Deficiency Photo1

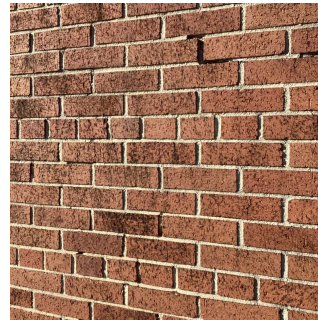
Chimney-1, 2

Violations	Main Entrance No violations recorded.
CHIMNEY	
Material Type(s)	Inspected Masonry
Condition	3 - Fair
Deficiency	BRICK: DETERIORATED JOINTS

100
S.F.
REPOINT
PRIORITY 3
LEVEL 2

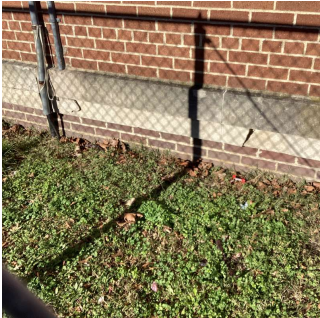
Question	Response
EXTERIOR	
EXTERIOR WALLS	
Replacement Uom	S.F.
Instance on All Facades	Inspected
Instance Condition	3 - Fair
Instance Quantity	32,000
Instance Quantity Uom	S.F.
Deficiency	CAST IN PLACE / PRE-CAST CONCRETE: MAJOR CRACKS/SPALLING
Roof Plan reference	<p>K271</p>

Deficiency Quantity	10
Quantity Uom	S.F.
Potential Action	REPLACE
Urgency of Action	PRIORITY 4
Purpose of Action	LEVEL 2
Deficiency Photo1

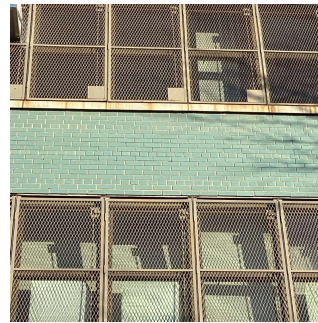
Facade A

BRICK: DETERIORATED JOINTS

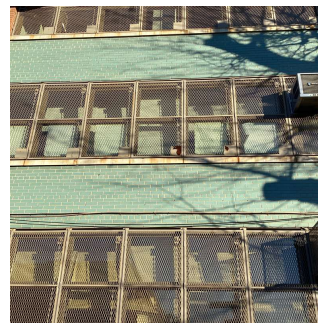
Facade A

BRICK: DETERIORATED MASONRY SILLS - MINOR

REPAIR

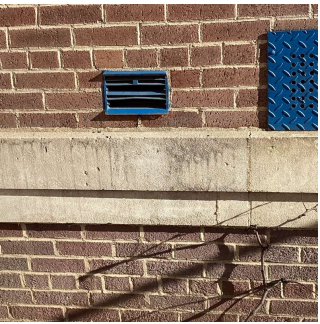
Question	Response
EXTERIOR	
LOADING DOCK	Does not Exist
LOUVER	Inspected
Condition	3 - Fair
Deficiency	BROKEN/ DENTED BLADES
Roof Plan reference	K271

Deficiency Quantity	10
Quantity Uom	S.F.
Potential Action	REPLACE
Urgency of Action	PRIORITY 4
Purpose of Action	LEVEL 2
Deficiency Photo1

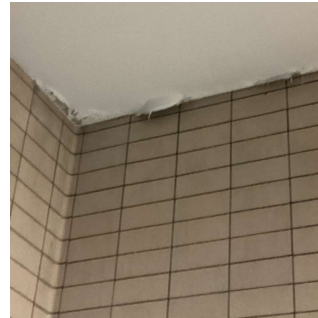
Roof 4 - Stair F/1

Roof 1
Instance Quantity	57,000
Instance Quantity Uom	S.F.
Does the roof have major mechanical equipment sitting on Dunnage Steel less than 18" above the Roofing?	No
Does this roof instance have a Sustainable Roof System?	No
Do solar panels exist on these roofs?	No
Is/Are the roof(s) suitable for Solar Panel installation?	Yes
Installation Year	2003
Source of Installation	Custodial Staff
Deficiency	BUILT-UP: ROOFING: MAJOR ACTIVE ROOF LEAKS IN INSTRUCTIONAL SPACE
Roof Plan reference

Deficiency Quantity	100
Quantity Uom	S.F.
Potential Action	REPLACE ROOFING WITHOUT MAJOR EQUIPMENT REMOVAL

Urgency of Action	PRIORITY 5
Purpose of Action	LEVEL 2

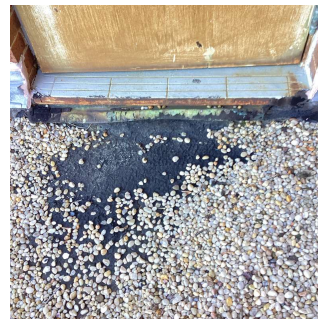
Door to Roof 3

BUILT-UP: FLASHING: CAP FLASHING DAMAGED

REPLACE

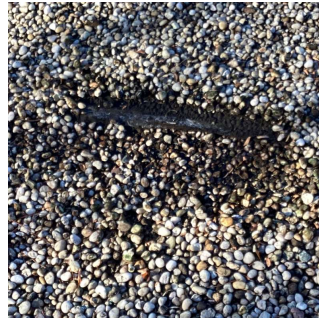
Question	Response
EXTERIOR	
ROOF	
Roofing	
ROOFING	
Quantity Uom	S.F.
Potential Action	REPLACE ROOFING WITHOUT MAJOR EQUIPMENT REMOVAL
Urgency of Action	PRIORITY 4
Purpose of Action	LEVEL 2
Deficiency Photo1

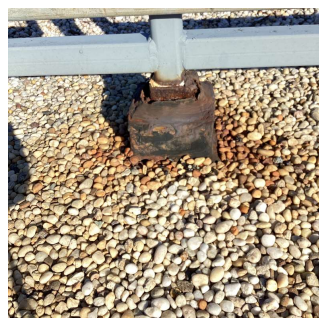
Roof 2	Roof 2
Violations	No violations recorded.
Deficiency	BUILT-UP: FLASHING: PITCH POCKET DETERIORATED - MINOR
Roof Plan reference

Deficiency Quantity	50
Quantity Uom	EACH
Potential Action	REPAIR
Urgency of Action	PRIORITY 3
Purpose of Action	LEVEL 2
Deficiency Photo1

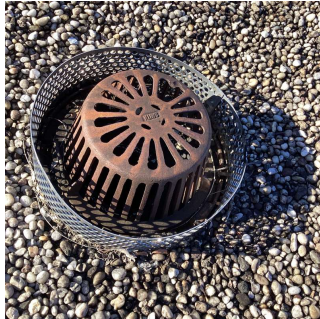
DETERIORATED

3
EACH
REPLACE
PRIORITY 4
LEVEL 2

Question	Response
EXTERIOR	
ROOF	
Roofing	
ROOFING DRAINS	
Deficiency Photo1

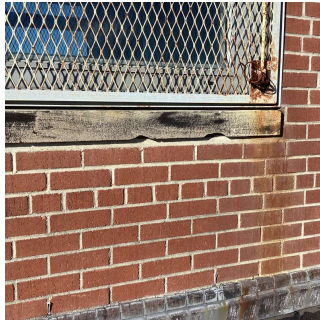
Violations	Roof 1 No violations recorded.
Specialties	Inspected
BULKHEAD/PENTHOUSE	Inspected
Condition	3 - Fair
Deficiency	BULKHEAD/PENTHOUSE WALLS/EXTERIOR: CRACKS/SPALLING - MAJOR
Roof Plan reference	K271

Deficiency Quantity	10
Quantity Uom	S.F.
Potential Action	REPLACE
Urgency of Action	PRIORITY 4
Purpose of Action	LEVEL 2
Deficiency Photo1

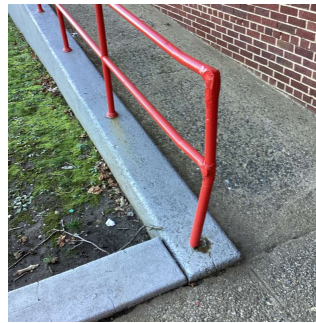
Exit 4

DAMAGED

10
L.F.
REPLACE
PRIORITY 4
LEVEL 2

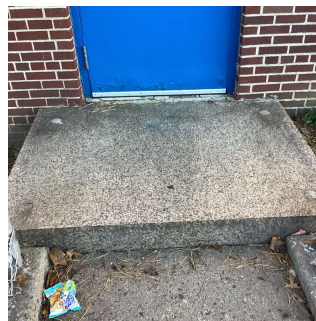
Exit 2

MISSING RAILING

REPLACE

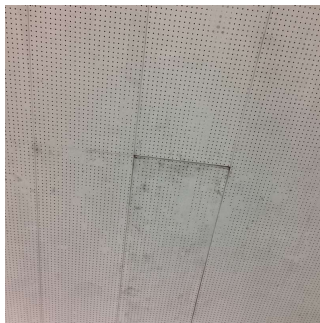
Question	Response
INTERIOR	
CAFETERIA	
Ceiling	
Deficiency Photo1

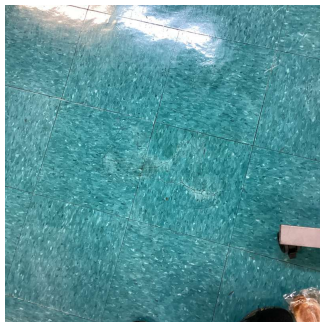
Violations	Near Stair F No violations recorded.
Door(s)	
Instance on Basement	Inspected
Condition	2 - Between Good and Fair
Deficiency	No deficiencies recorded
Fixed Equipment	
Instance on Basement	Does not Exist
Floor Finish	
Instance on Basement	Inspected
Condition	2 - Between Good and Fair
Deficiency	VINYL TILES: DETERIORATED SUBSTRATE
Deficiency Location/Instance	Left Side
Deficiency Quantity	10
Quantity Uom	S.F.
Potential Action	REPLACE
Urgency of Action	PRIORITY 3
Purpose of Action	LEVEL 2
Deficiency Photo1

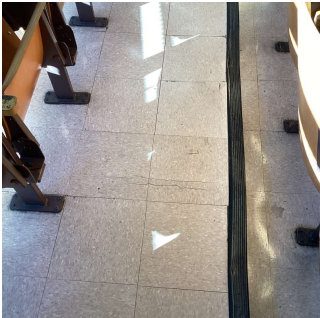
Question	Response
INTERIOR	
CLASSROOMS/CORRIDORS/ADMIN SPACES	
Floor Finish	
Violations	Room 333 No violations recorded.
Deficiency	VINYL TILES: DETERIORATED SUBSTRATE
Deficiency Location/Instance	Room 309
Deficiency Quantity	10
Quantity Uom	S.F.
Potential Action	REPLACE
Urgency of Action	PRIORITY 3
Purpose of Action	LEVEL 2
Deficiency Photo1

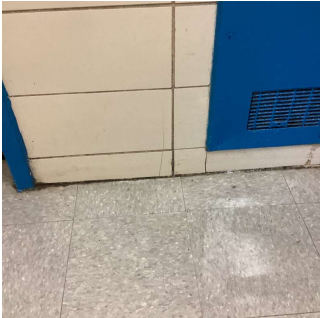
Violations	Room 309 No violations recorded.
Walls	Inspected
Condition	2 - Between Good and Fair
Deficiency	GLAZED BLOCK: CRACKS/SPALLING
Deficiency Location/Instance	Corridor near Rooms 114, 138
Deficiency Quantity	20
Quantity Uom	S.F.
Potential Action	REPLACE
Urgency of Action	PRIORITY 3
Purpose of Action	LEVEL 2
Deficiency Photo1

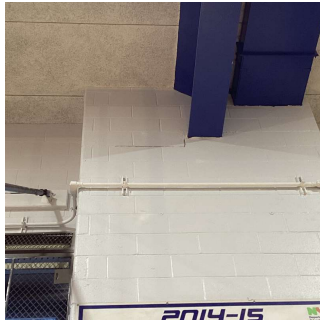
Question	Response
INTERIOR	
GYMNASIUM	
Walls	
Deficiency Photo1

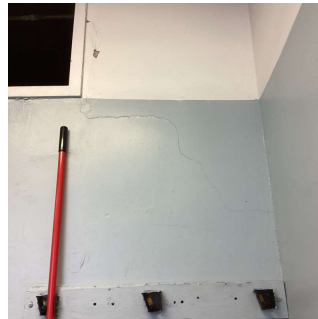
Instance on Basement	Inspected
Condition	2 - Between Good and Fair
Deficiency	PLASTER: CRACKS/SPALLING
Deficiency Location/Instance	Mop Room
Deficiency Quantity	10
Quantity Uom	S.F.
Potential Action	REPLACE
Urgency of Action	PRIORITY 3
Purpose of Action	LEVEL 2
Deficiency Photo1

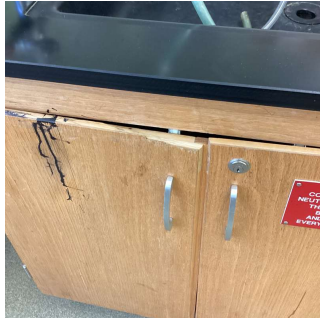
Question	Response
INTERIOR	
SCIENCE DEMO ROOM	
Fixed Equipment	
Deficiency Quantity	10
Quantity Uom	L.F.
Potential Action	REPLACE
Urgency of Action	PRIORITY 3
Purpose of Action	LEVEL 2
Deficiency Photo1	No photo recorded
Violations	No violations recorded.
SCIENCE LAB	Inspected
Instance on Room 101	Inspected
Alternative use	Yes
Instance on Room 304	Inspected
Alternative use	No
Fixed Equipment	
Instance on Room 304	Inspected
Condition	3 - Fair
Deficiency	CABINETS: MISSING/DAMAGED
Deficiency Location/Instance	Room 304
Deficiency Quantity	10
Quantity Uom	L.F.
Potential Action	REPLACE
Urgency of Action	PRIORITY 3
Purpose of Action	LEVEL 2
Deficiency Photo1

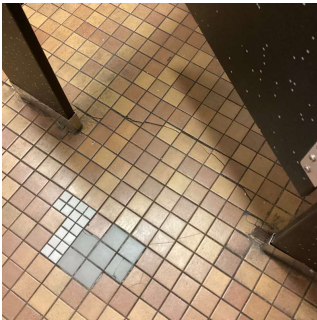
Question	Response
INTERIOR	
TOILET ROOMS - STAFF	
Door(s)	Inspected
	Room 142
Violations	No violations recorded.
Floor Finish	Inspected
Condition	3 - Fair
Deficiency	CERAMIC TILE: DETERIORATED SUBSTRATE
Deficiency Location/Instance	Room 144
Deficiency Quantity	10
Quantity Uom	S.F.
Potential Action	REPLACE
Urgency of Action	PRIORITY 3
Purpose of Action	LEVEL 2
Deficiency Photo1

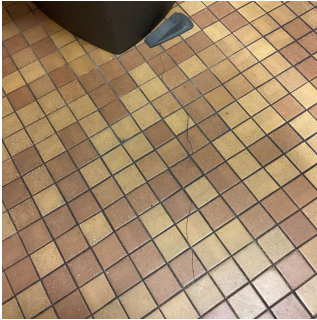
Room 144
Violations	No violations recorded.
Deficiency	CERAMIC TILE: BROKEN/MISSING TILES
Deficiency Location/Instance	Rooms B30, 241, 340, 343
Deficiency Quantity	30
Quantity Uom	S.F.
Potential Action	REPLACE
Urgency of Action	PRIORITY 3
Purpose of Action	LEVEL 2
Deficiency Photo1

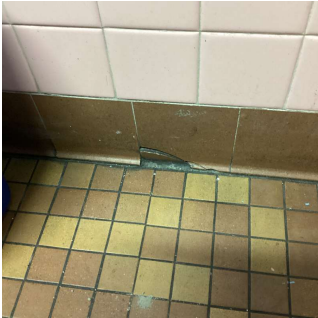
Question	Response
INTERIOR	
TOILET ROOMS - STAFF	
Walls	
Deficiency Quantity	25
Quantity Uom	S.F.
Potential Action	REPLACE
Urgency of Action	PRIORITY 3
Purpose of Action	LEVEL 2
Deficiency Photo1

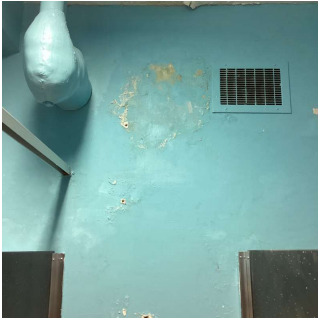
Room 240
Violations	No violations recorded.
Deficiency	PLASTER: CRACKS/SPALLING - ACTIVE LEAK
Deficiency Location/Instance	Room 240
Deficiency Quantity	20
Quantity Uom	S.F.
Potential Action	REPLACE
Urgency of Action	PRIORITY 5
Purpose of Action	LEVEL 2
Deficiency Photo1

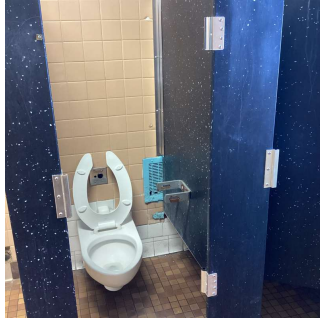
Question	Response
INTERIOR	
TOILET ROOMS - STUDENTS	
Stalls	
Urgency of Action	PRIORITY 3
Purpose of Action	LEVEL 2
Deficiency Photo1

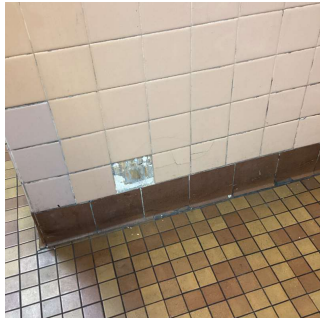
Room 318
Violations	No violations recorded.
Walls	
Condition	Inspected
Deficiency	2 - Between Good and Fair
Deficiency Location/Instance	CERAMIC TILE: BROKEN/ MISSING
Deficiency Quantity	Rooms 114, 118, 146, 218, 318, and others
Quantity Uom	100
Potential Action	S.F.
Urgency of Action	REPLACE
Purpose of Action	PRIORITY 3
Deficiency Photo1	LEVEL 2
