NYC Department of Education
Building Condition Assessment Survey 2023 - 2024

Architectural Inspection

Asset: P.S. 272 - BROOKLYN, 101-24 SEAVIEW AVENUE, New York, 11236

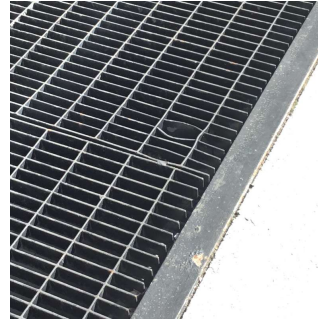
AW1

AREAWAY WALLS: CRACKS AND SPALLING

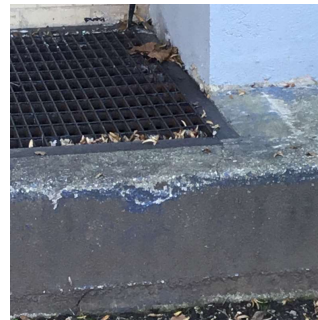
AW2

AREAWAY STAIRS: DETERIORATED TREADS/RISERS/NOSINGS

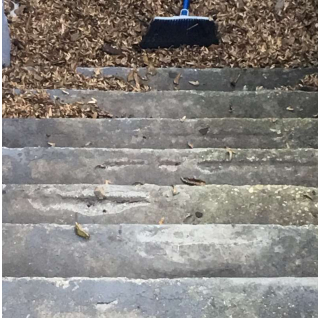
AW3
Violations	No violations recorded.
Deficiency	AREAWAY STAIRS: DETERIORATED MATERIAL SLIDE
Roof Plan reference

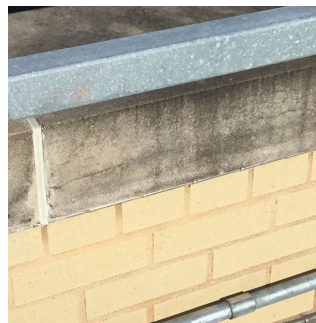
Roof 6

CAST STONE: CRACKED/BROKEN PIECES

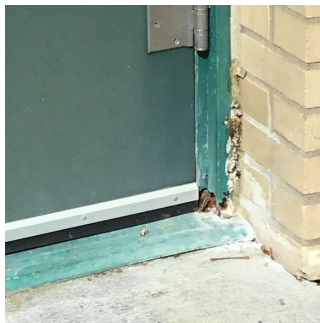
Violations	Facade C No violations recorded.
DOOR HARDWARE	Inspected
Condition	3 - Fair
Deficiency	No deficiencies recorded
LINTELS	Inspected
Condition	2 - Between Good and Fair
Deficiency	No deficiencies recorded
TRANSOM/SIDE LIGHT	Inspected
Condition	3 - Fair
Deficiency	METAL: BROKEN GLASS
Roof Plan reference

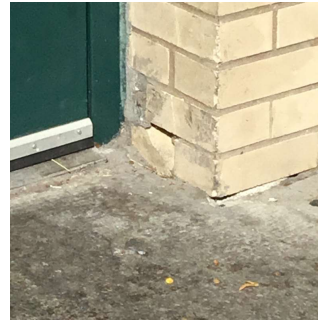
Facade C

BRICK: MASONRY SILLS - DETERIORATED JOINTS

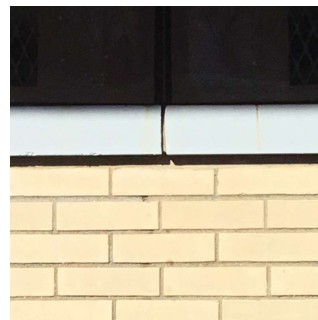
Facade C

CAST IN PLACE / PRE-CAST CONCRETE: MINOR CRACKS/SPALLING

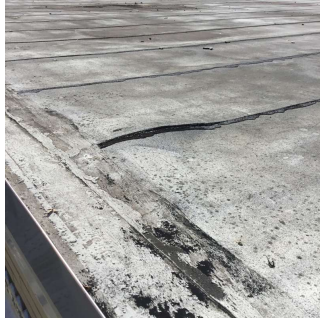
Roof 2
Violations	No violations recorded.
Deficiency	MODIFIED BITUMEN: ROOFING: MAJOR ACTIVE ROOF LEAKS IN INSTRUCTIONAL SPACE
Roof Plan reference

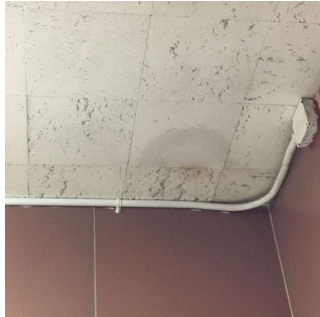
Roof 2 - Corridor near Cafeteria (Roof 4 - Gymnasium similar)
Violations	No violations recorded.
ROOFING DRAINS	
Condition	Inspected
Deficiency	2 - Between Good and Fair
Deficiency	No deficiencies recorded
Specialties	
Condition	Inspected
BULKHEAD/PENTHOUSE	
Condition	Inspected
Deficiency	3 - Fair
Deficiency	BULKHEAD/PENTHOUSE WALLS/EXTERIOR: CRACKS/SPALLING - MINOR

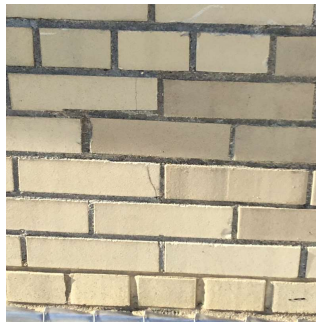
BH2
No violations recorded.

Deficiency **BULKHEAD/PENTHOUSE WALLS/EXTERIOR: DETERIORATED JOINTS**

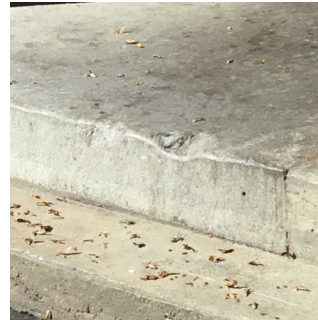
Facade C

CONCRETE: CRACKS/SPALLING - MAJOR

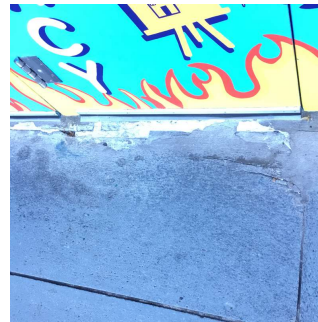
Facade A

STONE: DETERIORATED JOINTS

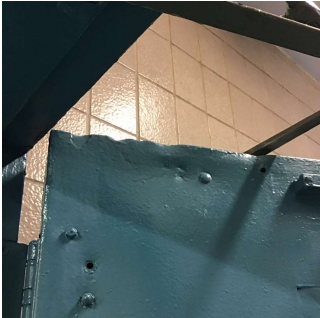
Violations	Stair A/3 35672099Z
Partition	
Does not Exist	
Railings	
Inspected	
Condition	2 - Between Good and Fair

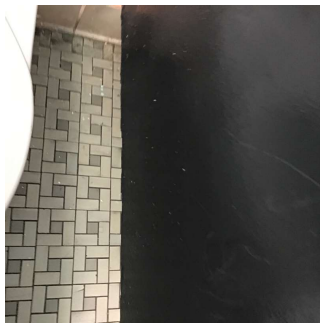
Violations	3rd Floor - Girls No violations recorded.
Walls	Inspected
Condition	2 - Between Good and Fair
Deficiency	CERAMIC TILE: BROKEN/ MISSING
Deficiency Location/Instance	3rd Floor - Girls, Boys, 2nd Floor - Boys, Girls, Room 103
Deficiency Quantity	80
Quantity Uom	S.F.
Potential Action	REPLACE
Urgency of Action	PRIORITY 3
Purpose of Action	LEVEL 2
Deficiency Photo1

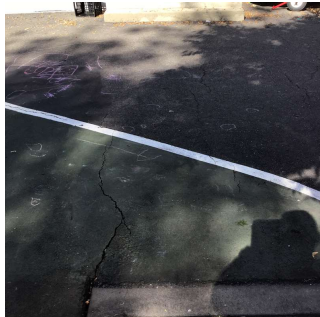
Violations	Near Playground No violations recorded.
Concrete	Inspected
Condition	2 - Between Good and Fair
Deficiency	No deficiencies recorded
Pavers	Inspected
Condition	2 - Between Good and Fair
Deficiency	HEAVING
Deficiency Location/Instance	Schoolyard
Deficiency Quantity	10
Quantity Uom	S.F.
Potential Action	REPLACE
Urgency of Action	PRIORITY 3
Purpose of Action	LEVEL 2

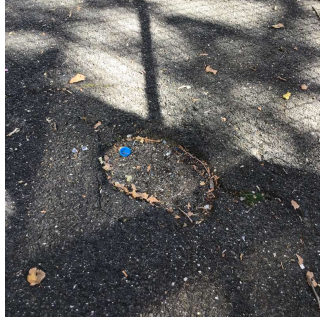
Violations	Between school and NYC park No violations recorded.
Deficiency	CRACKS - MAJOR
Deficiency Location/Instance	Walkway between School and NYC park, near Schoolyard
Deficiency Quantity	600
Quantity Uom	S.F.
Potential Action	REPLACE
Urgency of Action	PRIORITY 3
Purpose of Action	LEVEL 2
Deficiency Photo1

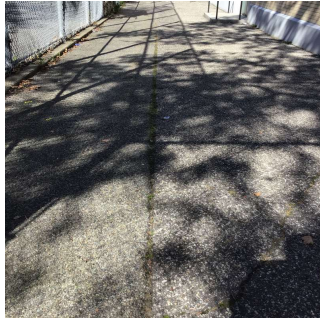
Violations	Between school and NYC parks No violations recorded.
Concrete	Inspected
Condition	3 - Fair
Deficiency	HEAVING
Deficiency Location/Instance	Along Seaview Avenue
Deficiency Quantity	25
Quantity Uom	S.F.
Potential Action	REPLACE
Urgency of Action	PRIORITY 3
Purpose of Action	LEVEL 2

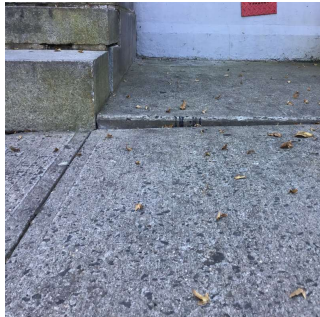
Violations	Along Seaview Avenue No violations recorded.
Deficiency	CRACKS - MAJOR
Deficiency Location/Instance	Along Seaview Avenue
Deficiency Quantity	50
Quantity Uom	S.F.
Potential Action	REPLACE
Urgency of Action	PRIORITY 3
Purpose of Action	LEVEL 2
Deficiency Photo1

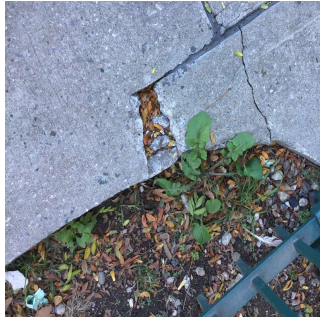
Violations	Along Seaview Avenue No violations recorded.
Pavers	Does not Exist
DOT Sidewalk	Inspected
Asphalt	Does not Exist
Concrete	Inspected
Condition	4 - Between Fair and Poor
Deficiency	HEAVING
Deficiency Location/Instance	Along Seaview Avenue
Deficiency Quantity	50
Quantity Uom	S.F.
Potential Action	REPLACE
Urgency of Action	PRIORITY 3
Purpose of Action	LEVEL 2
