**NYC Department of Education**  
**Building Condition Assessment Survey 2023 - 2024**

Architectural Inspection

**K274**

**Asset:** P.S. 274 - BROOKLYN, 800 BUSHWICK AVENUE, New York, 11221

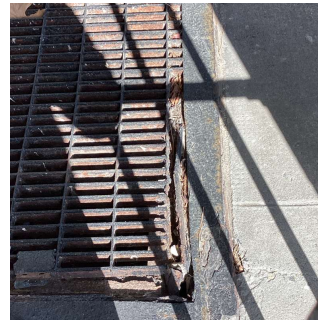
Facade A - AW1

Question	Response
<b>Architectural</b>	
<b>EXTERIOR</b>	Inspected
<b>AREAWAY</b>	Inspected
Instance on AW1-AW3	Inspected
Instance Condition	3 - Fair
Instance Quantity	3
Instance Quantity Uom	EACH
Deficiency	AREAWAY GRATINGS: MAJOR RUSTING AND / OR BROKEN SUPPORTS

20  
L.F.  
REPLACE  
PRIORITY 4  
LEVEL 2

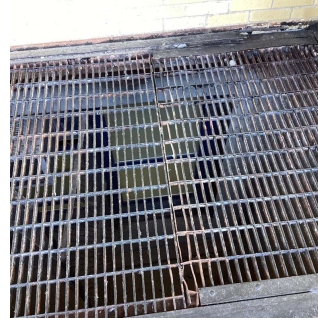
AW2  
No violations recorded.

**AREAWAY GRATINGS: MAJOR RUSTING / OR BROKEN**

80  
S.F.  
REPLACE  
PRIORITY 4  
LEVEL 2

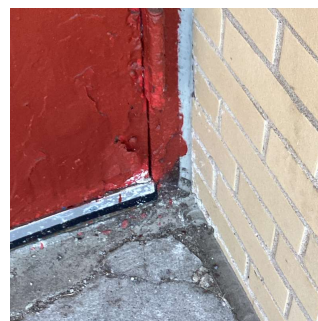
METAL CLAD: DETERIORATED DOOR AND FRAME - MAJOR DETERIORATION

4  
EACH  
REPLACE  
PRIORITY 4  
LEVEL 2

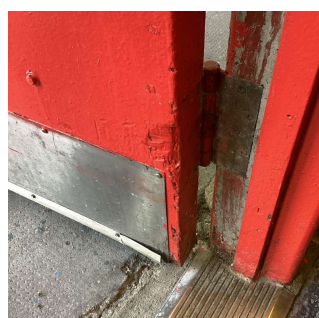
Question	Response
<b>EXTERIOR</b>	
<b>DOORS</b>	
<b>DOORS AND FRAMES</b>	
Violations	Facade B - Exit 3 No violations recorded.
Deficiency	METAL CLAD: DETERIORATED DOOR - MAJOR DETERIORATION
Roof Plan reference	K274

Deficiency Quantity	4
Quantity Uom	EACH
Potential Action	REPLACE
Urgency of Action	PRIORITY 4
Purpose of Action	LEVEL 2
Deficiency Photo1

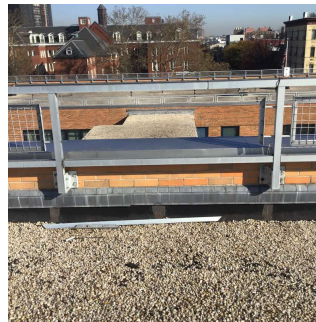
Roof 1 - Facade F

RAILINGS/PANELS: DETERIORATED, MAJOR RUSTING

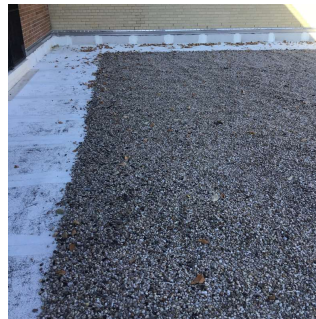
Roof 2, 4

Deficiency	<b>BUILT-UP: ROOFING: LOSS OF GRAVEL</b>
Roof Plan reference	K274

Deficiency Quantity	500
Quantity Uom	S.F.
Potential Action	INSTALL NEW GRAVEL
Urgency of Action	PRIORITY 3
Purpose of Action	LEVEL 2
Deficiency Photo 1

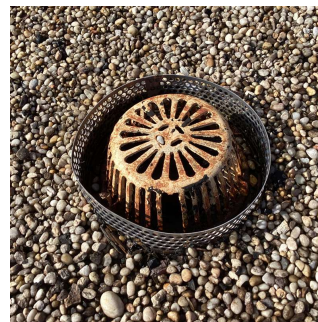
Roof 4  
 No violations recorded.

Condition	3 - Fair
Deficiency	DETERIORATED

1  
 EACH  
 REPLACE  
 PRIORITY 4  
 LEVEL 2

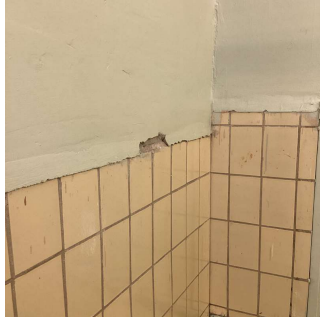
BULKHEAD/PENTHOUSE WALLS/INTERIOR: PLASTER  
 CRACKS/SPALLING

10  
 S.F.  
 REPLACE  
 PRIORITY 4  
 LEVEL 2

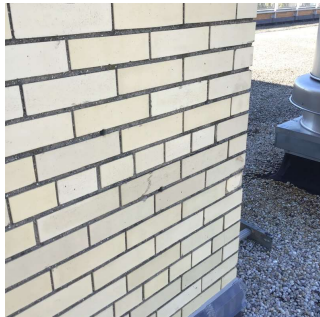
Violations	BH1 No violations recorded.
Deficiency	BULKHEAD/PENTHOUSE WALLS/EXTERIOR: DETERIORATED JOINTS
Roof Plan reference	K274

Deficiency Quantity	300
Quantity Uom	S.F.
Potential Action	REPOINT
Urgency of Action	PRIORITY 3
Purpose of Action	LEVEL 2
Deficiency Photo1

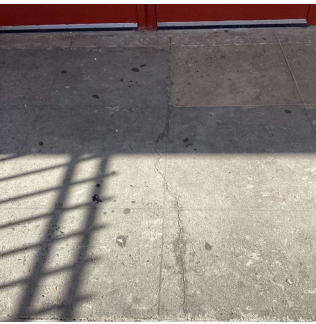
Question	Response
<b>EXTERIOR</b>	
<b>STAIRS/RAMPS: EXTERIOR</b>	
<b>BUILDING CHEEK/FLANK WALLS</b>	Inspected
Condition	2 - Between Good and Fair
Deficiency	No deficiencies recorded
<b>RAILINGS</b>	Inspected
Condition	2 - Between Good and Fair
Deficiency	No deficiencies recorded
<b>STAIRS/RAMPS</b>	Inspected
Condition	3 - Fair
Deficiency	<b>CONCRETE: CRACKS/SPALLING - MINOR</b>
Roof Plan reference	K274

Deficiency Quantity	20
Quantity Uom	S.F.
Potential Action	REPAIR
Urgency of Action	PRIORITY 3
Purpose of Action	LEVEL 2
Deficiency Photo1

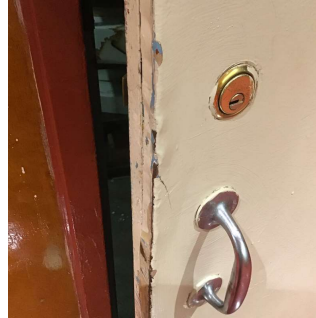
Projection Room

METAL: DETERIORATED DOOR

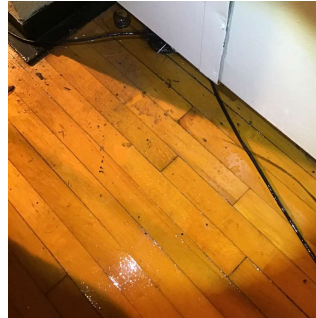
Right Rear

Deficiency DAMAGED FLOOR

Potential Action REPLACE

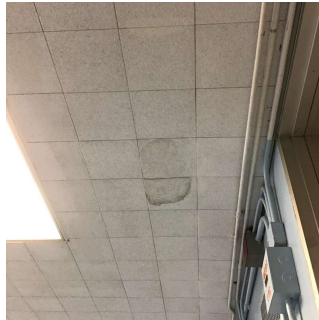
Deficiency	ACOUSTIC TILES ON PLASTER: DAMAGED/MISSING
Deficiency Location/Instance	Near Entrance, Center
Deficiency Quantity	20
Quantity Uom	S.F.
Potential Action	REPLACE
Urgency of Action	PRIORITY 3
Purpose of Action	LEVEL 2
Deficiency Photo1

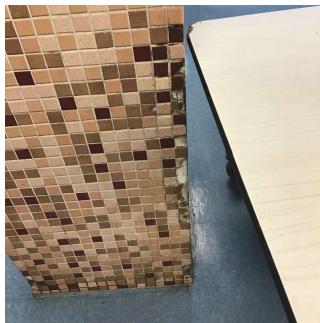
Near Windows
Violations	No violations recorded.
Deficiency	CERAMIC TILE: BROKEN/ MISSING
Deficiency Location/Instance	Columns at Center
Deficiency Quantity	40
Quantity Uom	S.F.
Potential Action	REPLACE

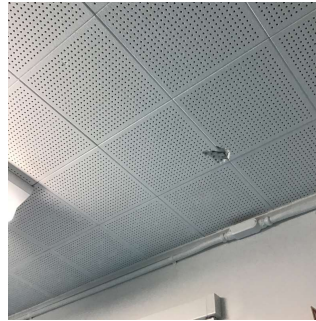
Corridor near Room 258

Violations	Room 227 No violations recorded.
Deficiency	ACOUSTIC TILES ON PLASTER: DAMAGED/MISSING
Deficiency Location/Instance	Corridor near Rooms B9, 141, 248, 258, 309, and others
Deficiency Quantity	180
Quantity Uom	S.F.
Potential Action	REPLACE
Urgency of Action	PRIORITY 3
Purpose of Action	LEVEL 2

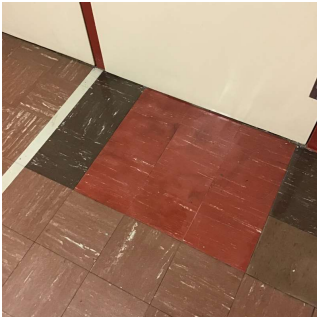
Room 143
Violations	No violations recorded.
Deficiency	VINYL TILES: DETERIORATED SUBSTRATE
Deficiency Location/Instance	Near Gymnasium Main Entrance
Deficiency Quantity	10
Quantity Uom	S.F.
Potential Action	REPLACE
Urgency of Action	PRIORITY 3
Purpose of Action	LEVEL 2
Deficiency Photo1

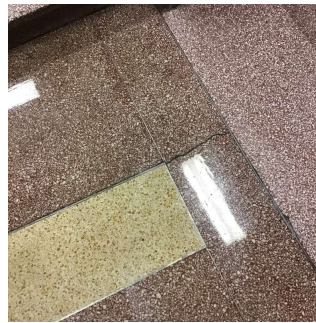
Near Gymnasium Main Entrance
Violations	No violations recorded.
Deficiency	TERRAZZO: CRACKS
Deficiency Location/Instance	Main Entrance Lobby
Deficiency Quantity	35
Quantity Uom	S.F.

Potential Action	REPLACE
Urgency of Action	PRIORITY 3
Purpose of Action	LEVEL 2

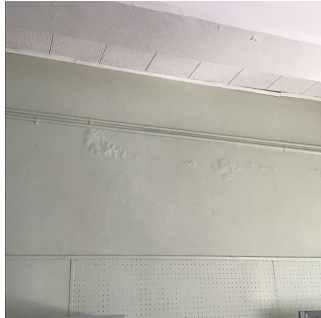
Room 131

Violations	Corridor Near Stair EF/1 No violations recorded.
Deficiency	PLASTER: CRACKS/SPALLING
Deficiency Location/Instance	Rooms 100, 131, 326, 1st Floor Dance Room, Corridor near Room 222
Deficiency Quantity	60
Quantity Uom	S.F.
Potential Action	REPLACE
Urgency of Action	PRIORITY 3
Purpose of Action	LEVEL 2
Deficiency Photo1

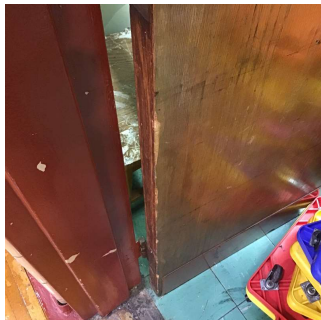
Office

Condition	5 - Poor
-----------	----------

Deficiency	WOOD: DETERIORATED DOOR
------------	-------------------------

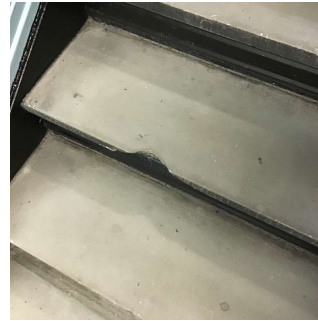
Yes	Tripping Hazard	Broken tread edge is a potential tripping hazard.	INTERIOR   STAIRS/RAMP S: INTERIOR   Stairs and Landings	Stair EF/2	Edgar Hiller	Fireman

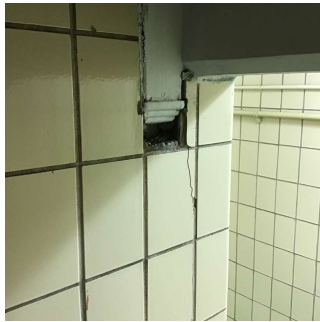
Violations	Stair GH/1 Vestibule No violations recorded.
Deficiency	GLAZED BLOCK: CRACKS/SPALLING
Deficiency Location/Instance	Stair BC/Basement, 1
Deficiency Quantity	20
Quantity Uom	S.F.
Potential Action	REPLACE
Urgency of Action	PRIORITY 3
Purpose of Action	LEVEL 2
Deficiency Photo1

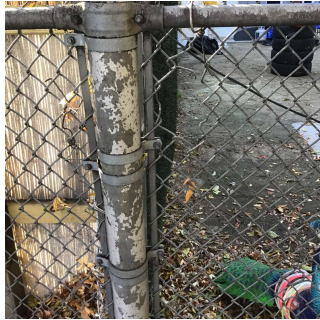
Violations	Schoolyard No violations recorded.
Deficiency	CHAIN LINK: DAMAGED/DETERIORATED
Deficiency Location/Instance	Schoolyard
Deficiency Quantity	100
Quantity Uom	S.F.
Potential Action	REPLACE
Urgency of Action	PRIORITY 3
Purpose of Action	LEVEL 2

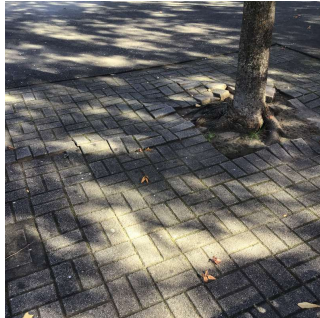
Violations	Schoolyard No violations recorded.
Deficiency	HEAVING
Deficiency Location/Instance	Schoolyard
Deficiency Quantity	75
Quantity Uom	S.F.
Potential Action	REPLACE
Urgency of Action	PRIORITY 3
Purpose of Action	LEVEL 2
Deficiency Photo1

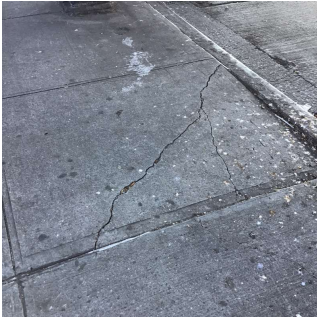
Violations	Kosciuszko Street No violations recorded.
Deficiency	DAMAGED/DETERIORATED/MISSING SECTIONS
Deficiency Location/Instance	Broadway, Kosciuszko Street, Bushwick Avenue
Deficiency Quantity	850
Quantity Uom	S.F.
Potential Action	REPLACE
Urgency of Action	PRIORITY 3
Purpose of Action	LEVEL 2
