**NYC Department of Education**  
**Building Condition Assessment Survey 2023 - 2024**

Architectural Inspection

**Asset: P.S. 276 - BROOKLYN, 1070 EAST 83 STREET, New York, 11236**

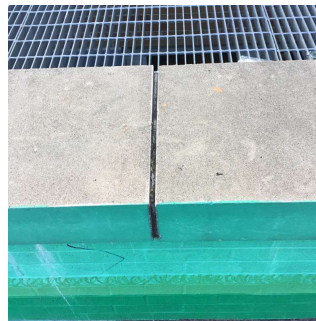
AW2  
No violations recorded.

AREAWAY WALLS: DETERIORATED JOINTS AT COPING STONES

30  
L.F.  
MAINTENANCE  
PRIORITY 3  
LEVEL 2

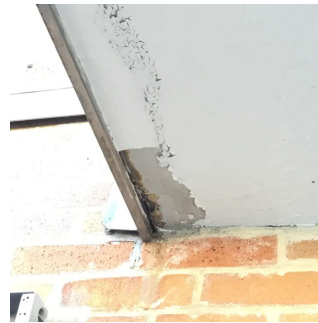
Facade A

CONCRETE: DETERIORATED

10  
S.F.  
REPLACE  
PRIORITY 4

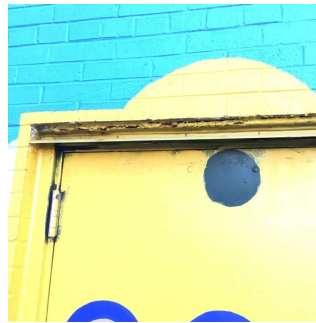
Facade F

STEEL: MAJOR RUSTING

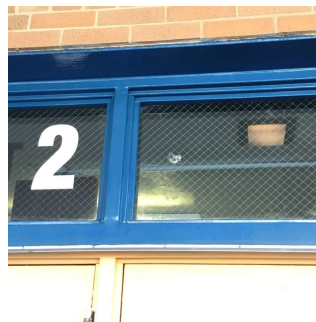
Facade A

METAL: BROKEN GLASS

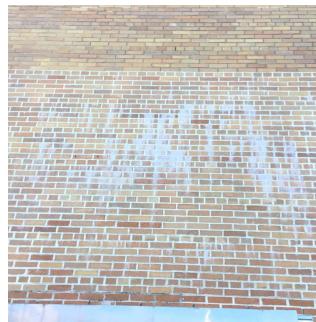
Facade A  
No violations recorded.

S.F.  
BRICK: EFFLORESCENCE  
K276

75  
S.F.  
MAINTENANCE  
PRIORITY 1  
LEVEL 1

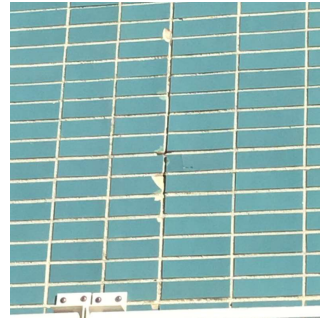
Facade E

BRICK: MINOR CRACKS AND SPALLING

25  
S.F.  
RESTITCH

PRIORITY 3  
LEVEL 2

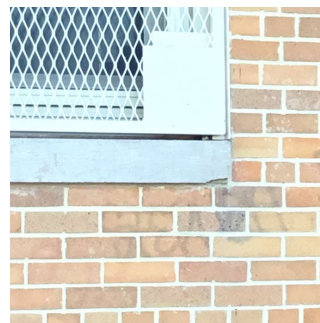
Facade D

BRICK: DETERIORATED MASONRY SILLS - MINOR

15  
L.F.  
REPAIR  
PRIORITY 3  
LEVEL 2

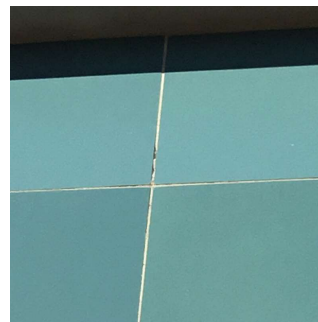
Facade B

CERAMIC TILE: DETERIORATED JOINTS

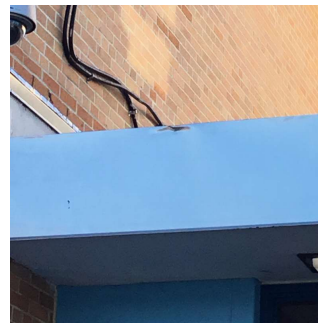
Roof 5

MODIFIED BITUMEN: FLASHING: DRIP EDGE/GRAVEL STOP DAMAGED

REPLACE

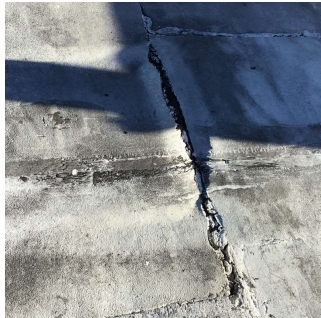
MODIFIED BITUMEN: ROOFING: DELAMINATION

REPLACE ROOFING WITHOUT MAJOR EQUIPMENT REMOVAL

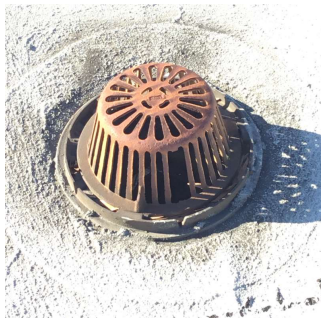
Violations	Roof 1 No violations recorded.
<b>ROOFING DRAINS</b>	Inspected
Condition	3 - Fair
Deficiency	DETERIORATED
Roof Plan reference	K276
Deficiency Quantity	1
Quantity Uom	EACH
Potential Action	REPLACE
Urgency of Action	PRIORITY 4
Purpose of Action	LEVEL 2
Deficiency Photo1

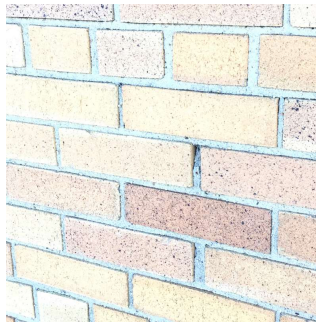
**BULKHEAD/PENTHOUSE WALLS/EXTERIOR: DETERIORATED  
JOINTS**

15  
S.F.  
REPOINT  
PRIORITY 4  
LEVEL 2

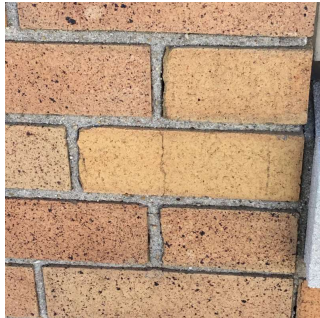
Deficiency	<b>BULKHEAD/PENTHOUSE WALLS/EXTERIOR: CRACKS/SPALLING - MINOR</b>
------------	---

25  
S.F.  
REPAIR  
PRIORITY 3  
LEVEL 2

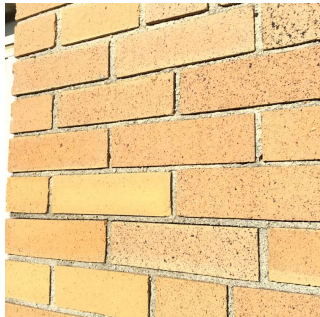
Violations	BH1 No violations recorded.
Deficiency	BULKHEAD/PENTHOUSE WALLS/EXTERIOR: DETERIORATED JOINTS
Roof Plan reference	K276

Deficiency Quantity	180
Quantity Uom	S.F.
Potential Action	REPOINT
Urgency of Action	PRIORITY 3
Purpose of Action	LEVEL 2
Deficiency Photo1

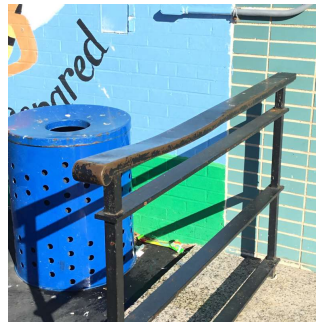
Facade E

Question	Response
<b>EXTERIOR</b>	
<b>STAIRS/RAMPS: EXTERIOR</b>	Inspected
<b>BUILDING CHEEK/FLANK WALLS</b>	Inspected
Condition	3 - Fair
Deficiency	CAST IN PLACE CONCRETE: CRACKS/SPALLING - MINOR
Roof Plan reference	K276 E. 82nd Street
Deficiency Quantity	35
Quantity Uom	S.F.
Potential Action	REPAIR
Urgency of Action	PRIORITY 3
Purpose of Action	LEVEL 2
Deficiency Photo1	
	Facade C
Violations	No violations recorded.
<b>RAILINGS</b>	Inspected
Condition	5 - Poor
Deficiency	DAMAGED
Roof Plan reference	K276 E. 82nd Street
Deficiency Quantity	10
Quantity Uom	L.F.
Potential Action	REPLACE
Urgency of Action	PRIORITY 4
Purpose of Action	LEVEL 2

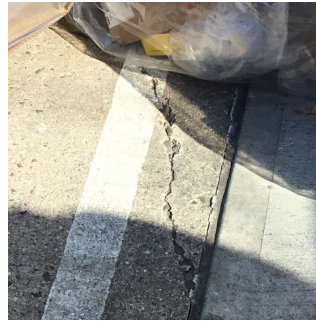
Facade C

**CONCRETE: CRACKS/SPALLING - MAJOR**

15  
 S.F.  
 REPLACE  
 PRIORITY 4  
 LEVEL 2

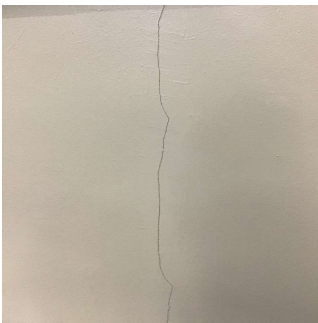
PLASTER: CRACKS/SPALLING

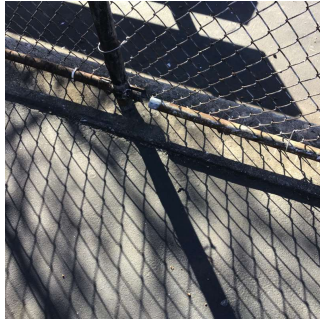
Question	Response
<b>SITE</b>	
<b>PLAYGROUNDS</b>	
<b>Benches</b>	
Deficiency Photo1	 
Violations	Rear No violations recorded.
<b>Fence</b>	
Instance on Schoolyard	Inspected
Condition	5 - Poor
Deficiency	CHAIN LINK: DAMAGED POST/RAIL
Deficiency Location/Instance	Rear
Deficiency Quantity	10
Quantity Uom	L.F.
Potential Action	REPLACE
Urgency of Action	PRIORITY 3
Purpose of Action	LEVEL 2
Deficiency Photo1

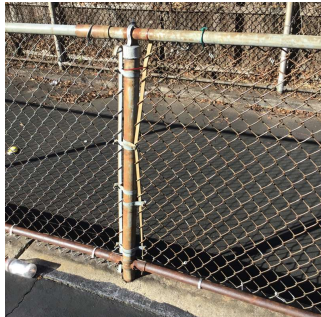
Right Side
Violations	No violations recorded.

Violations	Rear No violations recorded.
Deficiency	CHAIN LINK: RUST - MAJOR
Deficiency Location/Instance	Perimeter
Deficiency Quantity	850
Quantity Uom	S.F.
Potential Action	REPLACE
Urgency of Action	PRIORITY 3
Purpose of Action	LEVEL 2
Deficiency Photo1	No photo recorded
Violations	No violations recorded.
Deficiency	CHAIN LINK: DAMAGED/DETERIORATED
Deficiency Location/Instance	Right Side
Deficiency Quantity	50
Quantity Uom	S.F.
Potential Action	REPLACE
Urgency of Action	PRIORITY 3

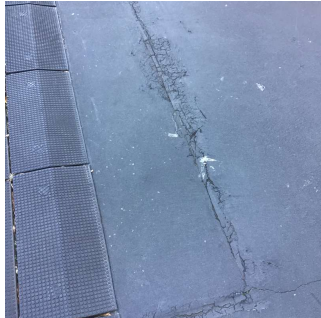
Perimeter
Violations	No violations recorded.

<b>Pavement</b>	
Instance on Schoolyard	Inspected
Condition	3 - Fair
Deficiency	ASPHALT: CRACKS - MAJOR
Deficiency Location/Instance	Perimeter
Deficiency Quantity	200
Quantity Uom	S.F.
Potential Action	REPLACE
Urgency of Action	PRIORITY 3
Purpose of Action	LEVEL 2
Deficiency Photo1

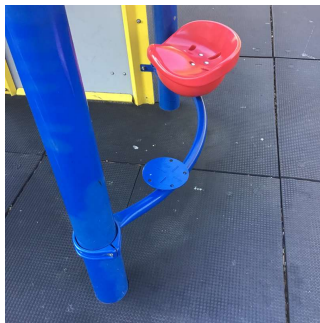
Priority Condition Exist Last Year?	Priority Category	Condition Description	Component Affected	Location Description	Person(s) Notified	Person(s) Title	PhotoImage
No	Protruding Elements	Broken Playground Equipment resulting in hazardous condition	SITE   PLAYGROUN DS   Play Equipment	Center	Joseph Cordero	Fireman

<b>Play Equipment</b>	
Instance on Schoolyard	Inspected
Condition	5 - Poor
Deficiency	BROKEN/DETERIORATED/MISSING
Deficiency Location/Instance	Center
Deficiency Quantity	1
Quantity Uom	EACH
Potential Action	REPLACE
Urgency of Action	PRIORITY 5
Purpose of Action	LEVEL 6
