NYC Department of Education
Building Condition Assessment Survey 2023 - 2024

Architectural Inspection

Asset: P.S. 277 - BROOKLYN, 2529 GERRITSEN AVENUE, New York, 11229

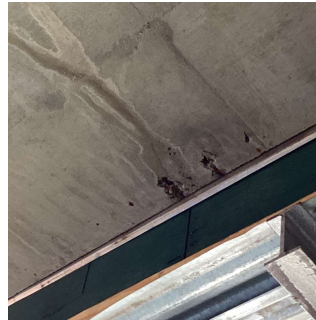
Facade A - Main Entrance

Question	Response
Architectural	
EXTERIOR	Inspected
AREAWAY	Does not Exist
AWNINGS AND CANOPIES	Inspected
Condition	3 - Fair
Deficiency	CONCRETE: DETERIORATED
Roof Plan reference	K277
Deficiency Quantity	10
Quantity Uom	S.F.
Potential Action	REPLACE
Urgency of Action	PRIORITY 4
Purpose of Action	LEVEL 2

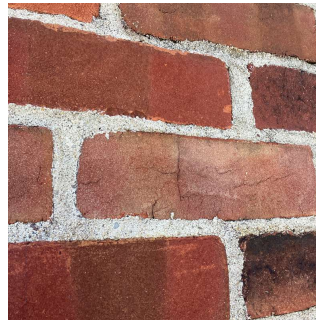
Roof 1 - CH

BRICK: MINOR CRACKS AND SPALLING

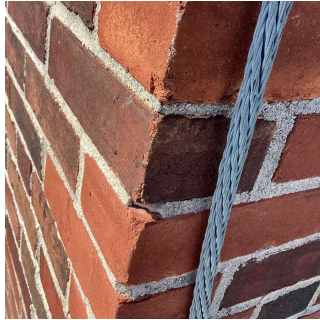
Roof 1 - CH
Violations	No violations recorded.
COPING	Under Construction
CORNICE	Does not Exist
DOORS	Inspected
DOORS AND FRAMES	Inspected
Condition	4 - Between Fair and Poor
Deficiency	METAL: DETERIORATED DOOR AND FRAME - MINOR DETERIORATION
Roof Plan reference	<p>K277</p>

BRICK: DETERIORATED JOINTS

Question	Response
EXTERIOR	
CHIMNEY	
Quantity Uom	S.F.
Potential Action	REPOINT
Urgency of Action	PRIORITY 3
Purpose of Action	LEVEL 2
Deficiency Photo1

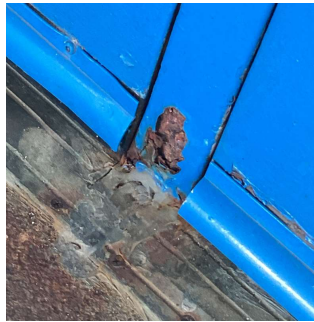
Facade A - Exit 2/3

Facade F - Exit 9
Violations	No violations recorded.
Deficiency	METAL: DETERIORATED DOOR - MAJOR DETERIORATION

4
EACH
REPLACE
PRIORITY 4
LEVEL 2

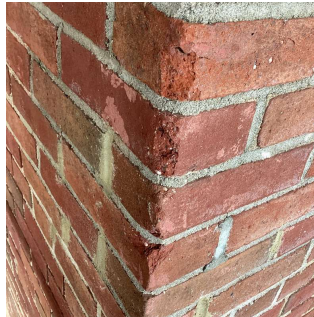
Corner of Facade D and Facade E

BRICK: CRACKS/DISPLACED/SPALLED BRICK AT BUILDING CORNERS

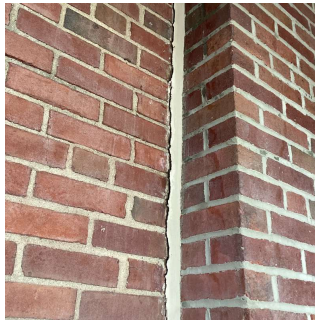
Facade F - Near Exit 12

BRICK: DETERIORATED CONTROL/EXPANSION JOINTS

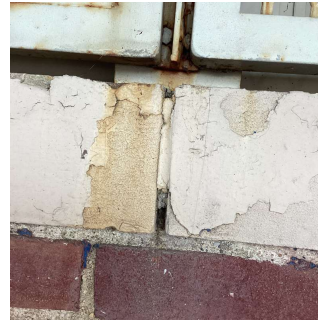
Facade F - Near Exit 12

BRICK: MASONRY SILLS - DETERIORATED JOINTS

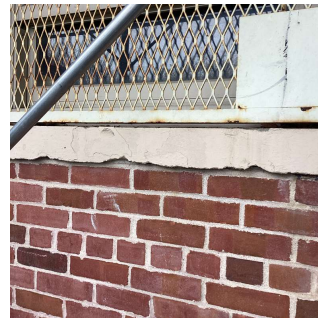
Facade G - Near Exit 9

BRICK: DETERIORATED MASONRY SILLS - MAJOR

REMOVE AND REPLACE

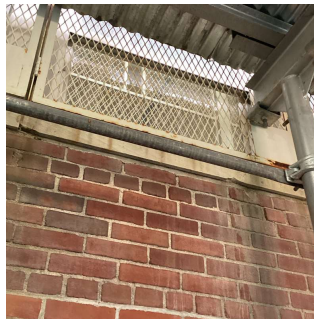
Facade H - Near Exit 11
No violations recorded.

BRICK: DETERIORATED MASONRY SILLS - MINOR

40
L.F.
REPAIR
PRIORITY 3
LEVEL 2

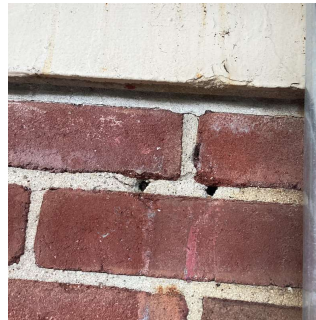
Facade J

BRICK: DETERIORATED JOINTS
K277

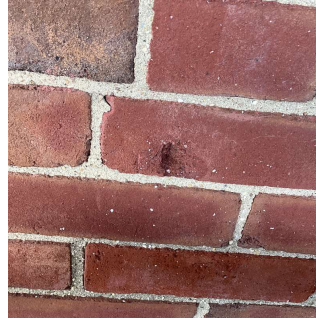
Facade J - Near Exit 8

BRICK: MINOR CRACKS AND SPALLING

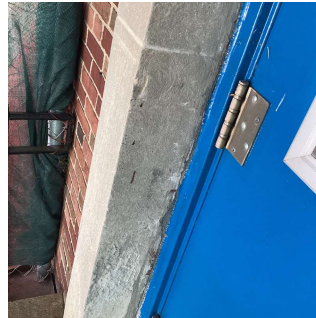
Facade A - Near Exit 2/3

CAST IN PLACE / PRE-CAST CONCRETE: MINOR
CRACKS/SPALLING

REPAIR

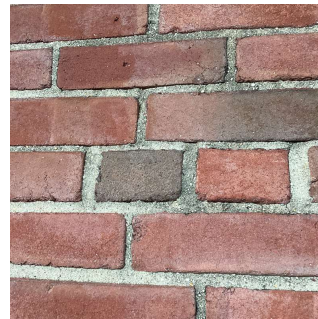
Facade J - Near Exit 8

BRICK: DETERIORATED JOINTS

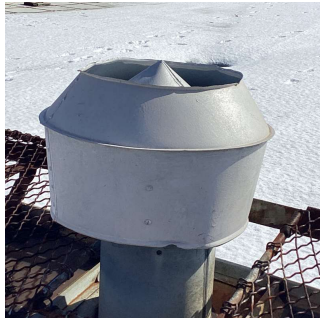
SHAFT VENTS DAMAGED

Violations	Roof 1 - SK No violations recorded.
Deficiency	DAMAGED GUARDS
Roof Plan reference	K277

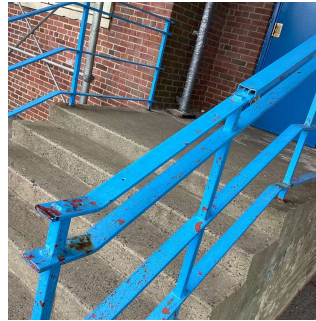
Facade F - Near Exit 12

DAMAGED

10
L.F.
REPLACE
PRIORITY 4
LEVEL 2

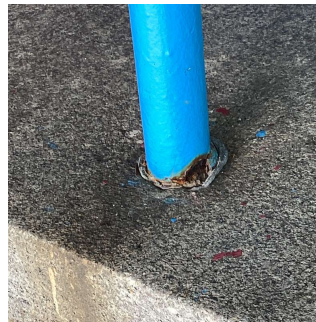
Facade A - Main Entrance

RUST - MAJOR

REPLACE

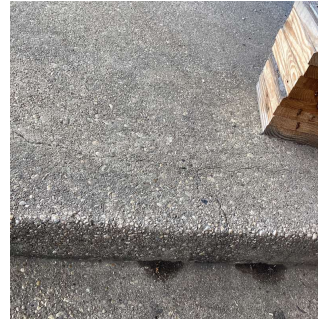
Facade D

CONCRETE: CRACKS/SPALLING - MINOR

S.F.
REPAIR
PRIORITY 3
LEVEL 2

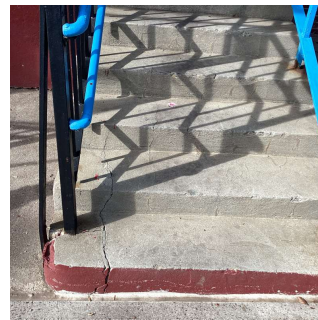
Facade J - Near Exit 8

CONCRETE: CRACKS/SPALLING - MAJOR
K277

60
S.F.
REPLACE
PRIORITY 4
LEVEL 2

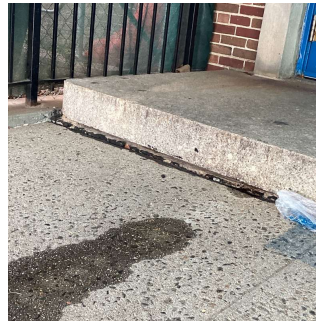
Facade A - Near Exit 2/3
No violations recorded.

CONCRETE: DETERIORATED SUBSTRATE

50
S.F.
REPLACE SUBSTRATE AND RESET
PRIORITY 4
LEVEL 2

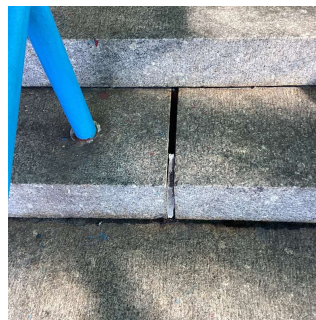
Facade A - Main Entrance

STONE: DETERIORATED JOINTS

20
L.F.
REPOINT
PRIORITY 4
LEVEL 2

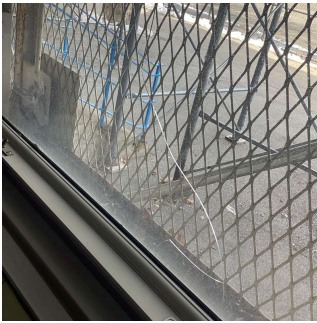
Deficiency	ALUMINUM - DOUBLE HUNG: BROKEN PANE
------------	-------------------------------------

Violations	Facade F - Room 114 No violations recorded.
Instance on Aluminum - Other: Facades A and Facade F	Inspected
Instance Condition	3 - Fair
Instance Quantity	500
Instance Quantity Uom	S.F.
Are these windows insulated	No
Installation Year	2004
Source of Installation	Custodial Staff
Deficiency	No deficiencies recorded
INTERIOR	Inspected
POOLS	Does not Exist
STRUCTURAL	Inspected
COLUMNS/BEAMS/BEARING WALLS	Inspected
Condition	3 - Fair
Deficiency	STEEL COLUMNS/BEAMS: DETERIORATED CONCRETE FIREPROOFING
Deficiency Location/Instance	Basement - Electrical Panel Room, Boiler Crawlspace, 2nd Floor - Fan Room
Deficiency Quantity	60
Quantity Uom	S.F.
Potential Action	REPLACE
Urgency of Action	PRIORITY 3
Purpose of Action	LEVEL 5
Deficiency Photo1	 
Violations	Basement - Electrical Panel Room No violations recorded.
FLOOR STRUCTURE	Inspected
Condition	3 - Fair

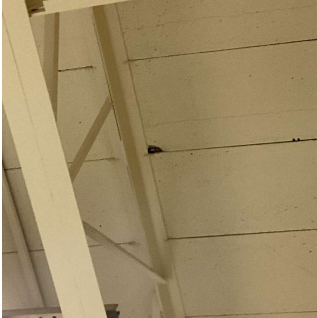
Deficiency	CONCRETE: CRACKS/SPALLED/REINFORCEMENT EXPOSED

Question	Response
INTERIOR	
STRUCTURAL	
FLOOR STRUCTURE	
Deficiency Location/Instance	Roof 3 - Cafeteria
Deficiency Quantity	40
Quantity Uom	S.F.
Potential Action	REPAIR
Urgency of Action	PRIORITY 3
Purpose of Action	LEVEL 5
Deficiency Photo1

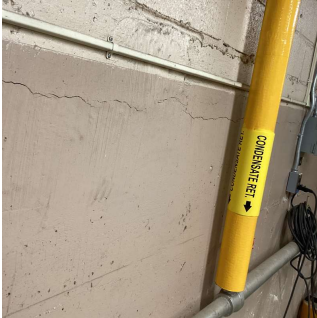
Violations	Roof 3 - Cafeteria No violations recorded.
FOUNDATION WALLS	
Material Type(s)	Inspected Concrete
Condition	4 - Between Fair and Poor
Deficiency	CONCRETE: CRACKED/SPALLED/REINFORCEMENT EXPOSED
Deficiency Location/Instance	Basement - MER
Deficiency Quantity	50
Quantity Uom	S.F.
Potential Action	REPAIR
Urgency of Action	PRIORITY 3
Purpose of Action	LEVEL 5
Deficiency Photo1

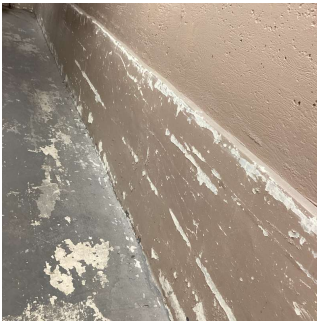
Violations	Basement - MER No violations recorded.
Deficiency	CONCRETE: WATER INFILTRATION IN NON- INSTRUCTIONAL SPACE
Deficiency Location/Instance	Basement - MER
Deficiency Quantity	100
Quantity Uom	S.F.
Potential Action	INSTALL WATERPROOFING
Urgency of Action	PRIORITY 5
Purpose of Action	LEVEL 5

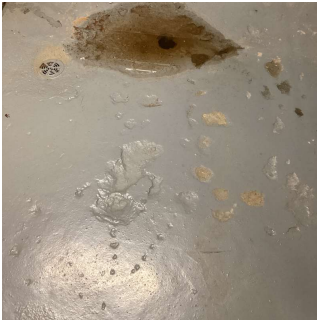
Violations	Basement - MER No violations recorded.
ROOF STRUCTURE	
Condition	Inspected 3 - Fair
Deficiency	CONCRETE: CRACKED/SPALLED/REINFORCEMENT EXPOSED
Deficiency Location/Instance	Basement - Boiler Room
Deficiency Quantity	30
Quantity Uom	S.F.
Potential Action	REPAIR
Urgency of Action	PRIORITY 3
Purpose of Action	LEVEL 5
Deficiency Photo1

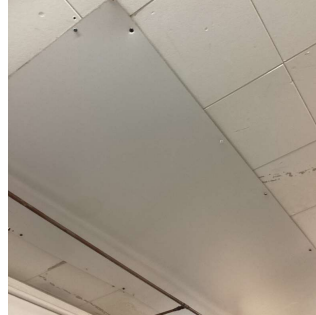
Corridor near room 208
 No violations recorded.

Ceiling	Inspected
Condition	2 - Between Good and Fair
Deficiency	ACOUSTIC TILES ON PLASTER: DAMAGED/MISSING
Deficiency Location/Instance	Corridor near rooms 208, 202, 117, 114, 112 and others
Deficiency Quantity	80
Quantity Uom	S.F.
Potential Action	REPLACE

PRIORITY 3
 LEVEL 2

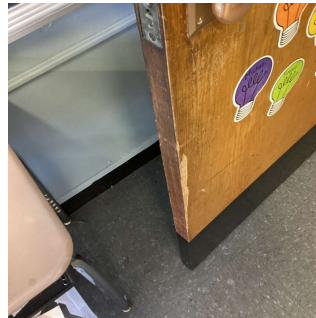
Room 204

WOOD: DETERIORATED DOOR

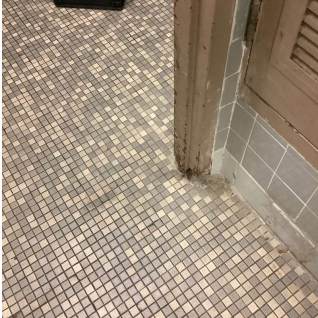
Question	Response
INTERIOR	
KITCHEN	
Door(s)	
Deficiency Location/Instance	Near Exit
Deficiency Quantity	1
Quantity Uom	EACH
Potential Action	MAINTENANCE
Urgency of Action	PRIORITY 3
Purpose of Action	LEVEL 2
Deficiency Photo1

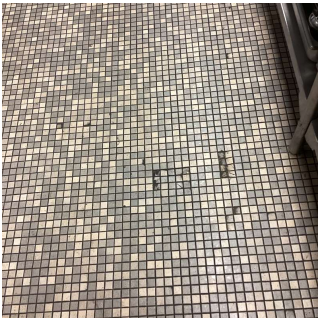
Violations	Near Exit No violations recorded.
Floor Finish	
Instance on 1st Floor	Inspected
Condition	2 - Between Good and Fair
Deficiency	CERAMIC TILE: BROKEN/MISSING TILES
Deficiency Location/Instance	Food Prep
Deficiency Quantity	15
Quantity Uom	S.F.
Potential Action	REPLACE
Urgency of Action	PRIORITY 3
Purpose of Action	LEVEL 2
Deficiency Photo1

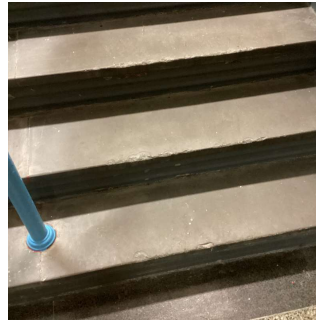
Stair C/1

Does not Exist
Railings	
	Inspected
Condition	2 - Between Good and Fair
Deficiency	No deficiencies recorded
Stairs and Landings	
	Inspected
Condition	2 - Between Good and Fair
Deficiency	STONE: BROKEN/MISSING
Deficiency Location/Instance	Stair C/1,2
Deficiency Quantity	40
Quantity Uom	S.F.
Potential Action	REPLACE
Urgency of Action	PRIORITY 3
Purpose of Action	LEVEL 2

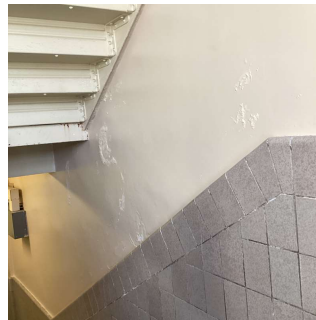
Stair C/1

PLASTER: CRACKS/SPALLING - ACTIVE LEAK

REPLACE

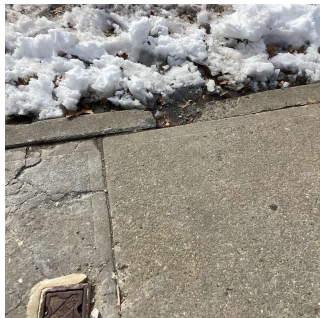
Gerritsen Avenue
Violations	No violations recorded.
Deficiency	DAMAGED/DETERIORATED/MISSING SECTIONS
Deficiency Location/Instance	Gerritsen Avenue
Deficiency Quantity	1,625
Quantity Uom	S.F.
Potential Action	REPLACE
Urgency of Action	PRIORITY 3
Purpose of Action	LEVEL 2
