NYC Department of Education
Building Condition Assessment Survey 2023 - 2024

Architectural Inspection

Asset: **I.S. 281 - BROOKLYN, 8787 24 AVENUE, New York, 11214**

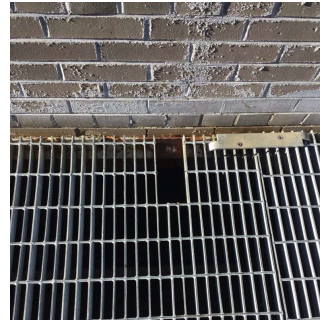
AW4

AREAWAY GRATINGS: MAJOR RUSTING / OR BROKEN

REPLACE

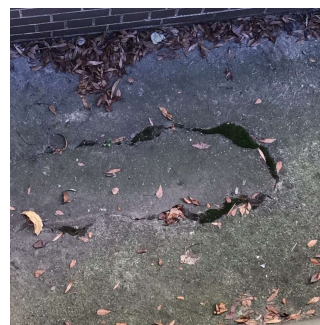
AW8

AREAWAY SLAB: CRACKS AND SPALLING

REPLACE

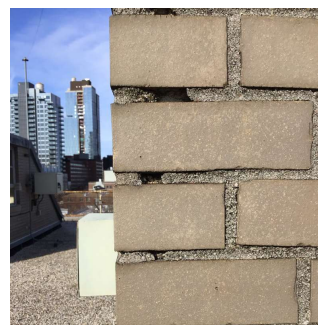
CHI

BRICK: DETERIORATED JOINTS

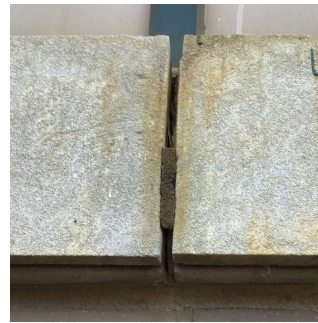
Facade A

BRICK: MASONRY SILLS - DETERIORATED JOINTS

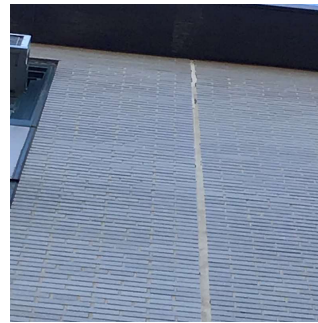
Facade A

BRICK: DETERIORATED CONTROL/EXPANSION JOINTS

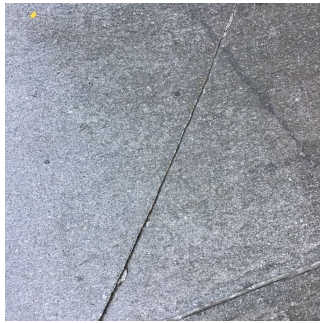
CONCRETE: CRACKS/SPALLING - MAJOR

Deficiency Quantity	25
Quantity Uom	S.F.
Potential Action	REPLACE
Urgency of Action	PRIORITY 4
Purpose of Action	LEVEL 2
Deficiency Photo1
