NYC Department of Education
Building Condition Assessment Survey 2023 - 2024

Architectural Inspection

Asset: P.S. 282 - BROOKLYN, 180 6TH AVENUE, New York, 11217

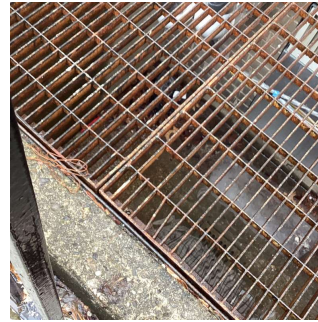
AW2

AREAWAY WALLS: CRACKS AND SPALLING

REPAIR

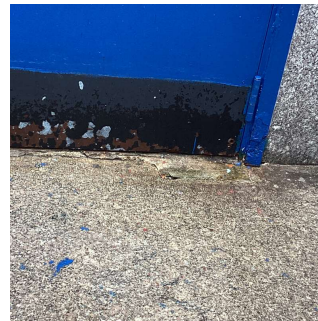
Facade G

METAL CLAD: DETERIORATED DOOR - MAJOR DETERIORATION

REPLACE

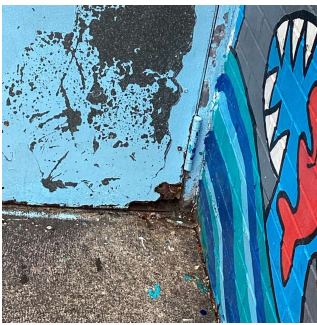
Violations	Facade E No violations recorded.
Deficiency	METAL: DETERIORATED DOOR AND FRAME - MAJOR DETERIORATION
Roof Plan reference

Deficiency Quantity	2
Quantity Uom	EACH
Potential Action	REPLACE
Urgency of Action	PRIORITY 4
Purpose of Action	LEVEL 2
Deficiency Photo1

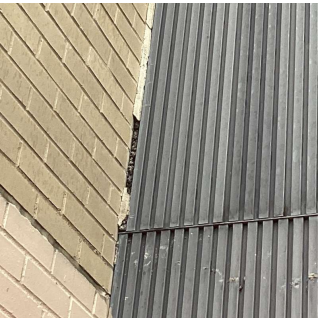
Violations	Facade J - Near Exit 7 35663329K
Deficiency	BRICK: DETERIORATED JOINTS

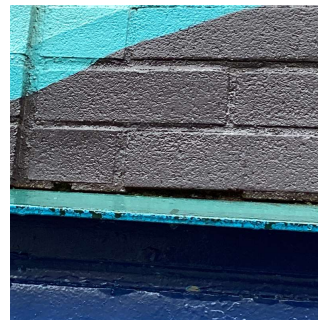
Facade A - Near Exit 2

BRICK: MAJOR / THRU CRACKS

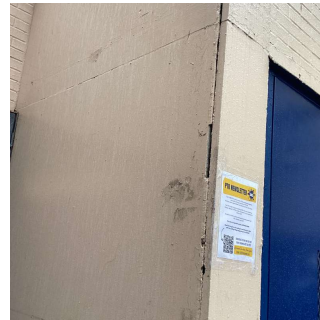
Facade A - Main Entrance

STONE: CHIPPED/SPALLED/BROKEN PIECES - MAJOR

REPLACE

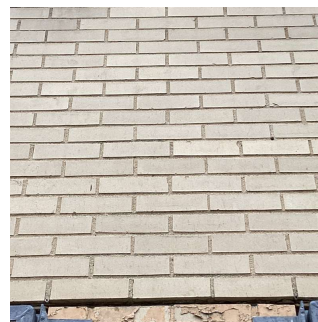
Facade J

BRICK: CRACKS/DISPLACED/SPALLED BRICK AT BUILDING CORNERS

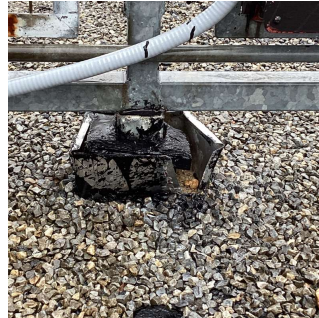
Violations	Roof 1 - Near BH2 No violations recorded.
Deficiency	BUILT-UP: ROOFING: MAJOR ACTIVE ROOF LEAKS IN INSTRUCTIONAL SPACE

200
S.F.
REPLACE ROOFING WITHOUT MAJOR EQUIPMENT
REMOVAL
PRIORITY 5
LEVEL 2

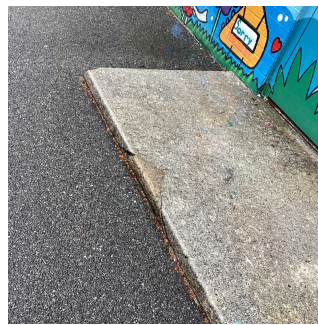
Facade E - Playground side
No violations recorded.

STONE: DETERIORATED JOINTS

10
L.F.
REPOINT
PRIORITY 4
LEVEL 2

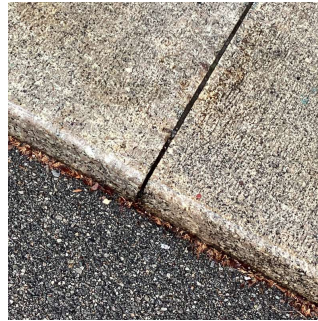
Facade E - Playground side

STONE: DETERIORATED SUBSTRATE

REPLACE SUBSTRATE AND RESET

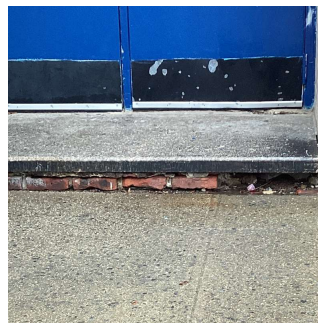
Facade J - Exit 7

STONE: CRACKS/SPALLING - MAJOR

30
 S.F.
 REPLACE
 PRIORITY 5
 LEVEL 6

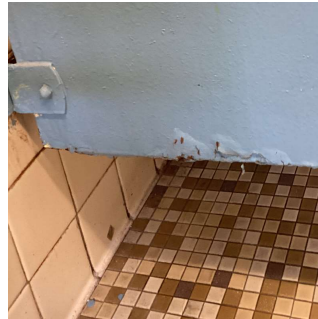
Room 221

Deficiency	RUST - MAJOR
Deficiency Location/Instance	Room 321, 221, 014
Deficiency Quantity	3
Quantity Uom	EACH
Potential Action	REPLACE
Urgency of Action	PRIORITY 3
Purpose of Action	LEVEL 2
Deficiency Photo1

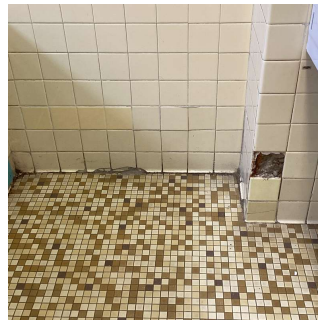
Room 221

Deficiency	CERAMIC TILE: BROKEN/ MISSING
Deficiency Location/Instance	Gymnasium Staff Toilet, 321, 221, 161, 157, and others
Deficiency Quantity	70
Quantity Uom	S.F.
Potential Action	REPLACE
Urgency of Action	PRIORITY 3
Purpose of Action	LEVEL 2
Deficiency Photo1

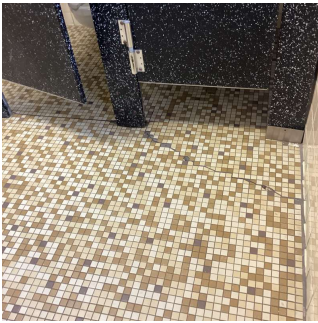
Violations	Room 118 No violations recorded.
Deficiency	CERAMIC TILE: BROKEN/MISSING TILES
Deficiency Location/Instance	Room 318, 316, 218, 112
Deficiency Quantity	40
Quantity Uom	S.F.
Potential Action	REPLACE
Urgency of Action	PRIORITY 3
Purpose of Action	LEVEL 2
Deficiency Photo1

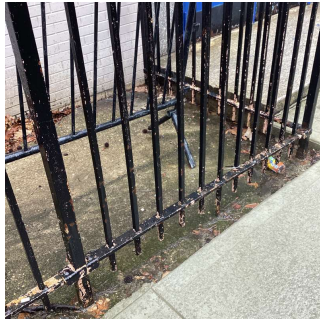
Violations	Near exit 6 35554008R
Deficiency	DAMAGED/DETERIORATED/MISSING SECTIONS
Deficiency Location/Instance	Along Lincoln Place
Deficiency Quantity	150
Quantity Uom	S.F.
Potential Action	REPLACE
Urgency of Action	PRIORITY 3
Purpose of Action	LEVEL 2
Deficiency Photo1

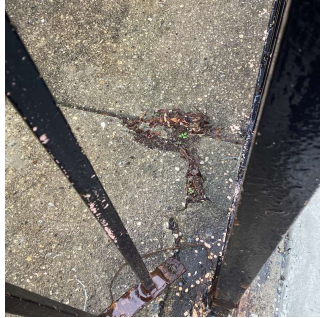
Violations	Along Lincoln Place No violations recorded.
Pavers	Does not Exist
Student Use	Does not Exist
Site Sidewalks & Walkways	Inspected
Asphalt	Inspected
Condition	4 - Between Fair and Poor
Deficiency	CRACKS - MAJOR

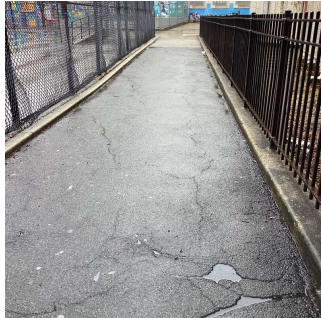
Violations	Between Gymnasium and Park No violations recorded.
Concrete	Inspected
Condition	4 - Between Fair and Poor
Deficiency	DAMAGED/DETERIORATED/MISSING SECTIONS
Deficiency Location/Instance	Along 6th Avenue, Exit near parks department, Exit 2
Deficiency Quantity	425
Quantity Uom	S.F.
Potential Action	REPLACE
Urgency of Action	PRIORITY 3
Purpose of Action	LEVEL 2
Deficiency Photo1

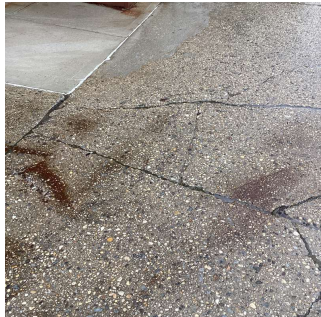
Violations	Along 6th Avenue No violations recorded.
Deficiency	HEAVING
Deficiency Location/Instance	Near Main Entrance
Deficiency Quantity	100
Quantity Uom	S.F.
Potential Action	REPLACE
Urgency of Action	PRIORITY 4
Purpose of Action	LEVEL 4

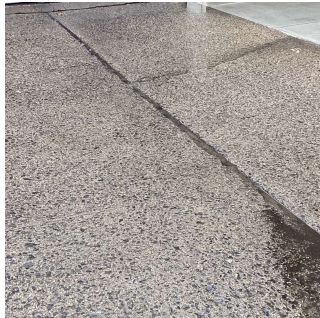
Near Main Entrance
Violations	35663329K
Deficiency	DAMAGED/DETERIORATED/MISSING SECTIONS
Deficiency Location/Instance	Near Main Entrance
Deficiency Quantity	650
Quantity Uom	S.F.
Potential Action	REPLACE
Urgency of Action	PRIORITY 4
Purpose of Action	LEVEL 4
Deficiency Photo1
