NYC Department of Education
Building Condition Assessment Survey 2023 - 2024

Architectural Inspection

Asset: P.S. 288 - BROOKLYN, 2950 WEST 25 STREET, New York, 11224

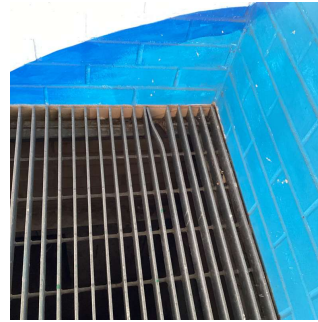
AW5

AREAWAY GRATINGS: MAJOR RUSTING / OR BROKEN

REPLACE

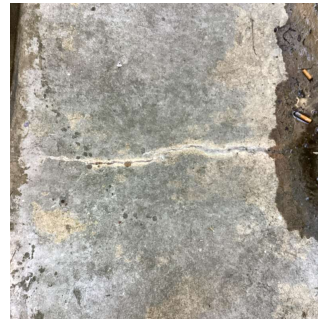
AW4

AREAWAY SLAB: CRACKS AND SPALLING

REPLACE

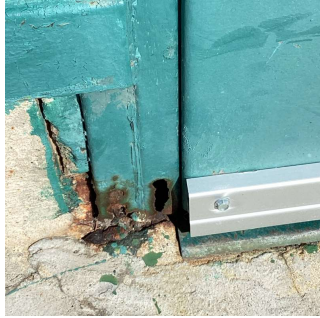
Question	Response
EXTERIOR	
DOORS	
DOORS AND FRAMES	Inspected
Condition	4 - Between Fair and Poor
Deficiency	METAL: DETERIORATED DOOR AND FRAME - MAJOR DETERIORATION
Roof Plan reference	K288 West 27th Street

West 25th Street
Deficiency Quantity	4
Quantity Uom	EACH
Potential Action	REPLACE
Urgency of Action	PRIORITY 4
Purpose of Action	LEVEL 2
Deficiency Photo1

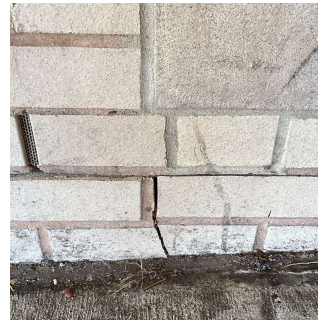
Facade C

Deficiency	BRICK: MAJOR / THRU CRACKS

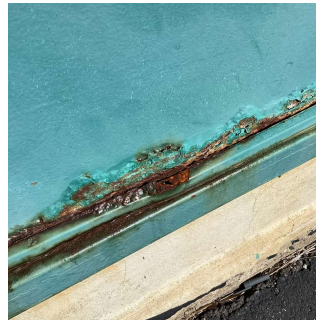
Facade B

METAL PANEL: MAJOR RUSTING

REPLACE

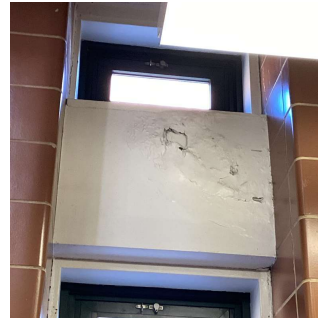
Facade B - Stair B/3, Facade D - Stairs D/3 (Shown)

BRICK: WATER INFILTRATION IN INSTRUCTIONAL SPACE

REPAIR

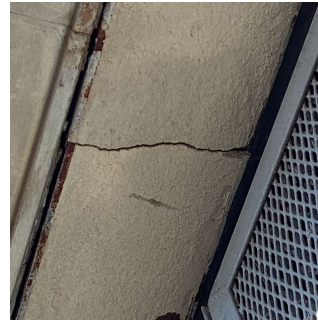
Facade B

STUCCO/PLASTER: MAJOR CRACKS/SPALLING

30
S.F.
REPLACE
PRIORITY 4
LEVEL 2

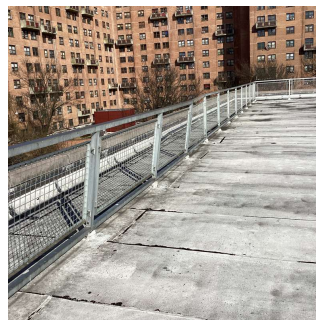
Roof 1

Question	Response
EXTERIOR	
LOUVER	Inspected
Condition	2 - Between Good and Fair
Deficiency	No deficiencies recorded
PARAPETS	Inspected
Material Type(s)	Masonry
Replacement Quantity	4,500
Replacement Uom	C.F.
Instance on All Facades	Inspected
Instance Condition	2 - Between Good and Fair
Instance Quantity	4,500
Instance Quantity Uom	C.F.
Deficiency	No deficiencies recorded
PLAZA DECK	Does not Exist
ROOF	Inspected
Roofing	Inspected
Replacement Quantity	34,500
Replacement Uom	S.F.
ROOF HATCH/SMOKE HATCH	Does not Exist
LEADERS, GUTTERS, DOWNSPOUTS, SCUPPERS	Inspected
Condition	1 - Good
Deficiency	No deficiencies recorded
ROOF BARRIER/FENCE	Inspected
Condition	3 - Fair
Deficiency	RAILINGS/PANELS: DETERIORATED, MAJOR RUSTING
Roof Plan reference	K288 West 27th Street

50
S.F.
REPLACE
PRIORITY 4
LEVEL 2

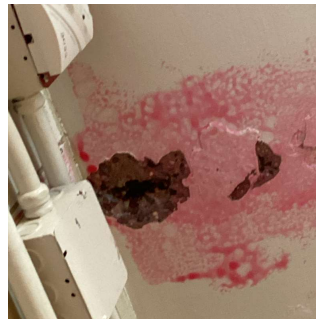
Does this roof instance have a Sustainable Roof System?	Yes
Sustainable Roof Type	White Roof
Sustainable Roof Location (Roof Number)	Roofs 1 - 3
Do solar panels exist on these roofs?	No
Is/Are the roof(s) suitable for Solar Panel installation?	Yes
Installation Year	2021
Source of Installation	Custodial Staff
Deficiency	MODIFIED BITUMEN: ROOFING: MAJOR ACTIVE ROOF LEAKS IN INSTRUCTIONAL SPACE

Roof 1 - Corridor near Rooms 351 (Shown), 349, 347, 319, 317
No violations recorded.

500
S.F.
REPLACE ROOFING WITHOUT MAJOR EQUIPMENT
REMOVAL
PRIORITY 5
LEVEL 2

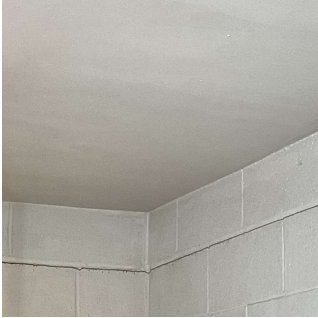
BULKHEAD/PENTHOUSE WALLS/INTERIOR: CMU
CRACKS/SPALLING

BH3
Violations	No violations recorded.
Deficiency	BULKHEAD/PENTHOUSE WALLS/EXTERIOR: WATER INFILTRATION
Roof Plan reference	K288 West 27th Street

Question	Response
EXTERIOR	
ROOF	
Specialties	
BULKHEAD/PENTHOUSE	
Potential Action	REPLACE
Urgency of Action	PRIORITY 4
Purpose of Action	LEVEL 2
Deficiency Photo1

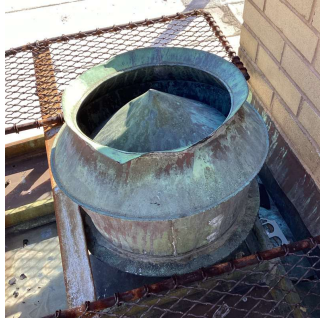
SK
Violations	No violations recorded.
Deficiency	DAMAGED GUARDS
Roof Plan reference	K288 West 27th Street

Question	Response
EXTERIOR	
ROOF	
Specialties	
SKYLIGHT/ROOF VENT	Inspected
Urgency of Action	PRIORITY 3
Purpose of Action	LEVEL 2
Deficiency Photo1

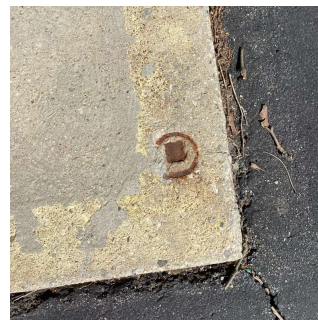
Facade B

CONCRETE: WORN-OUT TREAD/RISER/NOSING

10
S.F.
REPLACE
PRIORITY 4
LEVEL 2

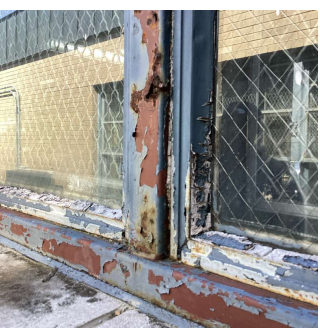
Violations	Facade F No violations recorded.
Instance on Aluminum - Other: Facades B, C, D	Inspected
Instance Condition	3 - Fair
Instance Quantity	2,200
Instance Quantity Uom	S.F.
Are these windows insulated	No
Installation Year	2007
Source of Installation	Custodial Staff
Deficiency	No deficiencies recorded
INTERIOR	Inspected
POOLS	Does not Exist
STRUCTURAL	Inspected

Deficiency Quantity	500
Quantity Uom	S.F.
Potential Action	REPLACE WINDOW
Urgency of Action	PRIORITY 4
Purpose of Action	LEVEL 2
Deficiency Photo1

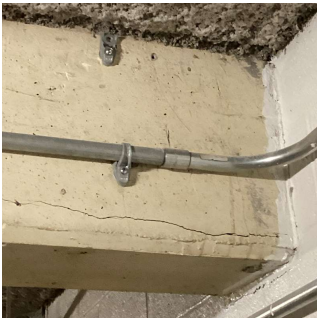
Question	Response
INTERIOR	
STRUCTURAL	
COLUMNS/BEAMS/BEARING WALLS	Inspected
Condition	3 - Fair
Deficiency	STEEL COLUMNS/BEAMS: DETERIORATED CONCRETE FIREPROOFING
Deficiency Location/Instance	Stair C/3, Basement - Gas Meter Room, Switchboard Room, Boiler Room, Crawl Space
Deficiency Quantity	50
Quantity Uom	S.F.
Potential Action	REPLACE
Urgency of Action	PRIORITY 4
Purpose of Action	LEVEL 5
Deficiency Photo1

Violations	Basement - Gas Meter Room No violations recorded.
FLOOR STRUCTURE	
	Inspected
Condition	4 - Between Fair and Poor
Deficiency	CONCRETE SLAB ON GRADE: WATER INFILTRATION IN NON-INSTRUCTIONAL SPACE
Deficiency Location/Instance	Basement - Gas Meter Room, Boiler Room
Deficiency Quantity	200
Quantity Uom	S.F.
Potential Action	INSTALL WATERPROOFING
Urgency of Action	PRIORITY 5
Purpose of Action	LEVEL 5
Deficiency Photo1

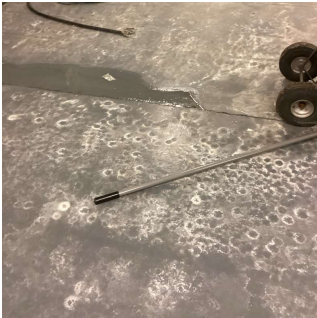
Violations	Basement - Boiler Room No violations recorded.
Deficiency	CONCRETE SLAB ON GRADE: THRU CRACKS

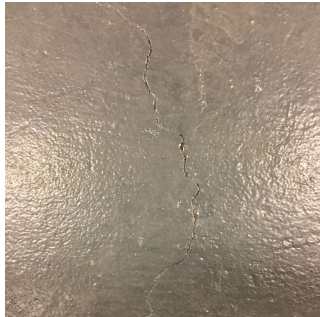
Deficiency Location/Instance	Basement - Boiler Room, Electrical Room
Deficiency Quantity	20
Quantity Uom	S.F.
Potential Action	REPLACE
Urgency of Action	PRIORITY 4

Basement - Boiler Room
Violations	No violations recorded.
FOUNDATION WALLS	
	Inspected
Material Type(s)	Concrete
Condition	3 - Fair
Deficiency	CONCRETE: CRACKED/SPALLED/REINFORCEMENT EXPOSED
Deficiency Location/Instance	Basement - Gas Meter Room
Deficiency Quantity	10
Quantity Uom	S.F.
Potential Action	REPAIR
Urgency of Action	PRIORITY 4
Purpose of Action	LEVEL 5
Deficiency Photo1

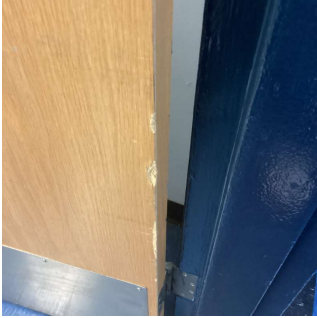
Question	Response
INTERIOR	
CAFETERIA	
Ceiling	
Instance on 1st Floor - Students	Inspected
Condition	2 - Between Good and Fair
Deficiency	No deficiencies recorded
Door(s)	
Instance on 1st Floor - Staff (600 SF)	Inspected
Condition	4 - Between Fair and Poor
Deficiency	WOOD: DETERIORATED DOOR
Deficiency Location/Instance	Main Entrance, Students Cafeteria
Deficiency Quantity	2
Quantity Uom	EACH
Potential Action	MAINTENANCE
Urgency of Action	PRIORITY 3
Purpose of Action	LEVEL 2
Deficiency Photo1

Violations	Main Entrance No violations recorded.
Instance on 1st Floor - Students	Inspected
Condition	5 - Poor
Deficiency	WOOD: DETERIORATED DOOR
Deficiency Location/Instance	Main Entrance
Deficiency Quantity	3
Quantity Uom	EACH
Potential Action	MAINTENANCE
Urgency of Action	PRIORITY 3
Purpose of Action	LEVEL 2
Deficiency Photo1

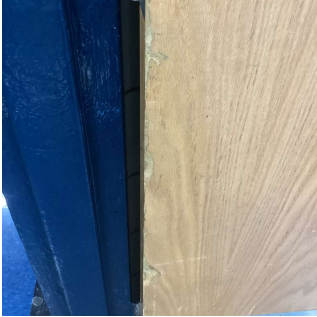
Violations	Main Entrance No violations recorded.
Fixed Equipment	
Instance on 1st Floor - Staff (600 SF)	Does not Exist

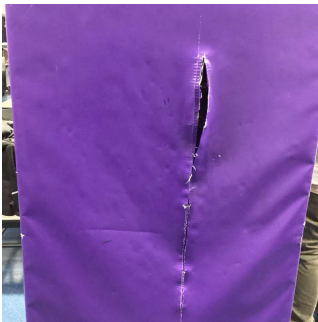
Question	Response
INTERIOR	
CAFETERIA	
Walls	
Instance on 1st Floor - Students	Inspected
Condition	3 - Fair
Deficiency	WALL PADDING: DETERIORATED
Deficiency Location/Instance	Near Main Entrance, Columns
Deficiency Quantity	160
Quantity Uom	S.F.
Potential Action	REPLACE
Urgency of Action	PRIORITY 3
Purpose of Action	LEVEL 2
Deficiency Photo1

Violations	Near Main Entrance No violations recorded.
Deficiency	GLAZED BLOCK: CRACKS/SPALLING
Deficiency Location/Instance	Near Exit 5, by Drinking Fountain
Deficiency Quantity	20
Quantity Uom	S.F.
Potential Action	REPLACE
Urgency of Action	PRIORITY 3
Purpose of Action	LEVEL 2
Deficiency Photo1

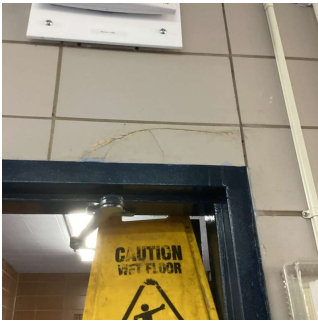
Violations	Near Exit 5 No violations recorded.
Window Curtains/Shades/Blinds	
Instance on 1st Floor - Staff (600 SF)	Does not Exist
Instance on 1st Floor - Students	Does not Exist
CLASSROOMS/CORRIDORS/ADMIN SPACES	
Ceiling	
Condition	Inspected
Condition	2 - Between Good and Fair
Deficiency	PLASTER: CRACKS/SPALLING

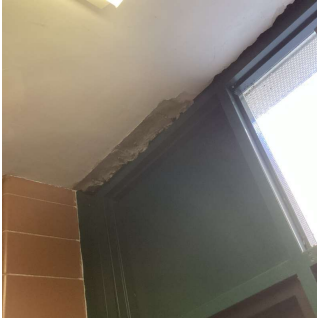
Deficiency Location/Instance	Exit 7 - Vestibule
Deficiency Quantity	10

Question	Response
INTERIOR	
CLASSROOMS/CORRIDORS/ADMIN SPACES	
Ceiling	
Quantity Uom	S.F.
Potential Action	REPLACE
Urgency of Action	PRIORITY 3
Purpose of Action	LEVEL 2
Deficiency Photo1

Violations	Exit 7 - Vestibule No violations recorded.
Deficiency	METAL PAN: DAMAGED/MISSING
Deficiency Location/Instance	Corridor near Rooms 343, 204, 145, 105, 103 and others
Deficiency Quantity	80
Quantity Uom	S.F.
Potential Action	REPLACE
Urgency of Action	PRIORITY 3
Purpose of Action	LEVEL 2
Deficiency Photo1

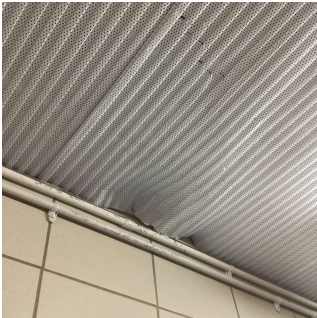
Violations	Corridor near Room 105 No violations recorded.
Deficiency	ACOUSTIC TILES: DAMAGED/MISSING
Deficiency Location/Instance	Main Entrance - Vestibule, Corridor near Stair A/1, by Cafeteria, Exits 2, 6 - Vestibules
Deficiency Quantity	70
Quantity Uom	S.F.
Potential Action	REPLACE
Urgency of Action	PRIORITY 3
Purpose of Action	LEVEL 2

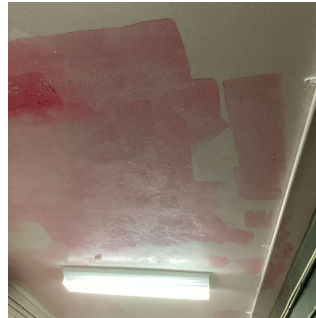
Corridor near Room 319

PLASTER: CRACKS/SPALLING - ACTIVE LEAK

REPLACE

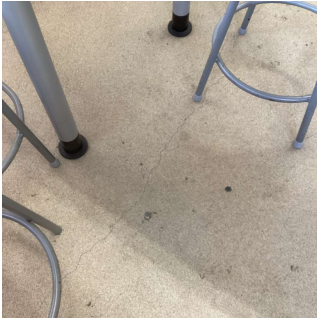
Corridor near Room 349
Violations	No violations recorded.
Deficiency	EPOXY FLOORING: CRACKS/SPALLING
Deficiency Location/Instance	Room 349
Deficiency Quantity	40
Quantity Uom	S.F.
Potential Action	REPLACE
Urgency of Action	PRIORITY 3
Purpose of Action	LEVEL 2
Deficiency Photo1

Room 349
Violations	No violations recorded.
Deficiency	VINYL TILES: TRIPPING HAZARD - ELECTRICAL OUTLET
Deficiency Location/Instance	Room 339
Deficiency Quantity	10
Quantity Uom	S.F.
Potential Action	REMOVE
Urgency of Action	PRIORITY 5

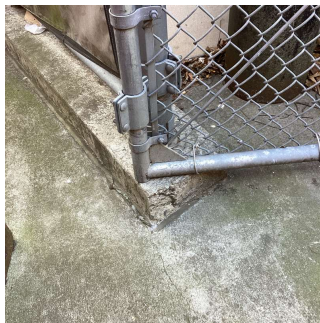
Violations	Near Exit 7 No violations recorded.
Deficiency	CHAIN LINK: DAMAGED/DETERIORATED
Deficiency Location/Instance	West 27th Street
Deficiency Quantity	50
Quantity Uom	S.F.
Potential Action	REPLACE
Urgency of Action	PRIORITY 5
Purpose of Action	LEVEL 6
Deficiency Photo1

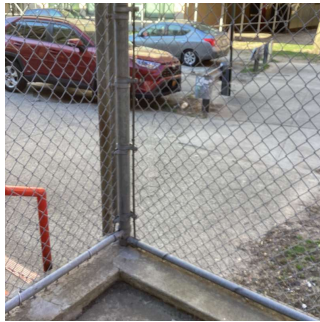
Violations	West 27th Street No violations recorded.
Deficiency	CHAIN LINK: DAMAGED/DETERIORATED
Deficiency Location/Instance	West 27th Street
Deficiency Quantity	150
Quantity Uom	S.F.
Potential Action	REPLACE
Urgency of Action	PRIORITY 3
Purpose of Action	LEVEL 2
Deficiency Photo1

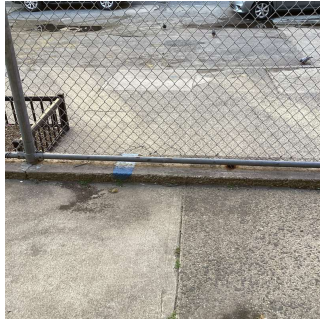
Violations	West 27th Street No violations recorded.

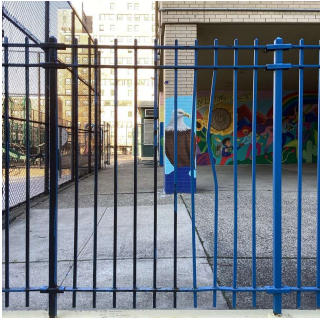
Violations	West 27th Street No violations recorded.
Deficiency	WROUGHT IRON: DAMAGED/DETERIORATED
Deficiency Location/Instance	West 25th Street
Deficiency Quantity	80
Quantity Uom	S.F.
Potential Action	REPLACE
Urgency of Action	PRIORITY 3
Purpose of Action	LEVEL 2
Deficiency Photo1

Violations	West 25th Street No violations recorded.
IRRIGATION SYSTEM	Does not Exist
PAVING	Inspected
Student Non-Use	Inspected
Gravel Exists?	No
Asphalt	Does not Exist
Concrete	Inspected
Condition	2 - Between Good and Fair
Deficiency	No deficiencies recorded
Pavers	Does not Exist
Student Use	Does not Exist
Site Sidewalks & Walkways	Inspected

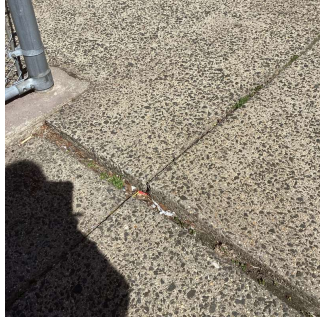
Near Exit 2
Violations	No violations recorded.
Deficiency	HEAVING
Deficiency Location/Instance	Near Exits 2, 5, 6, West 27th Street
Deficiency Quantity	325
Quantity Uom	S.F.
Potential Action	REPLACE
Urgency of Action	PRIORITY 3
Purpose of Action	LEVEL 2
Deficiency Photo1

West 27th Street
Violations	No violations recorded.
Pavers	Does not Exist
DOT Sidewalk	Inspected
Asphalt	Does not Exist
Concrete	Inspected
Condition	4 - Between Fair and Poor
Deficiency	DAMAGED/DETERIORATED/MISSING SECTIONS
Deficiency Location/Instance	West 25th Street, West 27th Street
