NYC Department of Education
Building Condition Assessment Survey 2023 - 2024

Architectural Inspection

Asset: P.S. 290 - BROOKLYN, 135 SCHENCK AVENUE, New York, 11207

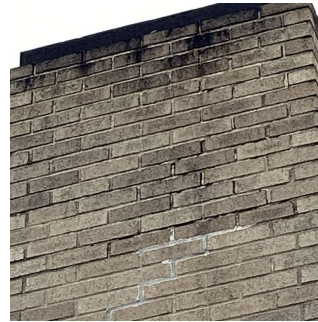
Question	Response
Architectural	
EXTERIOR	Inspected
AREAWAY	Inspected
Instance on AW1	Inspected
Instance Condition	2 - Between Good and Fair
Instance Quantity	1
Instance Quantity Uom	EACH
Deficiency	No deficiencies recorded
AWNINGS AND CANOPIES	Does not Exist
CHIMNEY	Inspected
Material Type(s)	Masonry
Condition	3 - Fair
Deficiency	BRICK: DETERIORATED JOINTS

20
S.F.
REPOINT
PRIORITY 4
LEVEL 2

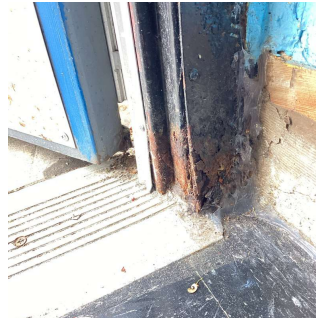
Facade C

METAL: DETERIORATED DOOR AND FRAME - MAJOR DETERIORATION

4
EACH
REPLACE
PRIORITY 4

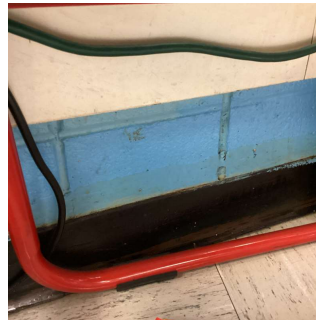
BRICK: WATER INFILTRATION IN INSTRUCTIONAL SPACE

Facade C - Room 201 (Facade B - Stair B/2, Room 200, Facade C - Room 203 similar)

REPAIR

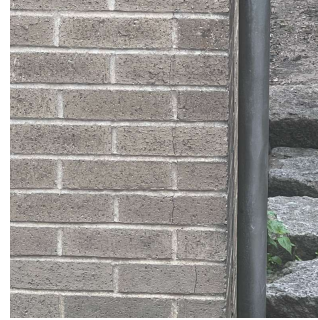
Facade A

BRICK: CRACKS/DISPLACED/SPALLED BRICK AT BUILDING CORNERS

S.F.
REMOVE AND REBUILD
PRIORITY 4
LEVEL 2

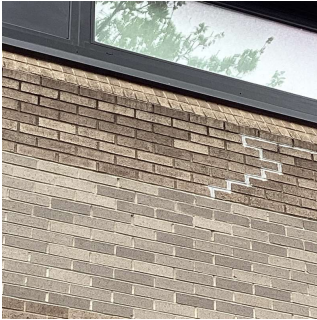
BRICK: DETERIORATED JOINTS

Facade A
Violations	No violations recorded.
EXTERIOR SOFFITS	Inspected
Condition	2 - Between Good and Fair
Deficiency	No deficiencies recorded
LOADING DOCK	Does not Exist
LOUVER	Inspected
Condition	2 - Between Good and Fair
Deficiency	No deficiencies recorded
PARAPETS	Inspected
Material Type(s)	Masonry
Replacement Quantity	6,000
Replacement Uom	C.F.
Instance on All Roofs	Inspected
Instance Condition	3 - Fair
Instance Quantity	6,000
Instance Quantity Uom	C.F.
Deficiency	BRICK: OUT OF PLUMB
Roof Plan reference

100
S.F.
REPOINT
PRIORITY 3
LEVEL 2

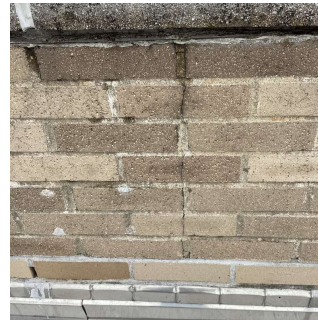
Roof 1

BRICK: MINOR CRACKS, SPALLING

REPAIR

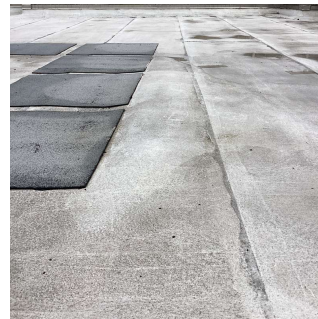
Installation Year	2021
Source of Installation	Custodial Staff
Deficiency	MODIFIED BITUMEN: ROOFING: DELAMINATION

Roof 1
No violations recorded.

100
S.F.
REPLACE ROOFING WITHOUT MAJOR EQUIPMENT
REMOVAL
PRIORITY 4
LEVEL 2

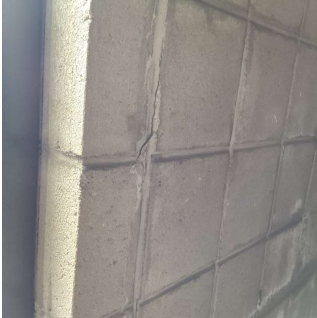
**BULKHEAD/PENTHOUSE WALLS/INTERIOR: CMU
CRACKS/SPALLING**

Question	Response
EXTERIOR	
ROOF	
Specialties	
BULKHEAD/PENTHOUSE	
Potential Action	REPLACE
Urgency of Action	PRIORITY 3
Purpose of Action	LEVEL 2
Deficiency Photo1

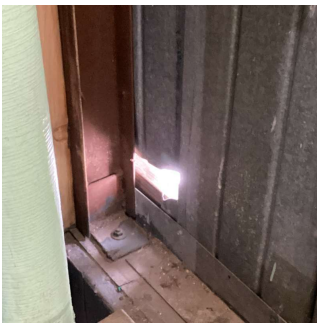
BH2
Violations	No violations recorded.
Deficiency	BULKHEAD/PENTHOUSE WALLS/EXTERIOR: DAMAGED METAL SIDING
Roof Plan reference

PH
Violations	No violations recorded.
CUPOLA/ SPIRES/ TOWERS	Does not Exist
DORMER	Does not Exist
DUNNAGE STEEL	Inspected
Condition	2 - Between Good and Fair

Deficiency Quantity	20
Quantity Uom	S.F.
Potential Action	REPLACE
Urgency of Action	PRIORITY 4
Purpose of Action	LEVEL 2
Deficiency Photo1

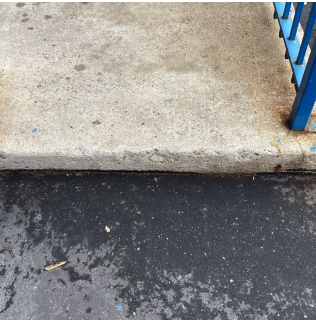
Question	Response
EXTERIOR	
ROOF	Inspected
Specialties	Inspected
DUNNAGE STEEL	Inspected
Deficiency	No deficiencies recorded
SKYLIGHT/ROOF VENT	Does not Exist
ROOF/GRAVITY TANK	Does not Exist
STAIRS/RAMPS: EXTERIOR	Inspected
BUILDING CHEEK/FLANK WALLS	Does not Exist
RAILINGS	Inspected
Condition	2 - Between Good and Fair
Deficiency	No deficiencies recorded
STAIRS/RAMPS	Inspected
Condition	4 - Between Fair and Poor
Deficiency	CONCRETE: WORN-OUT TREAD/RISER/NOSING
Roof Plan reference

Violations	Facade C No violations recorded.
Deficiency	CONCRETE: CRACKS/SPALLING - MAJOR

Deficiency Quantity	10
Quantity Uom	S.F.
Potential Action	REPLACE
Urgency of Action	PRIORITY 4
Purpose of Action	LEVEL 2
Deficiency Photo1

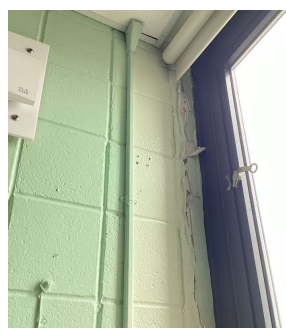
Question	Response
EXTERIOR	
STAIRS/RAMPS: EXTERIOR	Inspected
STAIRS/RAMPS	
Roof Plan reference	
Deficiency Quantity	10
Quantity Uom	S.F.
Potential Action	REPLACE
Urgency of Action	PRIORITY 4
Purpose of Action	LEVEL 2
Deficiency Photo1	
Violations	Facade C No violations recorded.
WINDOWS	Inspected
Replacement Quantity	3,400
Replacement Uom	S.F.
EXTERIOR GUARDS	Inspected
Condition	2 - Between Good and Fair
Deficiency	No deficiencies recorded
LINTELS	Inspected
Condition	1 - Good
Deficiency	No deficiencies recorded
WINDOWS	Inspected
Material Type(s)	Aluminum
Instance on Aluminum - Other: All Facades	Inspected
Instance Condition	3 - Fair
Instance Quantity	3,400
Instance Quantity Uom	S.F.
Are these windows insulated	Yes
Installation Year	2021
Source of Installation	Custodial Staff
Deficiency	ALUMINUM - OTHER: AIR/WATER INFILTRATION

Violations	Facade B - Room 401 (Facade B - Rooms 305, 403, Stair B/3, Stair B/4, Facade C - Room 400 similar) No violations recorded.
INTERIOR	
Inspected	
POOLS	
Does not Exist	
STRUCTURAL	
Inspected	
COLUMNS/BEAMS/BEARING WALLS	
Inspected	
Condition	3 - Fair
Deficiency	CONCRETE COLUMNS/BEAMS: CRACKED/SPALLED/REINFORCEMENT EXPOSED
Deficiency Location/Instance	BH1
Deficiency Quantity	10
Quantity Uom	S.F.
Potential Action	REPAIR

Deficiency Quantity	120
Quantity Uom	L.F.
Potential Action	REPLACE TRIM, SILLS OR WEATHERSTRIPPING
Urgency of Action	PRIORITY 5
Purpose of Action	LEVEL 2
Deficiency Photo1

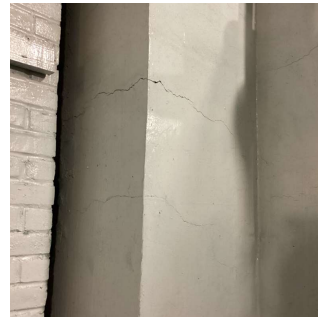
Boiler Room

STEEL COLUMNS/BEAMS: DETERIORATED CONCRETE FIREPROOFING

REPLACE

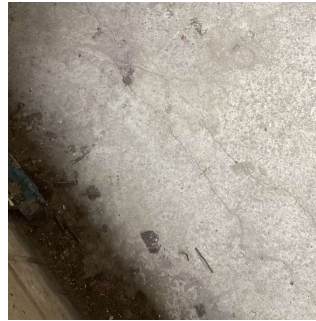
PH

CONCRETE: CRACKS/SPALLED/REINFORCEMENT EXPOSED

REPAIR

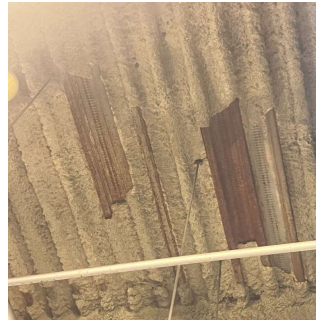
Room C19

METAL DECK AND CONCRETE: DETERIORATED

REPAIR

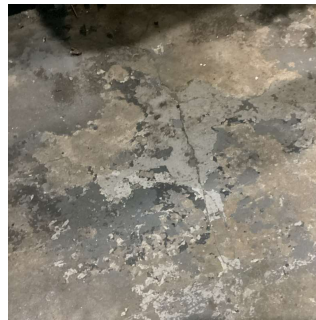
Boiler Room

CONCRETE SLAB ON GRADE: THRU CRACKS

REPAIR

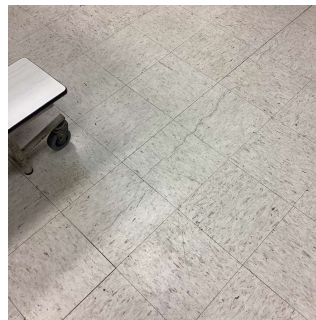
Near Exit 3

VINYL TILES: DETERIORATED SUBSTRATE

REPLACE

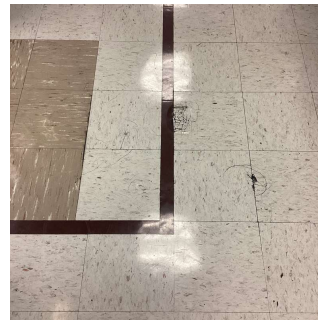
Corridor near Stair A/4

VINYL TILES: DETERIORATED SUBSTRATE

REPLACE

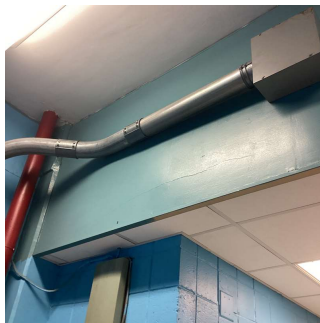
SHOWER ROOM	
Does not Exist	
STAIRS/RAMPS: INTERIOR	
Do Letter Stair Signs Exist?	Yes
Ceiling	
Condition	2 - Between Good and Fair
Deficiency	PLASTER: CRACKS/SPALLING
Deficiency Location/Instance	Stair B/2
Deficiency Quantity	10
Quantity Uom	S.F.
Potential Action	REPLACE
Urgency of Action	PRIORITY 3
Purpose of Action	LEVEL 2

Violations	Stair B/2 No violations recorded.
Door(s)	Inspected
Condition	4 - Between Fair and Poor
Deficiency	METAL: DETERIORATED DOOR AND FRAME
Deficiency Location/Instance	Stair B/1 Vestibule
Deficiency Quantity	2
Quantity Uom	EACH
Potential Action	MAINTENANCE
Urgency of Action	PRIORITY 3
Purpose of Action	LEVEL 2
Deficiency Photo1

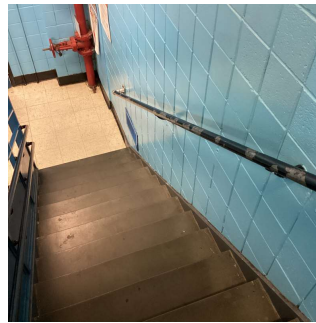
Violations	Stair B/1 Vestibule No violations recorded.
Partition	Does not Exist
Railings	Inspected
Condition	3 - Fair
Deficiency	METAL: DAMAGED
Deficiency Location/Instance	Stair B/1 (missing bottom rail)
Deficiency Quantity	18
Quantity Uom	L.F.
Potential Action	REPLACE
Urgency of Action	PRIORITY 3
Purpose of Action	LEVEL 2

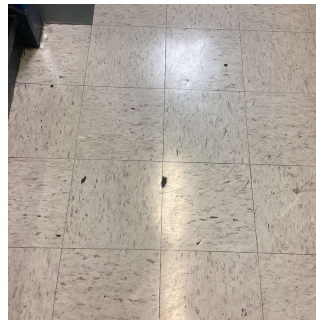
Stair A/3

VINYL TILES: BROKEN/DETERIORATED/MISSING TILES

REPLACE

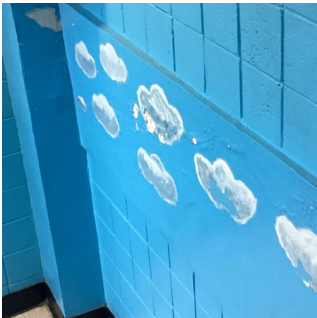
Stair B/2
Violations	No violations recorded.
Deficiency	PLASTER: CRACKS/SPALLING
Deficiency Location/Instance	Stair A/4
Deficiency Quantity	20
Quantity Uom	S.F.
Potential Action	REPLACE
Urgency of Action	PRIORITY 3
Purpose of Action	LEVEL 2
Deficiency Photo1

Stair A/4
Violations	No violations recorded.
Deficiency	MASONRY: CRACKS/SPALLING - ACTIVE LEAK
Deficiency Location/Instance	Stair B/3,4
Deficiency Quantity	40
Quantity Uom	S.F.
Potential Action	REPLACE
Urgency of Action	PRIORITY 5
Purpose of Action	LEVEL 2

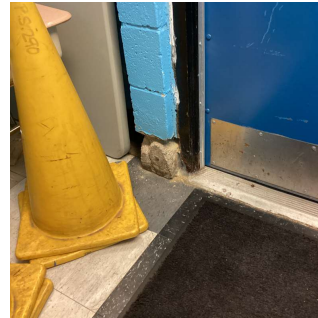
Stair B/1 Vestibule

MASONRY: CRACKS/SPALLING

REPLACE

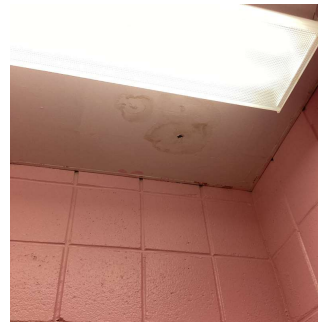
Room 310

GYPSUM BOARD: DAMAGED/DETERIORATED

REPLACE

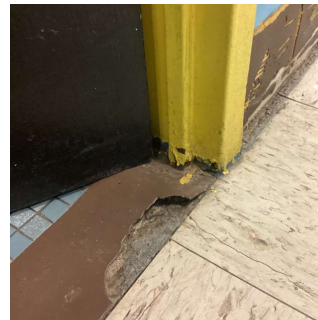
Room 314

METAL: DETERIORATED DOOR AND FRAME

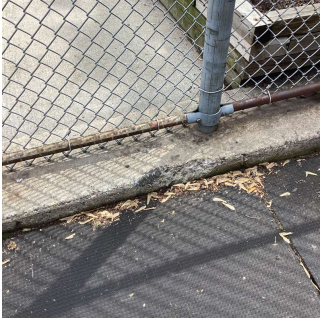
Question	Response
SITE	
FENCES	
Violations	Fulton Street No violations recorded.
Deficiency	WROUGHT IRON: DAMAGED/DETERIORATED
Deficiency Location/Instance	Schenck Avenue
Deficiency Quantity	40
Quantity Uom	S.F.
Potential Action	REPLACE
Urgency of Action	PRIORITY 3
Purpose of Action	LEVEL 2
Deficiency Photo1	 
Violations	Schenck Avenue No violations recorded.
Deficiency	CONCRETE CURB: DAMAGED/DETERIORATED
Deficiency Location/Instance	Schenck Avenue, Fulton Street, Barbey Street
Deficiency Quantity	45
Quantity Uom	S.F.
Potential Action	REPLACE
Urgency of Action	PRIORITY 3
Purpose of Action	LEVEL 2
Deficiency Photo1

Violations	Barbey Street No violations recorded.
IRRIGATION SYSTEM	Does not Exist
PAVING	Inspected
Student Non-Use	Inspected
Gravel Exists?	No
Asphalt	Does not Exist
Concrete	Inspected
Condition	2 - Between Good and Fair
Deficiency	No deficiencies recorded
Pavers	Does not Exist

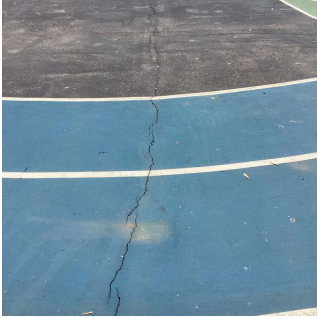
Question	Response
SITE	
PAVING	
Student Use	Inspected
Gravel Exists?	No
Asphalt	Inspected
Condition	3 - Fair
Deficiency	CRACKS - MAJOR
Deficiency Location/Instance	Schoolyard
Deficiency Quantity	300
Quantity Uom	S.F.
Potential Action	REPLACE
Urgency of Action	PRIORITY 3
Purpose of Action	LEVEL 2
Deficiency Photo1

Violations	Schoolyard No violations recorded.
Concrete	Does not Exist
Pavers	Does not Exist
Site Sidewalks & Walkways	Inspected
Asphalt	Inspected
Condition	2 - Between Good and Fair
Deficiency	HEAVING
Deficiency Location/Instance	Near Exit 3
Deficiency Quantity	10
Quantity Uom	S.F.
Potential Action	REPLACE
Urgency of Action	PRIORITY 3
Purpose of Action	LEVEL 2
Deficiency Photo1

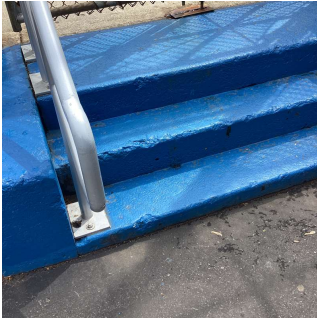
Question	Response
SITE	
STAIRS/RAMPS: EXTERIOR	
Stairs/ramps	
Deficiency	CAST IN PLACE CONCRETE: CRACKS/SPALLING - MAJOR
Deficiency Location/Instance	Schoolyard
Deficiency Quantity	40
Quantity Uom	S.F.
Potential Action	REPLACE
Urgency of Action	PRIORITY 3
Purpose of Action	LEVEL 2
Deficiency Photo1

Violations	Schoolyard No violations recorded.
ARTWORK	
Instance	Inspected
Instance Photo	Interior - All Purpose Room - 31238
