NYC Department of Education
Building Condition Assessment Survey 2023 - 2024

Architectural Inspection

Asset: P.S. 297 - BROOKLYN, 700 PARK AVENUE, New York, 11206

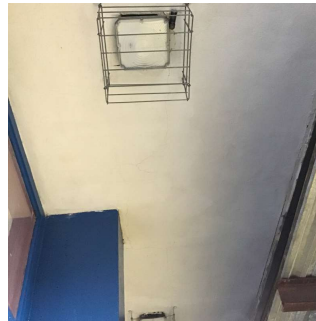
Main Entrance Canopy
 No violations recorded.

AWNINGS AND CANOPIES

Quantity Uom	S.F.
Potential Action	REPAIR
Urgency of Action	PRIORITY 4
Purpose of Action	LEVEL 2
Deficiency Photo1

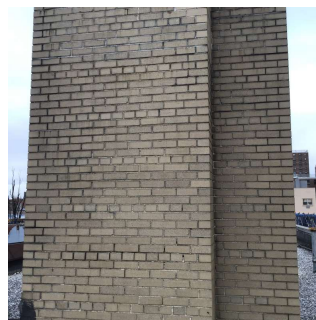
Roof 1
 No violations recorded.

BRICK: DETERIORATED JOINTS

200
 S.F.
 REPOINT
 PRIORITY 3
 LEVEL 2

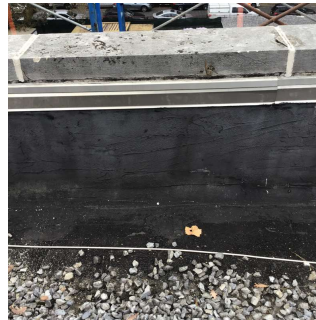
Roof 1 - Facade C

CAST STONE: DETERIORATED BED JOINT

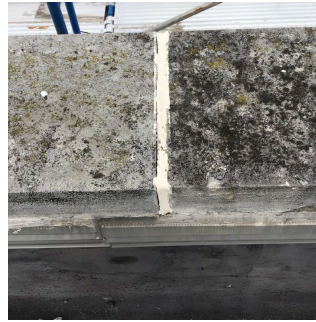
Roof 1 - Facade H

CAST STONE: DETERIORATED TRANSVERSE JOINTS

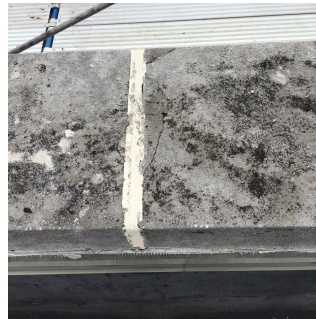
Roof 1 -south

CAST STONE: CRACKED/BROKEN PIECES

REPLACE-IN-KIND

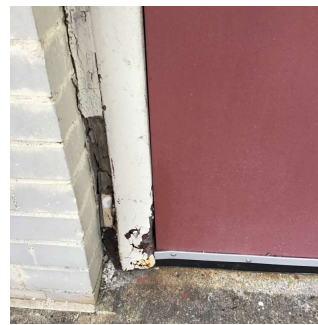
Facade D frame only
No violations recorded.

METAL: DETERIORATED DOOR AND FRAME - MAJOR DETERIORATION

2
EACH
REPLACE
PRIORITY 4
LEVEL 2

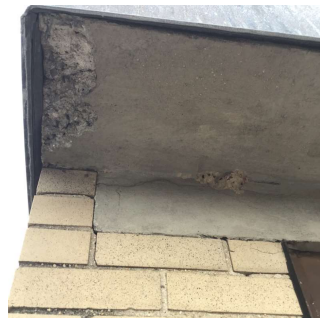
Deficiency	BULKHEAD/PENTHOUSE ROOF: DETERIORATED
Roof Plan reference	K297

Deficiency Quantity	20
Quantity Uom	S.F.
Potential Action	REPAIR
Urgency of Action	PRIORITY 3
Purpose of Action	LEVEL 2

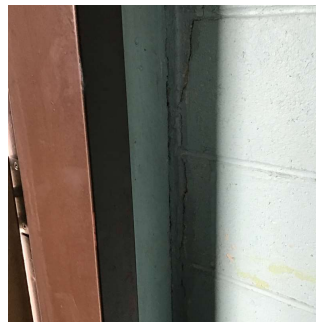
Bulkhead 3

**BULKHEAD/PENTHOUSE WALLS/INTERIOR: CMU
 CRACKS/SPALLING**

REPLACE

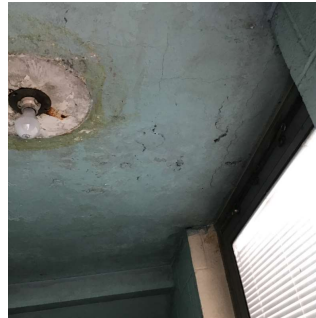
Bulkhead 3

**BULKHEAD/PENTHOUSE CEILING: PLASTER
 DAMAGED/DETERIORATED**

REPLACE

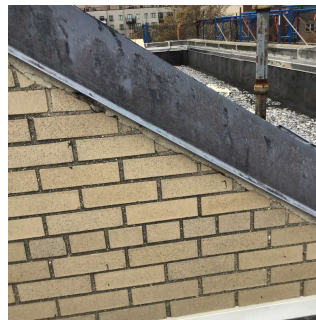
Bulkhead 3

**BULKHEAD/PENTHOUSE WALLS/EXTERIOR:
CRACKS/SPALLING - MAJOR**

REPLACE

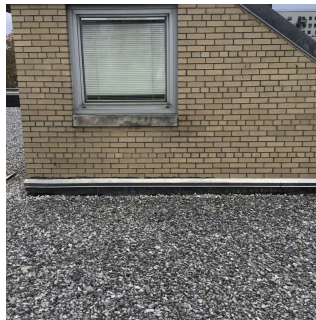
Bulkhead 3
No violations recorded.

**BULKHEAD/PENTHOUSE WALLS/EXTERIOR: DETERIORATED
JOINTS**

300
S.F.
REPOINT
PRIORITY 3
LEVEL 2

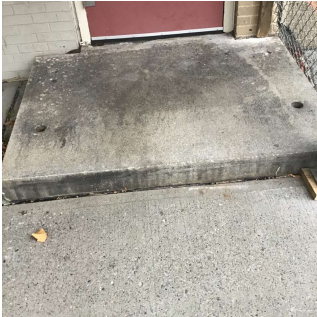
MISSING RAILING

Question	Response
EXTERIOR	
STAIRS/RAMPS: EXTERIOR	
RAILINGS	
Deficiency Quantity	10
Quantity Uom	L.F.
Potential Action	REPLACE
Urgency of Action	PRIORITY 5
Purpose of Action	LEVEL 6
Deficiency Photo1

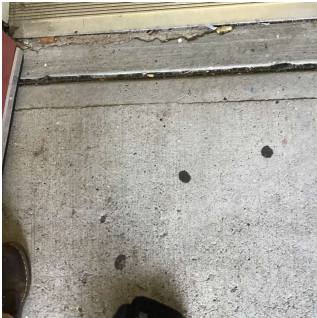
Exit 8
Violations	No violations recorded.
STAIRS/RAMPS	
Condition	Inspected
Deficiency	5 - Poor
Roof Plan reference	<p>CONCRETE: CRACKS/SPALLING - MAJOR</p>

<p>K297 Martin Luther King Jr Place Park Avenue</p>
Deficiency Quantity	30
Quantity Uom	S.F.
Potential Action	REPLACE
Urgency of Action	PRIORITY 4
Purpose of Action	LEVEL 2
Deficiency Photo1

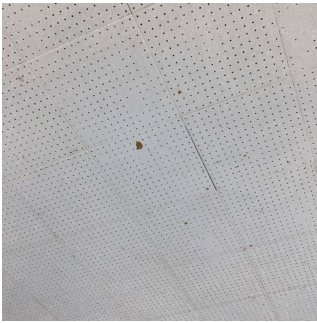
Question	Response
INTERIOR	
CAFETERIA	
Ceiling	
Deficiency Photo1

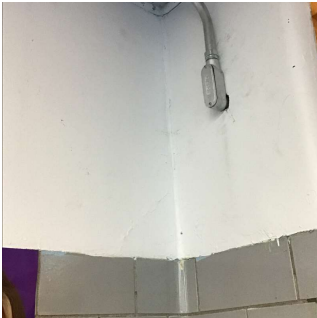
Question	Response
INTERIOR	
CAFETERIA	
Walls	
Deficiency Quantity	20
Quantity Uom	S.F.
Potential Action	REPLACE
Urgency of Action	PRIORITY 3
Purpose of Action	LEVEL 2
Deficiency Photo1

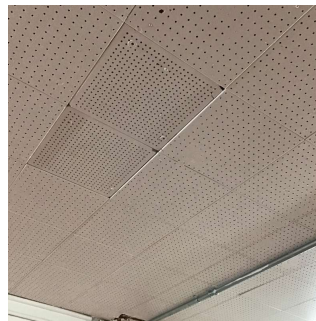
Corridor near Room 115

ACOUSTIC TILES ON PLASTER: DAMAGED/MISSING

REPLACE

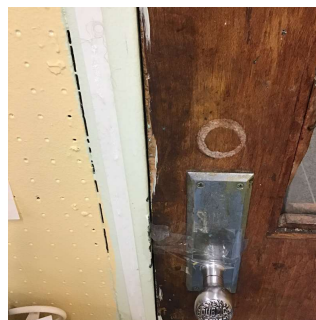
WOOD: DETERIORATED DOOR

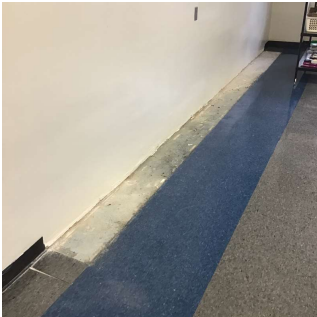
Exit 4 Vestibule
Violations	No violations recorded.
Deficiency	VINYL TILES: BROKEN/DETERIORATED/MISSING TILES
Deficiency Location/Instance	Rooms 204, 205, 304, 308, 314, and others
Deficiency Quantity	100
Quantity Uom	S.F.
Potential Action	REPLACE
Urgency of Action	PRIORITY 3
Purpose of Action	LEVEL 2
Deficiency Photo1

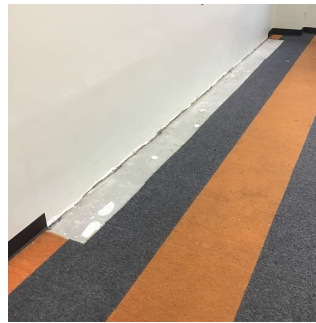
Room 303

Room 314
Violations	No violations recorded.
Deficiency	CARPET: WORN/DETERIORATED
Deficiency Location/Instance	Rooms 301, 303, 305
Deficiency Quantity	30
Quantity Uom	S.F.

Potential Action	REPLACE
Urgency of Action	PRIORITY 3
Purpose of Action	LEVEL 2

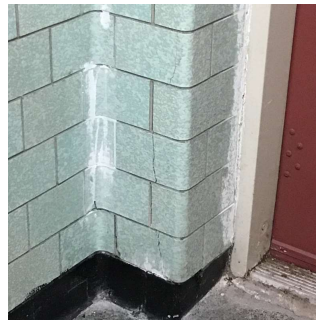
Exit 4 Vestibule

GLAZED BLOCK: CRACKS/SPALLING

REPLACE

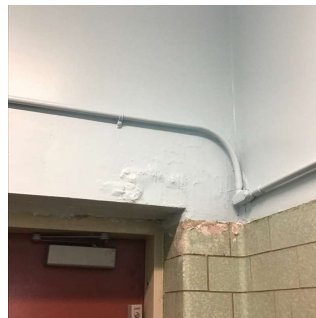
PLASTER: CRACKS/SPALLING

REPLACE

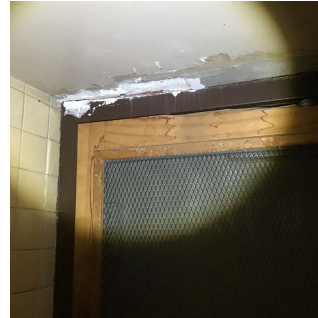
Near Storm Door

PLASTER: CRACKS/SPALLING

REPLACE

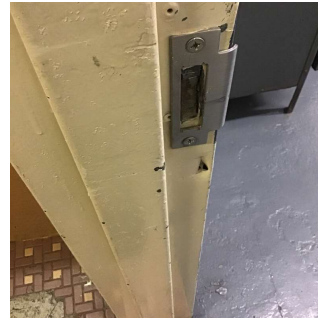
Store Room

METAL: DETERIORATED DOOR AND FRAME

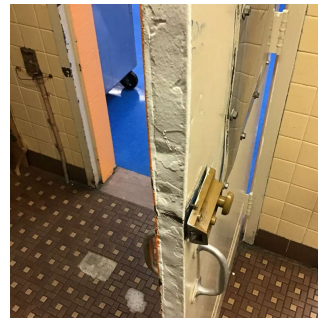
Entrance

METAL: DETERIORATED DOOR

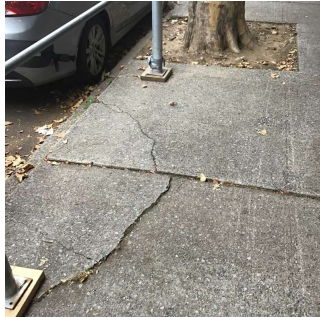
Park Avenue
Violations	No violations recorded.
Pavers	Does not Exist
DOT Sidewalk	Inspected
Asphalt	Does not Exist
Concrete	Inspected
Condition	4 - Between Fair and Poor
Deficiency	HEAVING
Deficiency Location/Instance	Park Avenue, Martin Luther King Jr. Place
Deficiency Quantity	225

Question	Response
SITE	
PAVING	
DOT Sidewalk	
Concrete	
Quantity Uom	S.F.
Potential Action	REPLACE
Urgency of Action	PRIORITY 3
Purpose of Action	LEVEL 2
Deficiency Photo1

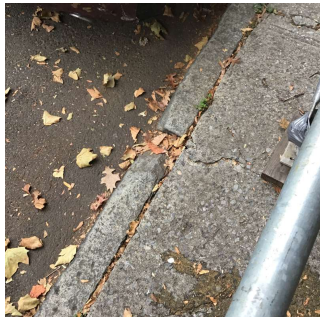
Park Avenue
Violations	No violations recorded.
Deficiency	DAMAGED CURBS
Deficiency Location/Instance	Park Avenue, Martin Luther King Jr. Place
Deficiency Quantity	95
Quantity Uom	L.F.
Potential Action	REPLACE
Urgency of Action	PRIORITY 3
Purpose of Action	LEVEL 2
Deficiency Photo1
