NYC Department of Education
Building Condition Assessment Survey 2023 - 2024

Architectural Inspection

Asset: P.S. 298 - BROOKLYN, 85 WATKINS STREET, New York, 11212

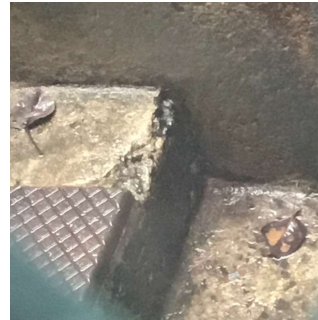
AW1

AREAWAY STAIRS: DETERIORATED MATERIAL SLIDE

REPLACE

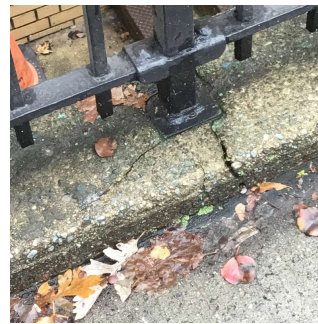
AW1
No violations recorded.

AREAWAY SLAB: CRACKS AND SPALLING

70
S.F.
REPAIR
PRIORITY 3
LEVEL 2

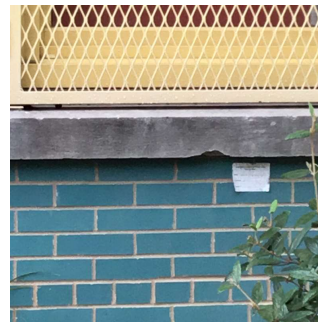
Facade D

BRICK: MASONRY SILLS - DETERIORATED JOINTS

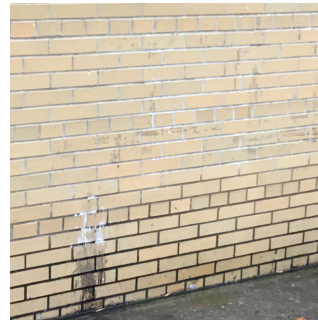
Facade B

BRICK: DETERIORATED JOINTS

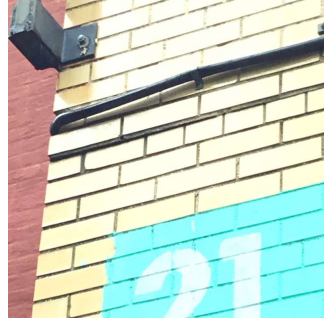
Deficiency	BRICK: DETERIORATED JOINTS
Roof Plan reference	K298

Deficiency Quantity	10
Quantity Uom	S.F.
Potential Action	REPOINT
Urgency of Action	PRIORITY 4
Purpose of Action	LEVEL 2

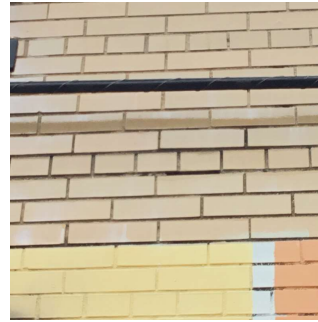
Facade E

BRICK: DETERIORATED JOINTS

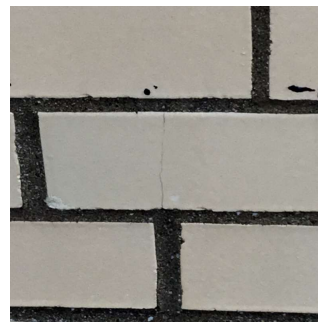
BH2
No violations recorded.

**BULKHEAD/PENTHOUSE WALLS/INTERIOR: CMU
CRACKS/SPALLING**

15
S.F.
REPLACE
PRIORITY 3
LEVEL 2

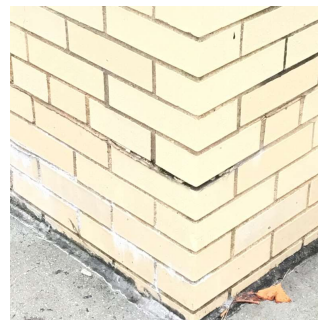
Facade B

BRICK: DETERIORATED COPING STONE

10
S.F.
REPLACE
PRIORITY 4
LEVEL 2

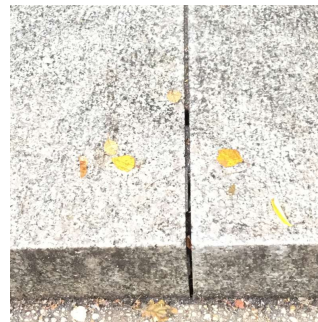
Facade D

STONE: DETERIORATED JOINTS

10
L.F.
REPOINT
PRIORITY 3
LEVEL 2

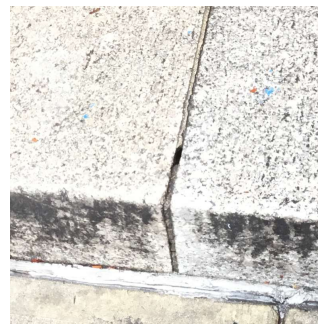
Facade A

CONCRETE: CRACKS/SPALLING - MAJOR

20
S.F.
REPLACE
PRIORITY 4
LEVEL 2

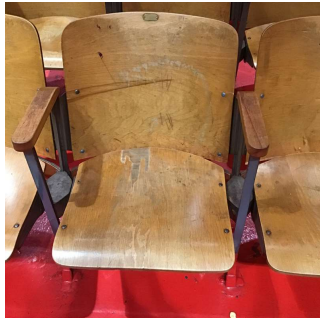
Violations	No violations recorded.
Deficiency	DAMAGED/BROKEN/INOPERABLE
Deficiency Location/Instance	Seats A/103, 107, 108, 109, 110, and others
Deficiency Quantity	35
Quantity Uom	EACH
Potential Action	REPLACE
Urgency of Action	PRIORITY 3
Purpose of Action	LEVEL 2
Deficiency Photo1

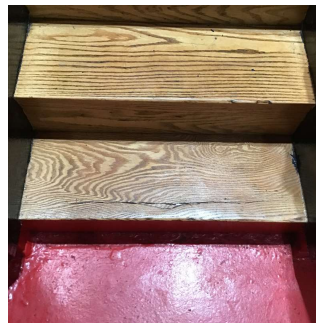
Right side

Deficiency	DAMAGED STEPS
Deficiency Location/Instance	Left and right sides
Deficiency Quantity	10
Quantity Uom	S.F.
Potential Action	REPLACE
Urgency of Action	PRIORITY 3
Purpose of Action	LEVEL 2
Deficiency Photo1

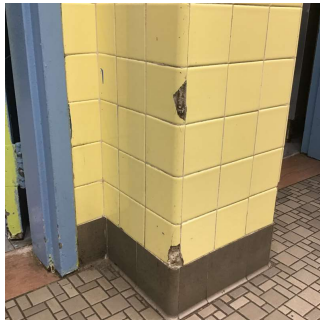
Violations	Office No violations recorded.
Deficiency	CERAMIC TILE: BROKEN/ MISSING
Deficiency Location/Instance	Entrance
Deficiency Quantity	10
Quantity Uom	S.F.
Potential Action	REPLACE
Urgency of Action	PRIORITY 3
Purpose of Action	LEVEL 2
Deficiency Photo1

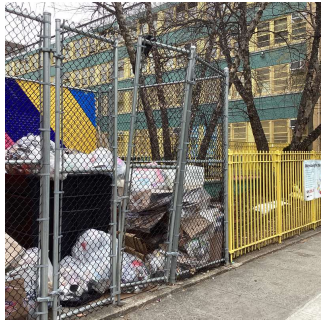
Violations	Near Schoolyard No violations recorded.
Deficiency	CHAIN LINK: RUST - MAJOR
Deficiency Location/Instance	Schoolyard
Deficiency Quantity	1,000
Quantity Uom	S.F.
Potential Action	REPLACE
Urgency of Action	PRIORITY 3
Purpose of Action	LEVEL 2
Deficiency Photo1	No photo recorded
Violations	No violations recorded.
Deficiency	WROUGHT IRON: DAMAGED/DETERIORATED
Deficiency Location/Instance	Along Watkins Street, Glenmore Avenue
Deficiency Quantity	160
Quantity Uom	S.F.

Potential Action	REPLACE
Urgency of Action	PRIORITY 3
Purpose of Action	LEVEL 2
Deficiency Photo1
