NYC Department of Education
Building Condition Assessment Survey 2023 - 2024

Architectural Inspection

Asset: P.S. 299 - BROOKLYN, 88 WOODBINE STREET, New York, 11221

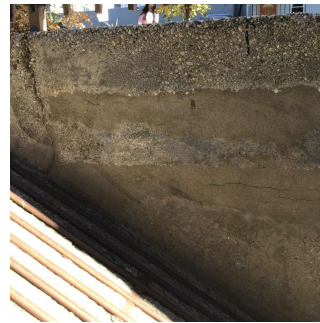
AW1
No violations recorded.

AREAWAY WALLS: CRACKS AND SPALLING

10
S.F.
REPAIR
PRIORITY 3
LEVEL 2

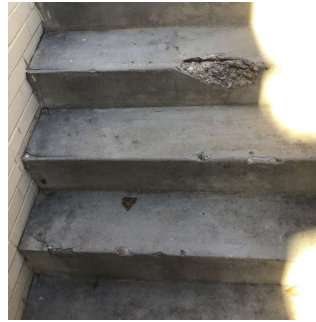
AW1

AREAWAY STAIRS: DETERIORATED TREADS/RISERS/NOSINGS

80
S.F.
REPLACE
PRIORITY 4
LEVEL 2

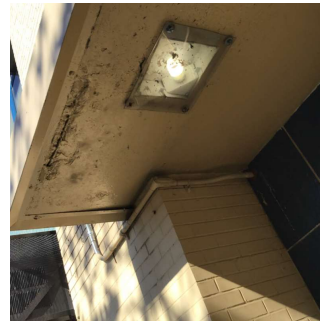
Facade C

CONCRETE: DETERIORATED

80
S.F.
REPLACE
PRIORITY 4
LEVEL 2

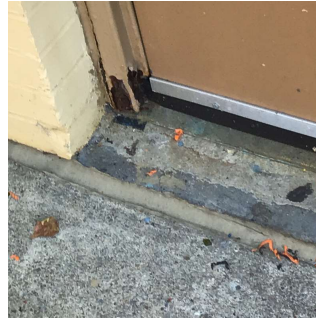
Facade A

METAL: DETERIORATED DOOR AND FRAME - MAJOR DETERIORATION

Deficiency Quantity	2
Quantity Uom	EACH
Potential Action	REPLACE
Urgency of Action	PRIORITY 4
Purpose of Action	LEVEL 2
Deficiency Photo1

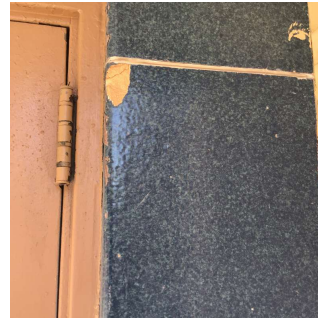
Exit 1

CERAMIC TILE: CHIPPED, SPALLED, BROKEN PIECES

PRIORITY 3
LEVEL 2

REPLACE

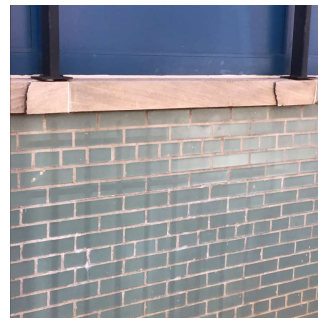
Facade A - West View

BRICK: DETERIORATED MASONRY SILLS - MAJOR

REMOVE AND REPLACE

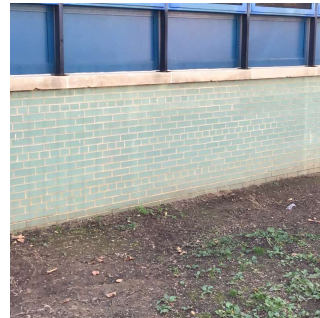
Facade A - West View

BRICK: DETERIORATED MASONRY SILLS - MINOR

REPAIR

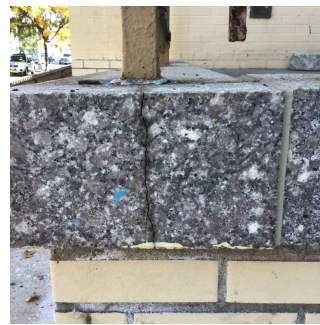
Facade A near Exit 2
No violations recorded.

Question	Response
EXTERIOR	
ROOF	
Specialties	Inspected
BULKHEAD/PENTHOUSE	Inspected
Condition	2 - Between Good and Fair
Deficiency	BULKHEAD/PENTHOUSE DOORS: AIR/WATER INFILTRATION WITH DAMAGED CAULKING
Roof Plan reference	
Deficiency Quantity	20
Quantity Uom	L.F.
Potential Action	MAINTENANCE
Urgency of Action	PRIORITY 3
Purpose of Action	LEVEL 2
Deficiency Photo1	
Violations	Bulk Head 2 No violations recorded.
CUPOLA/ SPIRES/ TOWERS	Does not Exist
DORMER	Does not Exist
DUNNAGE STEEL	Does not Exist
SKYLIGHT/ROOF VENT	Does not Exist
ROOF/GRAVITY TANK	Does not Exist
STAIRS/RAMPS: EXTERIOR	Inspected
BUILDING CHEEK/FLANK WALLS	Inspected
Condition	2 - Between Good and Fair
Deficiency	STONE: CRACKS/SPALLING - MINOR

10
S.F.
REPAIR
PRIORITY 3
LEVEL 2

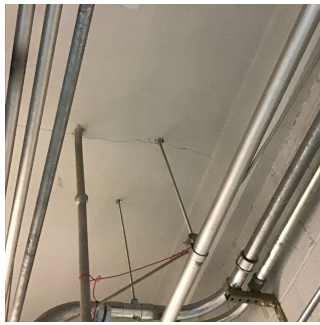
Violations	Exit 4 No violations recorded.
WINDOWS	Inspected
Replacement Quantity	9,000
Replacement Uom	S.F.
EXTERIOR GUARDS	Inspected
Condition	2 - Between Good and Fair
Deficiency	No deficiencies recorded
LINTELS	Inspected
Condition	2 - Between Good and Fair
Deficiency	No deficiencies recorded
WINDOWS	Inspected
Material Type(s)	Aluminum
Instance on Aluminum - Other: All Facades	Inspected
Instance Condition	3 - Fair
Instance Quantity	9,000
Instance Quantity Uom	S.F.
Are these windows insulated	Yes
Installation Year	2001
Source of Installation	Custodial Staff
Deficiency	No deficiencies recorded
INTERIOR	Inspected
POOLS	Does not Exist
STRUCTURAL	Inspected
COLUMNS/BEAMS/BEARING WALLS	Inspected
Condition	2 - Between Good and Fair
Deficiency	No deficiencies recorded
FLOOR STRUCTURE	Inspected
Condition	3 - Fair
Deficiency	CONCRETE: CRACKS/SPALLED/REINFORCEMENT EXPOSED

Deficiency Location/Instance	Electrical Room, Water, Gas, Sprinkler Room, Boiler Room, Oil Tank Room
Deficiency Quantity	500
Quantity Uom	S.F.
Potential Action	REPAIR
Urgency of Action	PRIORITY 3
Purpose of Action	LEVEL 5

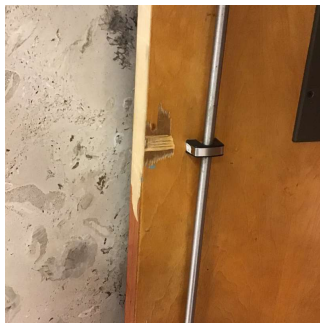
Condition	4 - Between Fair and Poor
Deficiency	WOOD: DETERIORATED DOOR
Deficiency Location/Instance	Entrance
Deficiency Quantity	2
Quantity Uom	EACH
Potential Action	MAINTENANCE
Urgency of Action	PRIORITY 3
Purpose of Action	LEVEL 2

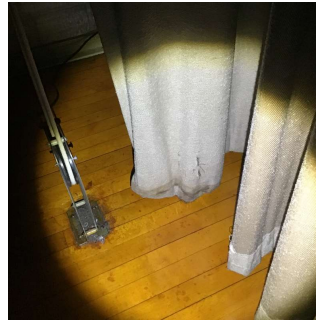
Right Side

Deficiency	WORN/DETERIORATED
Deficiency Location/Instance	Right Side, Left Side
Deficiency Quantity	200
Quantity Uom	S.F.
Potential Action	REPLACE
Urgency of Action	PRIORITY 3
Purpose of Action	LEVEL 2
Deficiency Photo1

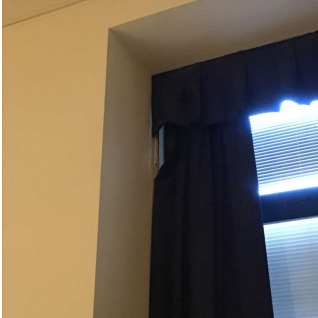
Question	Response
INTERIOR	
AUDITORIUM	
Window Curtains/Shades/Blinds	
Instance on 1st Floor (442 Seats)	Inspected
Condition	3 - Fair
Deficiency	WORN/DAMAGED CURTAINS
Deficiency Location/Instance	Left Side
Deficiency Quantity	100
Quantity Uom	S.F.
Potential Action	MAINTENANCE
Urgency of Action	PRIORITY 3
Purpose of Action	LEVEL 2
Deficiency Photo1

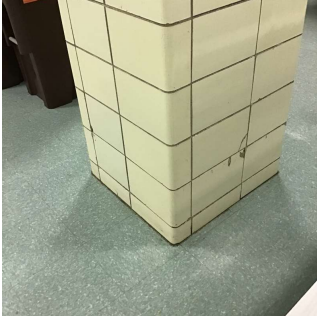
Walls	
Instance on 1st Floor	Inspected
Condition	2 - Between Good and Fair
Deficiency	GLAZED BLOCK: CRACKS/SPALLING
Deficiency Location/Instance	Columns at Center
Deficiency Quantity	10
Quantity Uom	S.F.

Question	Response
INTERIOR	
CAFETERIA	
Walls	
Potential Action	REPLACE
Urgency of Action	PRIORITY 3
Purpose of Action	LEVEL 2
Deficiency Photo1

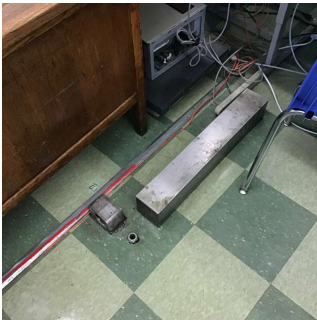
Corridor near Room 431
Violations	No violations recorded.
Deficiency	VINYL TILES: TRIPPING HAZARD - ELECTRICAL OUTLET
Deficiency Location/Instance	Room 425
Deficiency Quantity	10
Quantity Uom	S.F.
Potential Action	REMOVE
Urgency of Action	PRIORITY 5
Purpose of Action	LEVEL 6
Deficiency Photo1

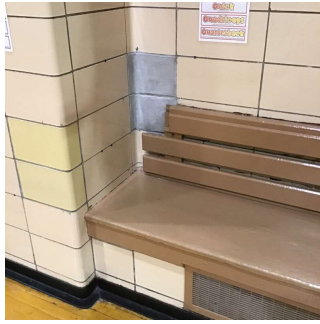
Violations	Left Side No violations recorded.
Seating	
Instance on 1st Floor	Inspected
Condition	4 - Between Fair and Poor
Deficiency	DAMAGED FIXED SEATING
Deficiency Location/Instance	Left Side
Deficiency Quantity	2
Quantity Uom	EACH
Potential Action	REPLACE
Urgency of Action	PRIORITY 3
Purpose of Action	LEVEL 2
Deficiency Photo1

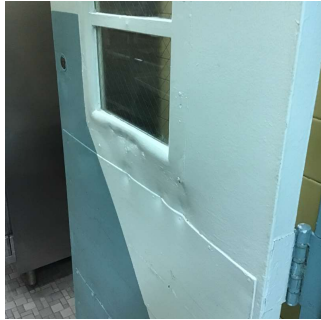
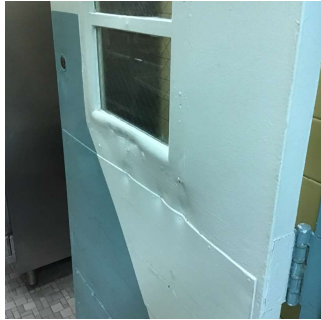
Instance on 1st Floor	Inspected
Condition	3 - Fair
Deficiency	METAL: DETERIORATED DOOR
Deficiency Location/Instance	Entrance from Cafeteria
Deficiency Quantity	1
Quantity Uom	EACH
Potential Action	MAINTENANCE
Urgency of Action	PRIORITY 3
Purpose of Action	LEVEL 2
Deficiency Photo1

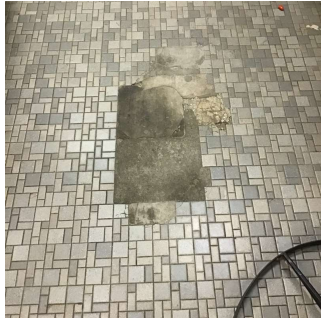
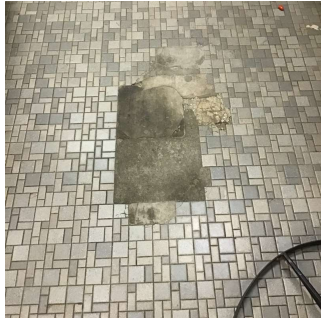
Instance on 1st Floor	Inspected
Condition	2 - Between Good and Fair
Deficiency	CERAMIC TILE: DETERIORATED SUBSTRATE
Deficiency Location/Instance	Center, Near Entrance from Cafeteria
Deficiency Quantity	20
Quantity Uom	S.F.
Potential Action	REPLACE
Urgency of Action	PRIORITY 3
Purpose of Action	LEVEL 2
Deficiency Photo1

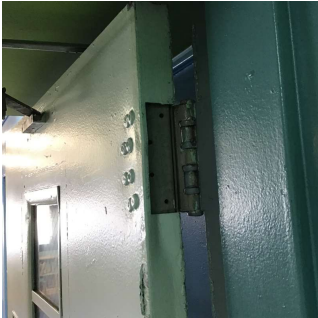
Violations	Left Side No violations recorded.
Door(s)	
Instance on Room 226	Inspected
Condition	3 - Fair
Deficiency	METAL: DETERIORATED DOOR
Deficiency Location/Instance	Entrance
Deficiency Quantity	1
Quantity Uom	EACH
Potential Action	MAINTENANCE
Urgency of Action	PRIORITY 3
Purpose of Action	LEVEL 2
Deficiency Photo1

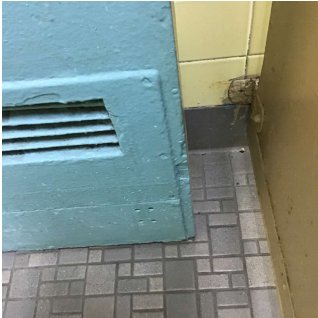
Violations	Room 402 No violations recorded.
Door(s)	Inspected
Condition	5 - Poor
Deficiency	WOOD: DETERIORATED DOOR
Deficiency Location/Instance	Rooms 113, 236, 302, 336, 436, and others
Deficiency Quantity	8
Quantity Uom	EACH
Potential Action	MAINTENANCE
Urgency of Action	PRIORITY 3
Purpose of Action	LEVEL 2
Deficiency Photo1

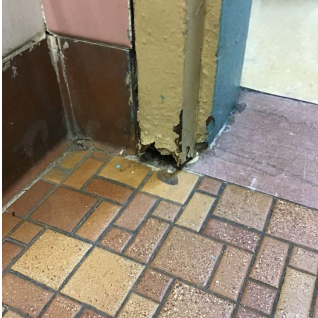
Violations	Room 113 No violations recorded.
Deficiency	METAL: DETERIORATED DOOR AND FRAME
Deficiency Location/Instance	Room 109
Deficiency Quantity	1

Question	Response
INTERIOR	
TOILET ROOMS - STUDENTS	Inspected
Door(s)	
Quantity Uom	EACH
Potential Action	MAINTENANCE
Urgency of Action	PRIORITY 3
Purpose of Action	LEVEL 2
Deficiency Photo1

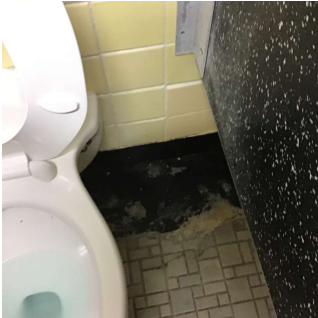
Room 109
Violations	No violations recorded.
Floor Finish	Inspected
Condition	2 - Between Good and Fair
Deficiency	CERAMIC TILE: BROKEN/MISSING TILES
Deficiency Location/Instance	Rooms 113, 336
Deficiency Quantity	20
Quantity Uom	S.F.
Potential Action	REPLACE
Urgency of Action	PRIORITY 3
Purpose of Action	LEVEL 2
Deficiency Photo1

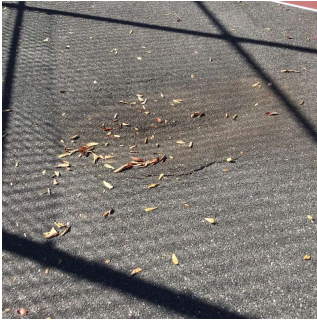
Courtyard
Violations	No violations recorded.
Pavers	Does not Exist
Student Use	Inspected
Gravel Exists?	No
Asphalt	Inspected
Condition	4 - Between Fair and Poor

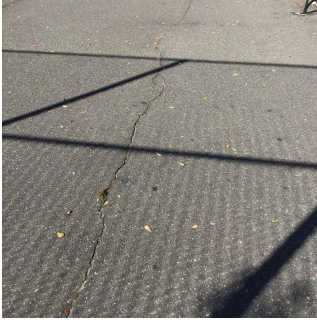
Schoolyard
Violations	No violations recorded.
Deficiency	CRACKS - MAJOR
Deficiency Location/Instance	Schoolyard
Deficiency Quantity	2,400
Quantity Uom	S.F.
Potential Action	REPLACE
Urgency of Action	PRIORITY 3
Purpose of Action	LEVEL 2
Deficiency Photo1

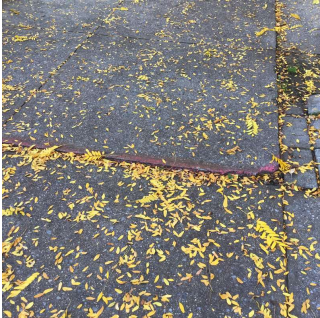
Woodbine Street
Violations	51516
Deficiency	DAMAGED CURBS
Deficiency Location/Instance	Woodbine Street, Evergreen Avenue, Madison Street
Deficiency Quantity	255
Quantity Uom	L.F.
Potential Action	REPLACE
Urgency of Action	PRIORITY 4
