**NYC Department of Education**  
**Building Condition Assessment Survey 2023 - 2024**

Architectural Inspection

**Asset:** P.S. 305 - BROOKLYN, 344 MONROE STREET, New York, 11216

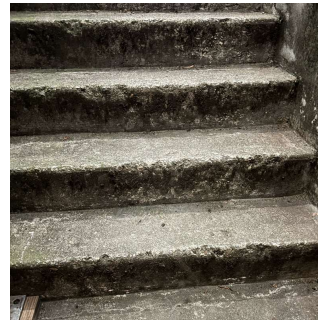
AW2

Question	Response
<b>Architectural</b>	
<b>EXTERIOR</b>	Inspected
<b>AREAWAY</b>	Inspected
Instance on AW1 - AW3	Inspected
Instance Condition	3 - Fair
Instance Quantity	3
Instance Quantity Uom	EACH
Deficiency	AREAWAY STAIRS: DETERIORATED TREADS/RISERS/NOSINGS

REPAIR

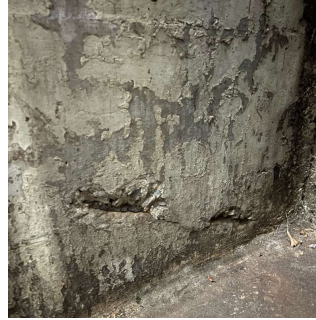
AW2  
No violations recorded.

AREAWAY WALLS: CRACKS AND SPALLING

REPLACE

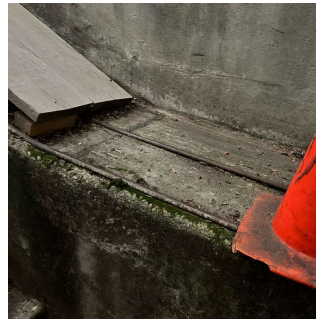
AW2  
No violations recorded.

AREAWAY STAIRS: DETERIORATED MATERIAL SLIDE  
K305

25  
S.F.  
REPAIR  
PRIORITY 3  
LEVEL 2

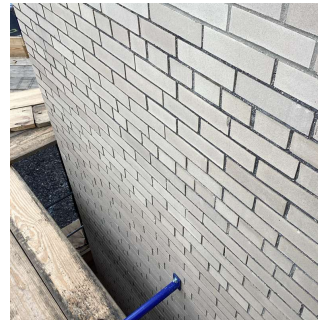
CH  
No violations recorded.

BRICK: DETERIORATED JOINTS

80  
S.F.  
REPOINT  
PRIORITY 3  
LEVEL 2

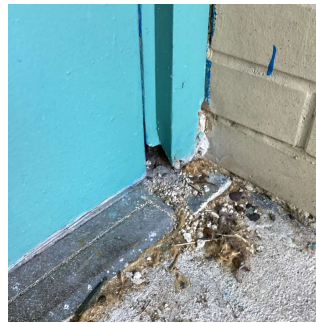
Facade C

METAL: DETERIORATED DOOR AND FRAME - MAJOR DETERIORATION

8  
EACH  
REPLACE  
PRIORITY 4  
LEVEL 2

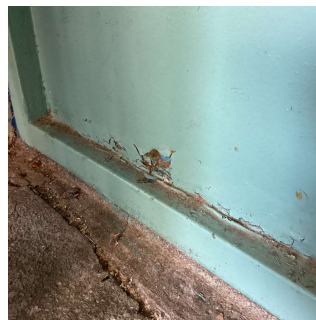
Facade A

METAL: DENTED, MAJOR RUSTING

REPLACE

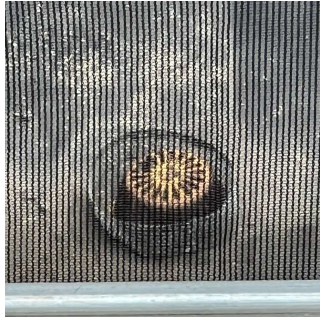
Condition	3 - Fair
Deficiency	DETERIORATED
Roof Plan reference	K305

Deficiency Quantity	1
Quantity Uom	EACH
Potential Action	REPLACE
Urgency of Action	PRIORITY 4
Purpose of Action	LEVEL 2

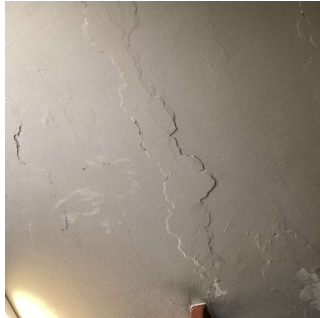
Violations	Roof 3 No violations recorded.
<b>Specialties</b>	Inspected
<b>BULKHEAD/PENTHOUSE</b>	Inspected
Condition	3 - Fair
Deficiency	BULKHEAD/PENTHOUSE CEILING: PLASTER DAMAGED/DETERIORATED
Roof Plan reference	K305

Deficiency Quantity	40
Quantity Uom	S.F.
Potential Action	REPLACE
Urgency of Action	PRIORITY 4
Purpose of Action	LEVEL 2
Deficiency Photo1

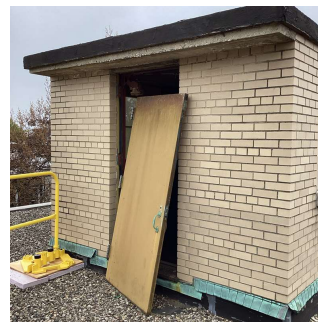
BH2  
 No violations recorded.

Violations	BH1 No violations recorded.
Deficiency	BULKHEAD/PENTHOUSE DOORS: DETERIORATED DOOR AND FRAME

1  
 EACH  
 REPLACE DOOR AND FRAME  
 PRIORITY 4  
 LEVEL 2

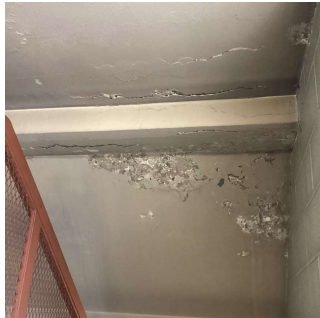
BULKHEAD/PENTHOUSE ROOF: MINOR LEAKAGE  
 K305

100  
 S.F.  
 MAINTENANCE  
 PRIORITY 3  
 LEVEL 2

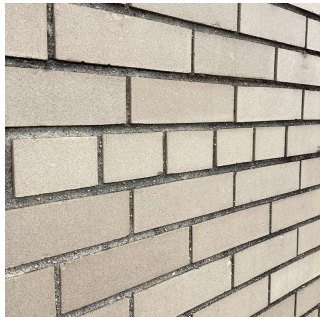
Violations	BH1 No violations recorded.
Deficiency	BULKHEAD/PENTHOUSE WALLS/EXTERIOR: DETERIORATED JOINTS
Roof Plan reference	K305

Deficiency Quantity	100
Quantity Uom	S.F.
Potential Action	REPOINT
Urgency of Action	PRIORITY 3
Purpose of Action	LEVEL 2
Deficiency Photo1

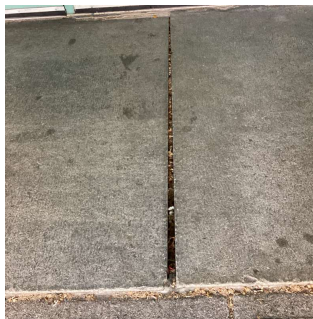
Facade A

Question	Response
<b>EXTERIOR</b>	
<b>ROOF</b>	Inspected
<b>Specialties</b>	Inspected
<b>ROOF/GRAVITY TANK</b>	Does not Exist
<b>STAIRS/RAMPS: EXTERIOR</b>	Inspected
<b>BUILDING CHEEK/FLANK WALLS</b>	Inspected
Condition	2 - Between Good and Fair
Deficiency	No deficiencies recorded
<b>RAILINGS</b>	Inspected
Condition	2 - Between Good and Fair
Deficiency	No deficiencies recorded
<b>STAIRS/RAMPS</b>	Inspected
Condition	5 - Poor
Deficiency	STONE: DETERIORATED JOINTS
Roof Plan reference	K305

10  
L.F.  
REPOINT  
PRIORITY 4  
LEVEL 2

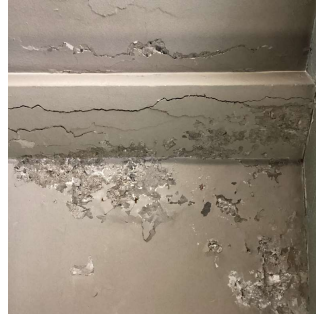
Yes	Potential Falling Debris	Deteriorated concrete fireproofing at ceiling beam is a potential falling debris hazard.	INTERIOR   STRUCTURAL   ROOF STRUCTURE	Stair D Bulkhead	Anahi Lopez	Fireman

STEEL COLUMNS/BEAMS: DETERIORATED CONCRETE FIREPROOFING

REPLACE

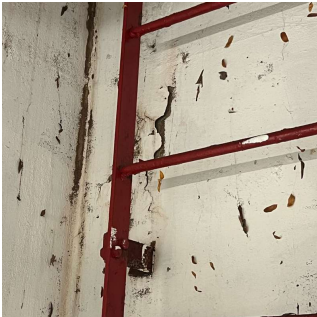
CRACKS, SPALLING

REPAIR

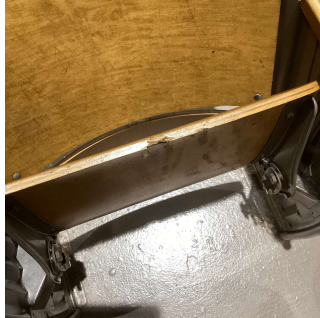
Question	Response
<b>INTERIOR</b>	
<b>STRUCTURAL</b>	
<b>VAULTS-BUNKERS</b>	
<b>Vault/Ash Hoist Doors and Framing</b>	
Deficiency Photo1	 
	Ash Hoist Vault
Violations	No violations recorded.
<b>AUDITORIUM</b>	
	Inspected
Instance on 1st Floor (400Seats)	Inspected
<b>Ceiling</b>	
Instance on 1st Floor (400Seats)	Inspected
Condition	2 - Between Good and Fair
Deficiency	No deficiencies recorded
<b>Door(s)</b>	
Instance on 1st Floor (400Seats)	Inspected
Condition	3 - Fair
Deficiency	METAL: DETERIORATED DOOR
Deficiency Location/Instance	Left side exit
Deficiency Quantity	1
Quantity Uom	EACH
Potential Action	MAINTENANCE
Urgency of Action	PRIORITY 3
Purpose of Action	LEVEL 2
Deficiency Photo1	 
	Left side
Violations	No violations recorded.
<b>Fixed H/C Lift</b>	
Instance on 1st Floor (400Seats)	Does not Exist
<b>Fixed Seating</b>	
Instance on 1st Floor (400Seats)	Inspected
Condition	3 - Fair
Deficiency	DAMAGED/BROKEN/INOPERABLE

Deficiency Location/Instance	Seats B/3, 101, J/12, I/102, M /102 and others
Deficiency Quantity	14

Question	Response
<b>INTERIOR</b>	
<b>AUDITORIUM</b>	
<b>Fixed Seating</b>	
Quantity Uom	EACH
Potential Action	REPLACE
Urgency of Action	PRIORITY 3
Purpose of Action	LEVEL 2
Deficiency Photo1

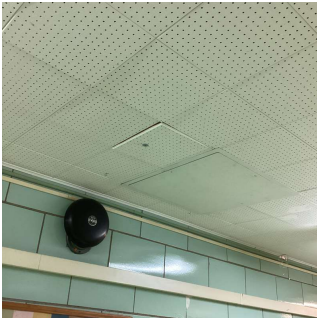
<b>Ceiling</b>	
	Inspected
Condition	2 - Between Good and Fair
Deficiency	ACOUSTIC TILES ON PLASTER: DAMAGED/MISSING
Deficiency Location/Instance	Corridor near Room 143, 330, Corridor near Gymnasium,

Question	Response
<b>INTERIOR</b>	
<b>CLASSROOMS/CORRIDORS/ADMIN SPACES</b>	
<b>Ceiling</b>	
Deficiency Quantity	25
Quantity Uom	S.F.
Potential Action	REPLACE
Urgency of Action	PRIORITY 3
Purpose of Action	LEVEL 2
Deficiency Photo1

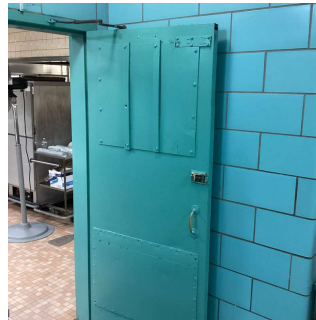
Question	Response
<b>INTERIOR</b>	
<b>GYMNASIUM</b>	
<b>Walls</b>	
Deficiency Photo1	 
Violations	Left side No violations recorded.
<b>Window Curtains/Shades/Blinds</b>	
Instance on 2nd Floor	Does not Exist
<b>INTERIOR DOOR HARDWARE</b>	
Condition	Inspected 3 - Fair
Deficiency	No deficiencies recorded
<b>INTERIOR GUARDS</b>	
Condition	Inspected 2 - Between Good and Fair
Deficiency	No deficiencies recorded
<b>KITCHEN</b>	
Instance on 1st Floor	Inspected
<b>Ceiling</b>	
Instance on 1st Floor	Inspected
Condition	2 - Between Good and Fair
Deficiency	METAL PAN: DAMAGED/MISSING
Deficiency Location/Instance	Near , near Entrance
Deficiency Quantity	25
Quantity Uom	S.F.
Potential Action	REPLACE
Urgency of Action	PRIORITY 3
Purpose of Action	LEVEL 2
Deficiency Photo1	 
Violations	Near refrigerator No violations recorded.
<b>Door(s)</b>	
Instance on 1st Floor	Inspected
Condition	4 - Between Fair and Poor
Deficiency	METAL: DETERIORATED DOOR

Deficiency Location/Instance	Entrance

Deficiency Quantity	2
Quantity Uom	EACH
Potential Action	MAINTENANCE
Urgency of Action	PRIORITY 3
Purpose of Action	LEVEL 2
Deficiency Photo1

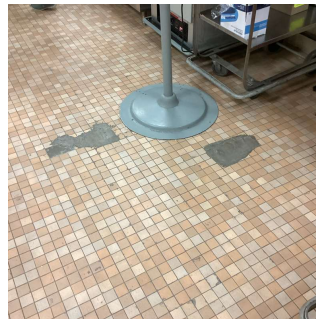
Near Entrance

Instance on 1st Floor	Inspected
Condition	3 - Fair
Deficiency	CERAMIC TILE: BROKEN/MISSING TILES
Deficiency Location/Instance	Near Entrance, near sink
Deficiency Quantity	50
Quantity Uom	S.F.
Potential Action	REPLACE
Urgency of Action	PRIORITY 3
Purpose of Action	LEVEL 2
Deficiency Photo1

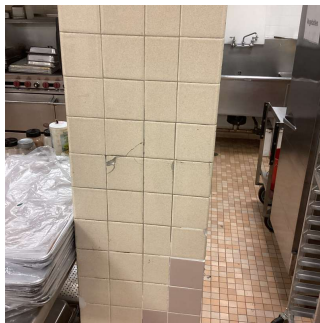
Instance on 1st Floor	Inspected
Condition	2 - Between Good and Fair
Deficiency	CERAMIC TILE: BROKEN/ MISSING
Deficiency Location/Instance	Near Refrigerator
Deficiency Quantity	15
Quantity Uom	S.F.
Potential Action	REPLACE
Urgency of Action	PRIORITY 3
Purpose of Action	LEVEL 2

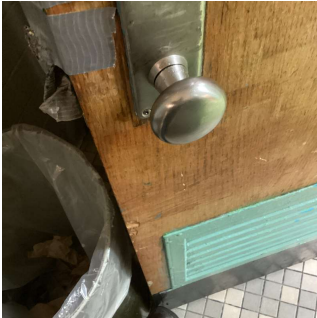
Question	Response
<b>INTERIOR</b>	
<b>TOILET ROOMS - STAFF</b>	
<b>Door(s)</b>	
Deficiency	WOOD: DETERIORATED DOOR
Deficiency Location/Instance	Room 143
Deficiency Quantity	1
Quantity Uom	EACH
Potential Action	MAINTENANCE
Urgency of Action	PRIORITY 3
Purpose of Action	LEVEL 2
Deficiency Photo1

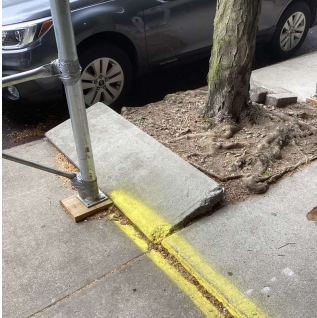
Madison Street
Violations	No violations recorded.
Deficiency	HEAVING
Deficiency Location/Instance	Monroe Street

Question	Response
<b>SITE</b>	
<b>PAVING</b>	
<b>DOT Sidewalk</b>	
<b>Concrete</b>	
Deficiency Quantity	100
Quantity Uom	S.F.
Potential Action	REPLACE
Urgency of Action	PRIORITY 5
Purpose of Action	LEVEL 6
Deficiency Photo1
