NYC Department of Education
Building Condition Assessment Survey 2023 - 2024

Architectural Inspection

Asset: P.S. 309 - BROOKLYN, 794 MONROE STREET, New York, 11221

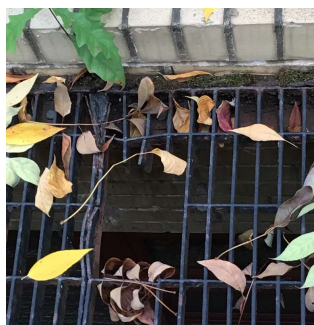
AW1
 No violations recorded.

AREAWAY GRATINGS: MAJOR RUSTING / OR BROKEN

30
 S.F.
 REPLACE
 PRIORITY 4
 LEVEL 2

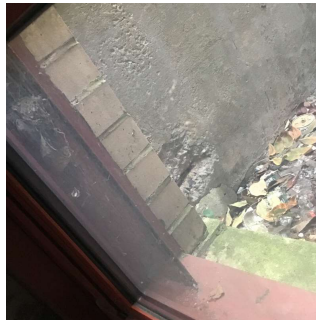
AW1
No violations recorded.

AREAWAY WALLS: CRACKS AND SPALLING

10
S.F.
REPAIR
PRIORITY 3
LEVEL 2

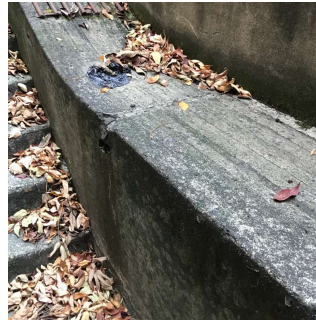
AW

AREAWAY STAIRS: DETERIORATED MATERIAL SLIDE

10
S.F.
REPLACE
PRIORITY 3
LEVEL 2

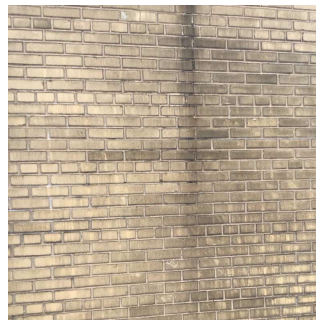
Chimney

BRICK: DETERIORATED JOINTS

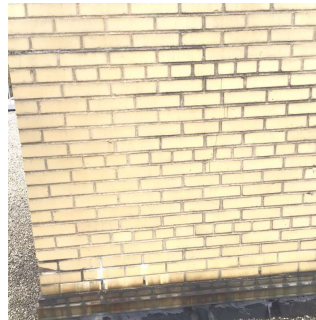
Chimney
 No violations recorded.

BRICK: MINOR CRACKS AND SPALLING

50
 S.F.
 RESTITCH
 PRIORITY 3
 LEVEL 2

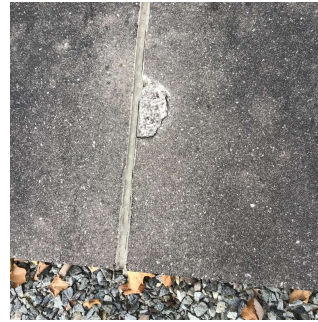
Facade F

CAST STONE: CRACKED/BROKEN PIECES

10
 L.F.
 REPLACE-IN-KIND
 PRIORITY 4
 LEVEL 2

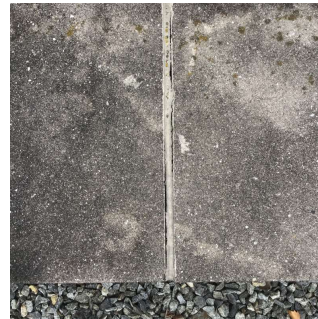
Facade E

CAST STONE: DETERIORATED TRANSVERSE JOINTS

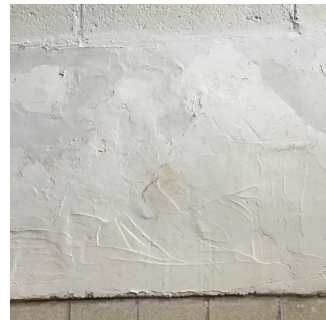
Facade H - Stair G/3

BRICK: WATER INFILTRATION IN INSTRUCTIONAL SPACE

REPAIR

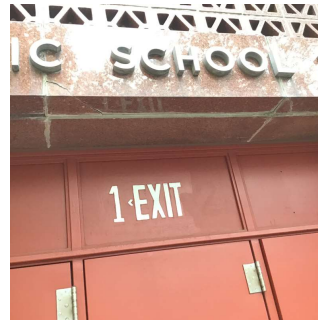
Facade A - Main Entry
35671665J

STONE: CHIPPED/SPALLED/BROKEN PIECES - MAJOR

REPLACE

PRIORITY 5
LEVEL 6

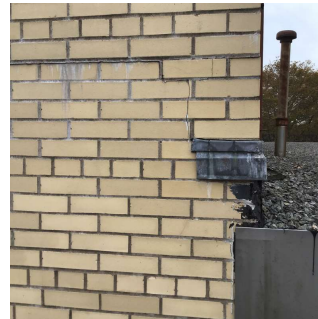
Roof 5 - East View

BRICK: CRACKS/DISPLACED/SPALLED BRICK AT BUILDING CORNERS

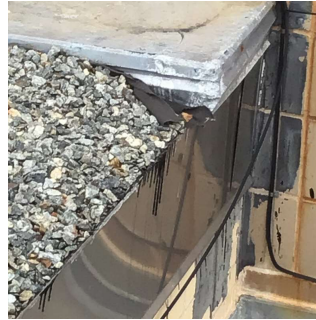
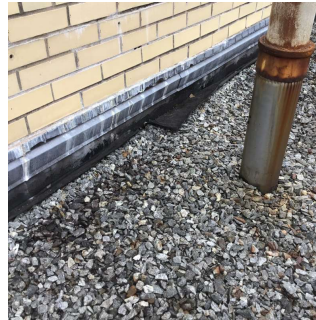
Roof 3

Source of Installation	Custodial Staff
Deficiency	IRMA: FLASHING: BASE FLASHING DETERIORATED
Roof Plan reference	K309

REPAIR
PRIORITY 3
LEVEL 2

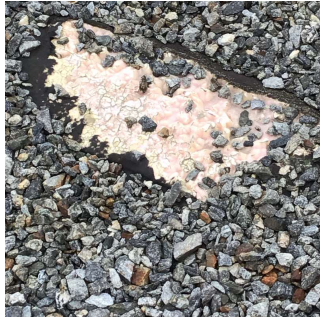
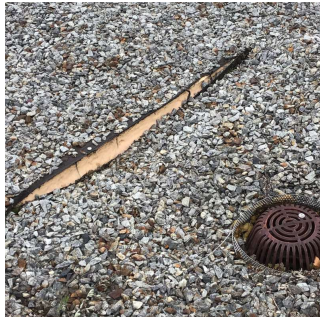
IRMA: ROOFING: DAMAGED INSULATION

<p>Roof 3 - Near Ladder</p>

REPLACE

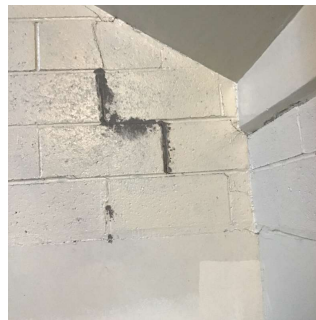
Bulk Head 2

**BULKHEAD/PENTHOUSE WALLS/INTERIOR: CMU
CRACKS/SPALLING**

REPLACE

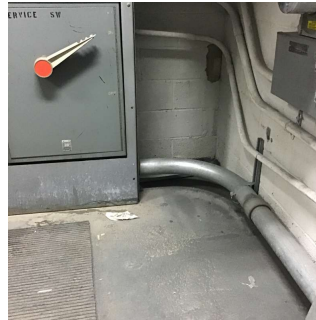
Electrical Panel Room

CONCRETE: WATER INFILTRATION IN ELECTRICAL PANEL ROOM

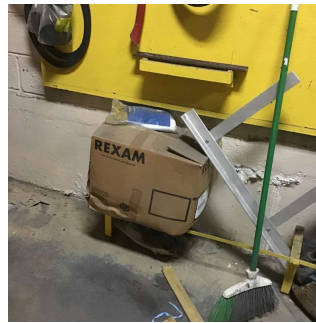
Boiler Room

CONCRETE: WATER INFILTRATION IN NON- INSTRUCTIONAL SPACE
