NYC Department of Education
Building Condition Assessment Survey 2023 - 2024

Architectural Inspection

K310

Asset: PS 310 THE SCHOOL FOR FUTURE LEADERS - BROOKLYN, 942 62 STREET, New York, 11219

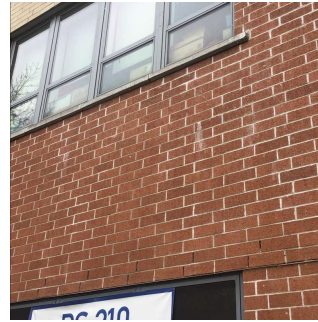
Facade B

BRICK: EFFLORESCENCE

Deficiency Quantity

100

Potential Action

MAINTENANCE

Urgency of Action

PRIORITY 1

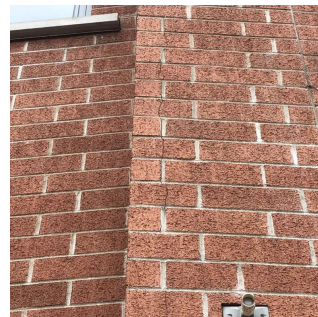
Facade A

BRICK: MINOR CRACKS AND SPALLING

Deficiency Quantity

40

Potential Action

RESTITCH

Urgency of Action

PRIORITY 3

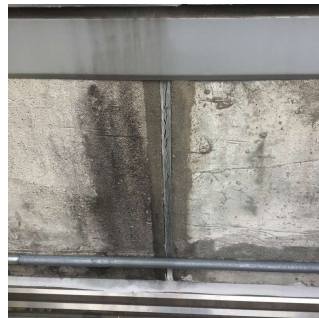
Question	Response
EXTERIOR	
EXTERIOR SOFFITS	Inspected
Condition	2 - Between Good and Fair
Deficiency	No deficiencies recorded
LOADING DOCK	Does not Exist
LOUVER	Inspected
Condition	2 - Between Good and Fair
Deficiency	No deficiencies recorded
PARAPETS	Inspected
Material Type(s)	Concrete, Masonry
Replacement Quantity	6,000
Replacement Uom	C.F.
Instance on All Roofs	Inspected
Instance Condition	2 - Between Good and Fair
Instance Quantity	6,000
Instance Quantity Uom	C.F.
Deficiency	CONCRETE: DETERIORATED CONTROL/EXPANSION JOINT
Roof Plan reference

Deficiency Quantity	20
Quantity Uom	L.F.
Potential Action	MAINTENANCE
Urgency of Action	PRIORITY 3
Purpose of Action	LEVEL 2
Deficiency Photo1

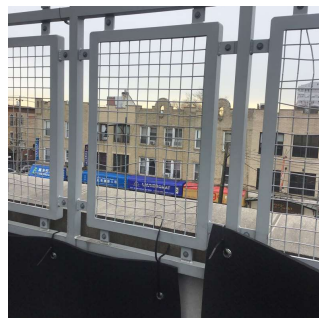
Question	Response
EXTERIOR	
PARAPETS	
Roof Plan reference	
Deficiency Quantity	40
Quantity Uom	S.F.
Potential Action	REPAIR
Urgency of Action	PRIORITY 3
Purpose of Action	LEVEL 2
Deficiency Photo1	
Violations	Roof 3 - Facade C No violations recorded.
PLAZA DECK	Inspected
Instance on Pavers: Roof 3	Inspected
Instance Condition	2 - Between Good and Fair
Instance Quantity	5,000
Instance Quantity Uom	S.F.
Installation Year	2012
Source of Installation	Custodial Staff
Deficiency	No deficiencies recorded
ROOF	Inspected
Roofing	Inspected
Replacement Quantity	14,000
Replacement Uom	S.F.
ROOF HATCH/SMOKE HATCH	Inspected
Condition	2 - Between Good and Fair
Deficiency	No deficiencies recorded
LEADERS, GUTTERS, DOWNSPOUTS, SCUPPERS	Inspected
Condition	2 - Between Good and Fair
Deficiency	No deficiencies recorded
ROOF BARRIER/FENCE	Inspected
Condition	3 - Fair
Deficiency	RAILINGS/PANELS: DETERIORATED, MAJOR RUSTING

Deficiency Quantity	80
Quantity Uom	S.F.
Potential Action	REPLACE
Urgency of Action	PRIORITY 4
Purpose of Action	LEVEL 2
Deficiency Photo1

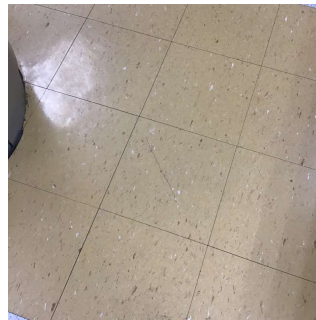
Instance on Basement	Inspected
Condition	2 - Between Good and Fair
Deficiency	VINYL TILES: BROKEN/DETERIORATED/MISSING TILES
Deficiency Location/Instance	Near Main Entrance
Deficiency Quantity	10
Quantity Uom	S.F.
Potential Action	REPLACE
Urgency of Action	PRIORITY 3
Purpose of Action	LEVEL 2
Deficiency Photo1

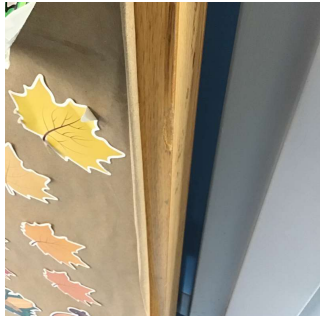
Question	Response
INTERIOR	
CAFETERIA	
Stage	
Instance on Basement	Does not Exist
Walls	
Instance on Basement	Inspected
Condition	2 - Between Good and Fair
Deficiency	No deficiencies recorded
Window Curtains/Shades/Blinds	
Instance on Basement	Does not Exist
CLASSROOMS/CORRIDORS/ADMIN SPACES	
Ceiling	Inspected
Condition	2 - Between Good and Fair
Deficiency	ACOUSTIC TILES: DAMAGED/MISSING
Deficiency Location/Instance	Room 505, Main Entrance Lobby, Corridor near Rooms 111,507,509 and others
Deficiency Quantity	100
Quantity Uom	S.F.
Potential Action	REPLACE
Urgency of Action	PRIORITY 3
Purpose of Action	LEVEL 2
Deficiency Photo1	 
	Corridor near Room 111
Violations	No violations recorded.
Door(s)	Inspected
Condition	3 - Fair
Deficiency	WOOD: DETERIORATED DOOR
Deficiency Location/Instance	Room 502
Deficiency Quantity	1
Quantity Uom	EACH
Potential Action	MAINTENANCE
Urgency of Action	PRIORITY 3
Purpose of Action	LEVEL 2
Deficiency Photo1

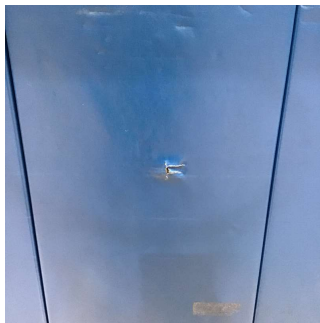
Stage Curtains	
Instance on 1st Floor	Inspected
Condition	2 - Between Good and Fair
Deficiency	No deficiencies recorded
Walls	
Instance on 1st Floor	Inspected
Condition	2 - Between Good and Fair
Deficiency	WALL PADDING: DETERIORATED
Deficiency Location/Instance	Rear Wal
Deficiency Quantity	20
Quantity Uom	S.F.
Potential Action	REPLACE
Urgency of Action	PRIORITY 3
Purpose of Action	LEVEL 2

Rear Wall
Violations	No violations recorded.
Window Curtains/Shades/Blinds	
Instance on 1st Floor	Does not Exist
INTERIOR DOOR HARDWARE	
Condition	2 - Between Good and Fair
Deficiency	No deficiencies recorded
INTERIOR GUARDS	
Condition	2 - Between Good and Fair
Deficiency	No deficiencies recorded
KITCHEN	
Instance on Basement	Inspected
Ceiling	
Instance on Basement	Inspected
Condition	2 - Between Good and Fair
Deficiency	No deficiencies recorded
Door(s)	
Instance on Basement	Inspected
Condition	2 - Between Good and Fair
Deficiency	No deficiencies recorded
Floor Finish	
Instance on Basement	Inspected
Condition	2 - Between Good and Fair
Deficiency	No deficiencies recorded
Walls	
Instance on Basement	Inspected
Condition	2 - Between Good and Fair
Deficiency	No deficiencies recorded
LIBRARY	
Instance on Room 401	Inspected
Built-in Furnishing	
Instance on Room 401	Does not Exist

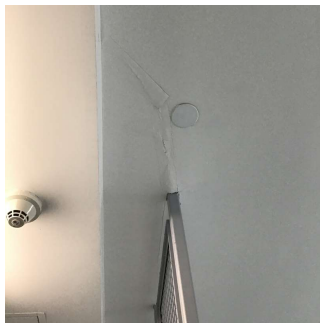
Inspected
Condition	2 - Between Good and Fair
Deficiency	GYPSUM BOARD: DAMAGED/DETERIORATED
Deficiency Location/Instance	Stairs A/Basement, B/5
Deficiency Quantity	20
Quantity Uom	S.F.
Potential Action	REPLACE
Urgency of Action	PRIORITY 3
Purpose of Action	LEVEL 2

Stair B/5
Violations	No violations recorded.
Door(s)	Inspected
Condition	2 - Between Good and Fair
Deficiency	No deficiencies recorded
Partition	Does not Exist
Railings	Inspected
Condition	2 - Between Good and Fair
Deficiency	No deficiencies recorded
Stairs and Landings	Inspected
Condition	2 - Between Good and Fair
Deficiency	No deficiencies recorded
Walls	Inspected
Condition	2 - Between Good and Fair
Deficiency	CERAMIC TILE: BROKEN/ MISSING
Deficiency Location/Instance	Stair A/1
Deficiency Quantity	10
Quantity Uom	S.F.
Potential Action	REPLACE
Urgency of Action	PRIORITY 3
Purpose of Action	LEVEL 2
Deficiency Photo1

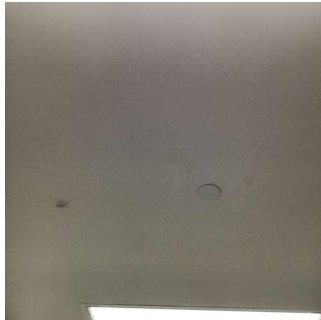
Ceiling	Inspected
Condition	2 - Between Good and Fair
Deficiency	GYPSUM BOARD: DAMAGED/DETERIORATED
Deficiency Location/Instance	Room C04G
Deficiency Quantity	10
Quantity Uom	S.F.
Potential Action	REPLACE
Urgency of Action	PRIORITY 3
Purpose of Action	LEVEL 2
Deficiency Photo1

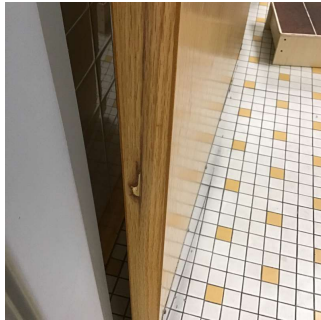
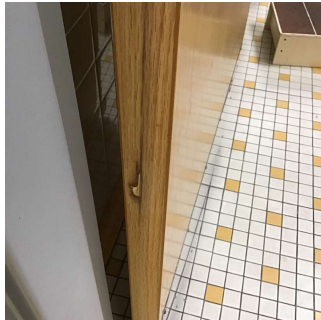
Door(s)	Inspected
Condition	4 - Between Fair and Poor
Deficiency	WOOD: DETERIORATED DOOR
Deficiency Location/Instance	In Room 202
Deficiency Quantity	1
Quantity Uom	EACH
Potential Action	MAINTENANCE
Urgency of Action	PRIORITY 3
Purpose of Action	LEVEL 2
Deficiency Photo1
