NYC Department of Education
Building Condition Assessment Survey 2023 - 2024

Architectural Inspection

Asset: P.S. 312 - BROOKLYN, 7103 AVENUE T, New York, 11234

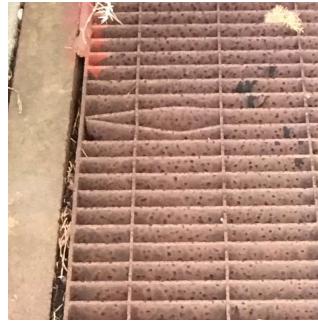
AW1
No violations recorded.

CONCRETE: DETERIORATED

10

REPLACE

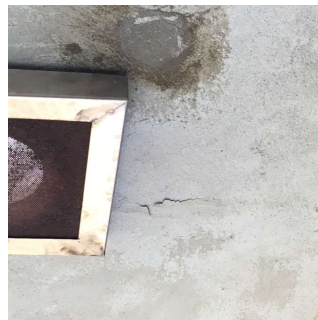
Facade B
No violations recorded.

METAL: DETERIORATION/DAMAGED/MISSING PIECES

20
S.F.
REPLACE
PRIORITY 4
LEVEL 2

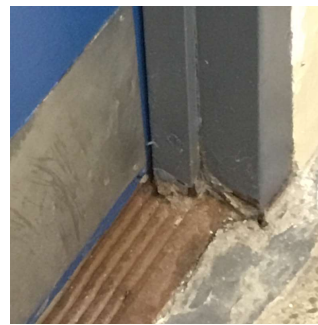
Facade D

DOOR HARDWARE	Inspected
Condition	3 - Fair
Deficiency	No deficiencies recorded
LINTELS	Inspected
Condition	2 - Between Good and Fair
Deficiency	No deficiencies recorded
TRANSOM/SIDE LIGHT	Inspected
Condition	2 - Between Good and Fair
Deficiency	No deficiencies recorded
EXTERIOR WALLS	Inspected
Material Type(s)	Concrete, Masonry
Replacement Quantity	27,000
Replacement Uom	S.F.
Instance on All Facades	Inspected
Instance Condition	3 - Fair
Instance Quantity	27,000
Instance Quantity Uom	S.F.
Deficiency	CAST IN PLACE / PRE-CAST CONCRETE: MINOR CRACKS/SPALLING

10

REPAIR

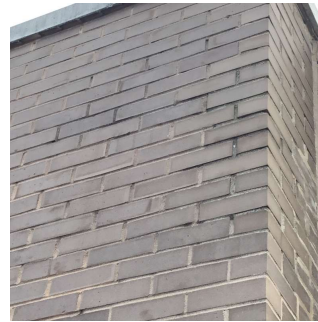
Roof 1
No violations recorded.

CONCRETE: MINOR CRACKS, SPALLING
K312

10
S.F.
REPAIR
PRIORITY 3
LEVEL 2

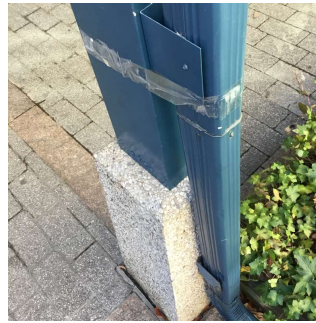
Main Entrance Canopy
No violations recorded.

RAILINGS/PANELS: DETERIORATED, MAJOR RUSTING

20
S.F.
REPLACE
PRIORITY 4
LEVEL 2

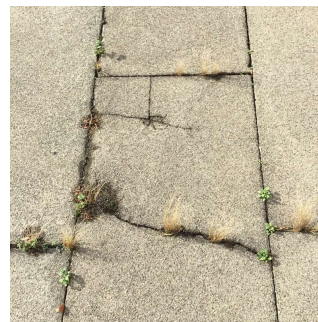
Roof 2
No violations recorded.

IRMA: ROOFING: DAMAGED INSULATION

30
S.F.
REPLACE
PRIORITY 4
LEVEL 2

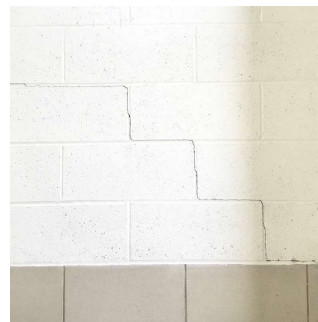
BH1
No violations recorded.

**BULKHEAD/PENTHOUSE WALLS/INTERIOR: PLASTER
CRACKS/SPALLING**

20
S.F.
REPLACE
PRIORITY 3
LEVEL 2

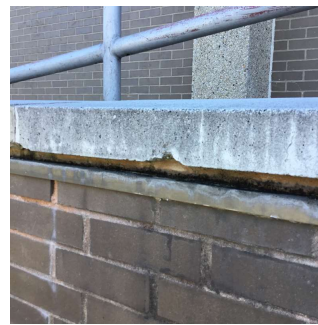
Facade D

BRICK: DETERIORATED JOINTS AT COPING STONES

10
L.F.
MAINTENANCE
PRIORITY 3
LEVEL 2

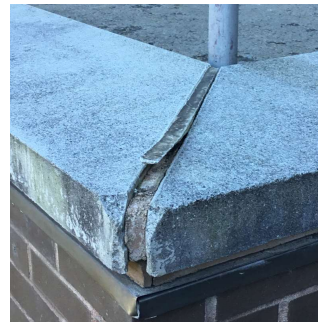
Facade D

BRICK: CRACKS/SPALLING - MAJOR

30

REPLACE

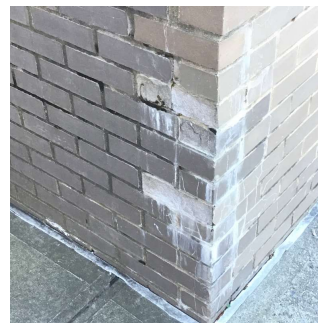
Facade C

DAMAGED

10
L.F.
REPLACE
PRIORITY 4
LEVEL 2

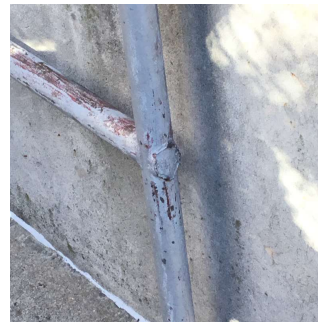
Facade D

RUST - MAJOR

20
L.F.
REPLACE
PRIORITY 4
LEVEL 2

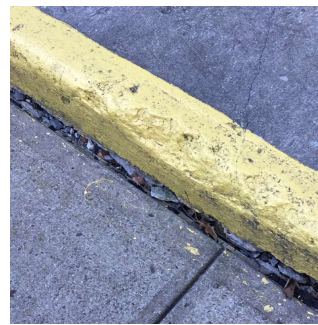
Facade D

CONCRETE: CRACKS/SPALLING - MAJOR

70
S.F.
REPLACE
PRIORITY 4
LEVEL 2

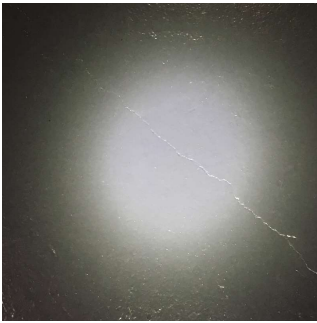
Violations	Room 217 No violations recorded.
Deficiency	CONCRETE: CRACKS/SPALLED/REINFORCEMENT EXPOSED
Deficiency Location/Instance	2nd Floor
Deficiency Quantity	15
Quantity Uom	S.F.
Potential Action	REPAIR
Urgency of Action	PRIORITY 4
Purpose of Action	LEVEL 5
Deficiency Photo1

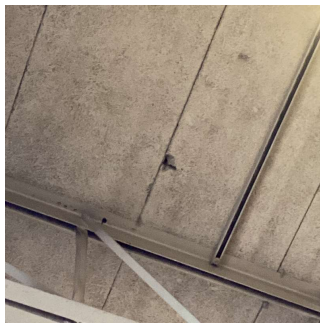
Violations	Near the windows No violations recorded.
Deficiency	ACOUSTIC TILES ON PLASTER: DAMAGED/MISSING
Deficiency Location/Instance	Near Entrance
Deficiency Quantity	10
Quantity Uom	S.F.
Potential Action	REPLACE
Urgency of Action	PRIORITY 3
Purpose of Action	LEVEL 2
Deficiency Photo1

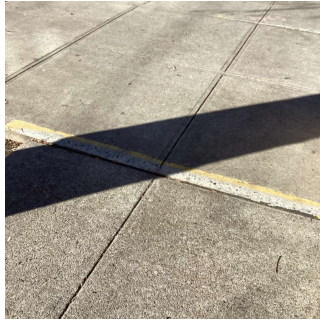
Violations	East 71st Street No violations recorded.
Deficiency	DAMAGED/DETERIORATED/MISSING SECTIONS
Deficiency Location/Instance	East 71st Street, Avenue T
Deficiency Quantity	525
Quantity Uom	S.F.
Potential Action	REPLACE
Urgency of Action	PRIORITY 3
Purpose of Action	LEVEL 2

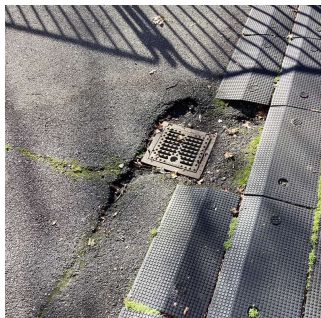
Violations	Near Exit 12 No violations recorded.
Deficiency	ASPHALT: CRACKS - MAJOR
Deficiency Location/Instance	Near Exit 10, Near Exit 12
Deficiency Quantity	120
