**NYC Department of Education**  
**Building Condition Assessment Survey 2023 - 2024**

Architectural Inspection

**K316**

**Asset:** P.S. 316 - BROOKLYN, 750 CLASSON AVENUE, New York, 11238

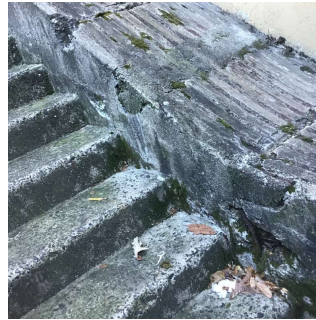
AW1

**AREAWAY WALLS: CRACKS AND SPALLING**

REPAIR

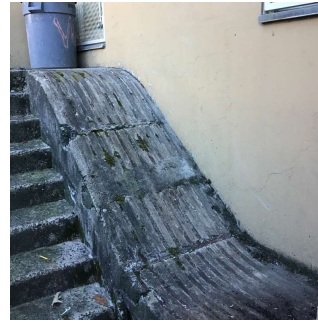
AW1

**AREAWAY STAIRS: DETERIORATED MATERIAL SLIDE**

REPAIR

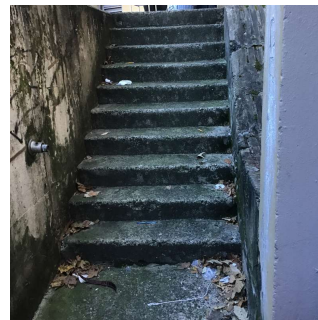
AW1

**AREAWAY STAIRS: DETERIORATED TREADS/RISERS/NOSINGS**

REPAIR

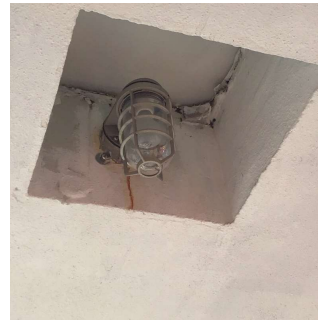
Main Entrance Canopy  
No violations recorded.

10  
S.F.  
REPAIR  
PRIORITY 5  
LEVEL 2

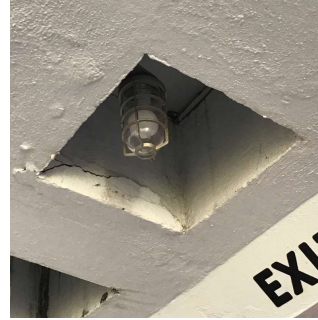
Exit 6 Canopy

Yes	Potential Falling Debris	Deteriorated concrete canopy is a potential falling debris hazard.	EXTERIOR   AWNINGS AND CANOPIES	Exit 6 Exterior Canopy	Denis Wanamaker	Custodian

**CONCRETE: MAJOR CRACKS/SPALLING**

10  
S.F.  
REPAIR  
PRIORITY 5  
LEVEL 6

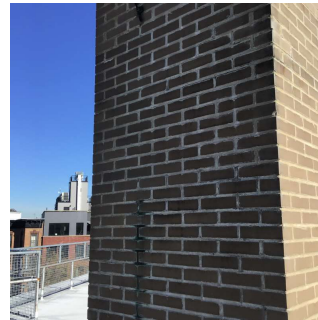
Chimney

**BRICK: DETERIORATED JOINTS**

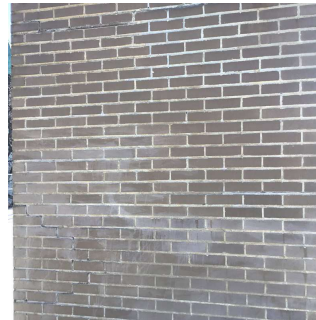
Chimney  
 No violations recorded.

**BRICK: MINOR CRACKS AND SPALLING**

10  
 S.F.  
 RESTITCH  
 PRIORITY 3  
 LEVEL 2

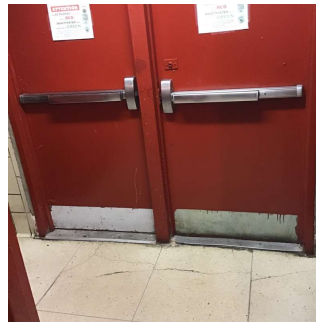
Exit 5, 8

METAL CLAD: DETERIORATED DOOR - MINOR DETERIORATION

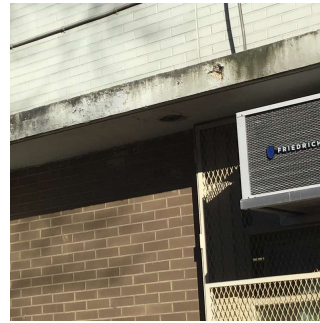
Facade N

CONCRETE: MAJOR CRACKS/SPALLING

S.F.  
REPLACE  
PRIORITY 4  
LEVEL 2

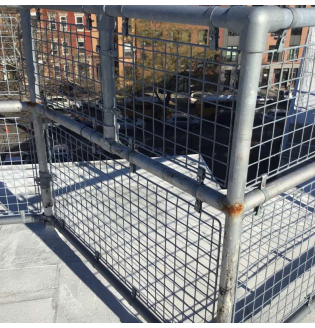
Question	Response
<b>EXTERIOR</b>	
<b>ROOF</b>	
<b>Roofing</b>	
<b>ROOF BARRIER/FENCE</b>	Inspected
Condition	3 - Fair
Deficiency	RAILINGS/PANELS: DETERIORATED, MAJOR RUSTING
Roof Plan reference

Deficiency Quantity	25
Quantity Uom	S.F.
Potential Action	REPLACE
Urgency of Action	PRIORITY 4
Purpose of Action	LEVEL 2
Deficiency Photo1

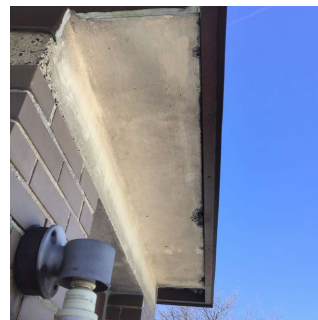
Bulkhead 3  
No violations recorded.

Violations	Bulkhead 1 No violations recorded.
Deficiency	<b>BULKHEAD/PENTHOUSE ROOF: DETERIORATED</b>

20  
S.F.  
REPAIR  
PRIORITY 3  
LEVEL 2

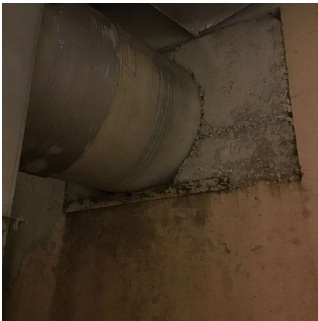
<b>Question</b>	<b>Response</b>
<b>EXTERIOR</b>	Inspected
<b>WINDOWS</b>	Inspected
<b>WINDOWS</b>	
Source of Installation	Custodial Staff
Deficiency	No deficiencies recorded
<b>INTERIOR</b>	Inspected
<b>POOLS</b>	Does not Exist
<b>STRUCTURAL</b>	Inspected
<b>COLUMNS/BEAMS/BEARING WALLS</b>	Inspected
Condition	2 - Between Good and Fair
Deficiency	No deficiencies recorded
<b>FLOOR STRUCTURE</b>	Inspected
Condition	4 - Between Fair and Poor
Deficiency	CONCRETE SLAB ON GRADE: WATER INFILTRATION IN NON-INSTRUCTIONAL SPACE
Deficiency Location/Instance	Basement Fan Room Crawl Space below Auditorium
Deficiency Quantity	100
Quantity Uom	S.F.
Potential Action	INSTALL WATERPROOFING
Urgency of Action	PRIORITY 5
Purpose of Action	LEVEL 5
Deficiency Photo1	 
Basement Fan Room Crawl Space below Auditorium	
Violations	No violations recorded.
<b>FOUNDATION WALLS</b>	Inspected
Material Type(s)	Concrete
Condition	3 - Fair
Deficiency	CONCRETE: WATER INFILTRATION IN NON- INSTRUCTIONAL SPACE

Deficiency Location/Instance	Basement Fan Room below Auditorium
Deficiency Quantity	50
Quantity Uom	S.F.
Potential Action	INSTALL WATERPROOFING
Urgency of Action	PRIORITY 5
Purpose of Action	LEVEL 5

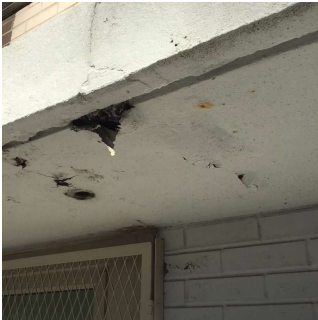
Violations	Basement Fan Room below Auditorium No violations recorded.
<b>ROOF STRUCTURE</b>	Inspected
Condition	3 - Fair
Deficiency	CONCRETE: CRACKED/SPALLED/REINFORCEMENT EXPOSED
Deficiency Location/Instance	Facades G, H, K
Deficiency Quantity	50
Quantity Uom	S.F.
Potential Action	REPAIR
Urgency of Action	PRIORITY 3
Purpose of Action	LEVEL 5
Deficiency Photo1

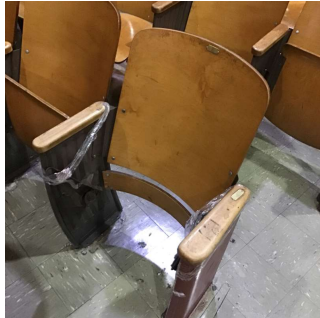
Question	Response
<b>INTERIOR</b>	
<b>STRUCTURAL</b>	
<b>VAULTS-BUNKERS</b>	
<b>Vault/Ash Hoist Doors and Framing</b>	
Purpose of Action	LEVEL 2
Deficiency Photo1	 
	Vault
Violations	No violations recorded.
<b>AUDITORIUM</b>	
	Inspected
Instance on 1st Floor (212 seats)	Inspected
<b>Ceiling</b>	
Instance on 1st Floor (212 seats)	Inspected
Condition	2 - Between Good and Fair
Deficiency	No deficiencies recorded
<b>Door(s)</b>	
Instance on 1st Floor (212 seats)	Inspected
Condition	2 - Between Good and Fair
Deficiency	No deficiencies recorded
<b>Fixed H/C Lift</b>	
Instance on 1st Floor (212 seats)	Does not Exist
<b>Fixed Seating</b>	
Instance on 1st Floor (212 seats)	Inspected
Condition	2 - Between Good and Fair
Deficiency	DAMAGED/BROKEN/INOPERABLE
Deficiency Location/Instance	Seat F/2
Deficiency Quantity	1
Quantity Uom	EACH
Potential Action	REPLACE
Urgency of Action	PRIORITY 5
Purpose of Action	LEVEL 6
Deficiency Photo1

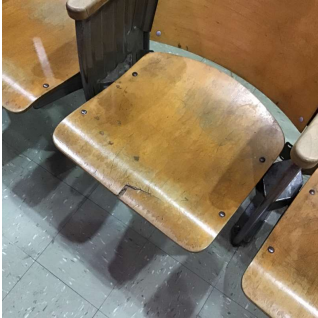
Question	Response
<b>INTERIOR</b>	
<b>AUDITORIUM</b>	
<b>Fixed Seating</b>	
Deficiency Location/Instance	Seat A/111, 106
Deficiency Quantity	2
Quantity Uom	EACH
Potential Action	REPLACE
Urgency of Action	PRIORITY 3
Purpose of Action	LEVEL 2
Deficiency Photo1

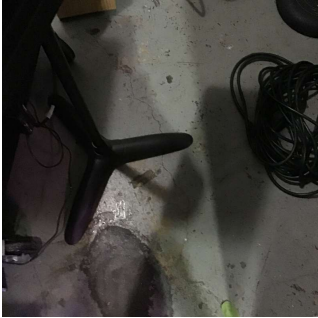
Violations	Seat A/111 No violations recorded.
<b>Floor Finish</b>	
Instance on 1st Floor (212 seats)	Inspected
Condition	2 - Between Good and Fair
Deficiency	CONCRETE: CRACKS
Deficiency Location/Instance	Room 185
Deficiency Quantity	10
Quantity Uom	S.F.
Potential Action	REPLACE
Urgency of Action	PRIORITY 3
Purpose of Action	LEVEL 2
Deficiency Photo1

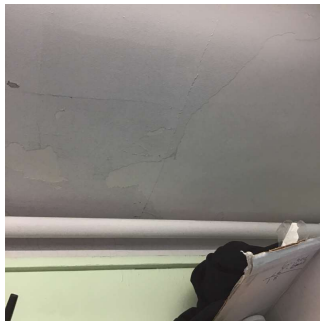
Question	Response
<b>INTERIOR</b>	
<b>AUDITORIUM</b>	
<b>Walls</b>	
Deficiency Photo1	 
Violations	Left side of stage No violations recorded.
<b>Window Curtains/Shades/Blinds</b>	
Instance on 1st Floor (212 seats)	Does not Exist
<b>CAFETERIA</b>	
Instance on 1st Floor - Staff (600 SF)	Inspected
Instance on 1st Floor - Student	Inspected
<b>Ceiling</b>	
Instance on 1st Floor - Staff (600 SF)	Inspected
Condition	2 - Between Good and Fair
Deficiency	GYPSUM BOARD: DAMAGED/DETERIORATED
Deficiency Location/Instance	Near Entrance
Deficiency Quantity	10
Quantity Uom	S.F.
Potential Action	REPLACE
Urgency of Action	PRIORITY 3
Purpose of Action	LEVEL 2
Deficiency Photo1

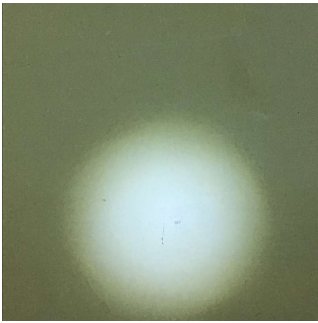
Violations	Near Entrance No violations recorded.
Instance on 1st Floor - Student	Inspected
Condition	2 - Between Good and Fair
Deficiency	PLASTER: CRACKS/SPALLING
Deficiency Location/Instance	Near sink
Deficiency Quantity	10
Quantity Uom	S.F.
Potential Action	REPLACE

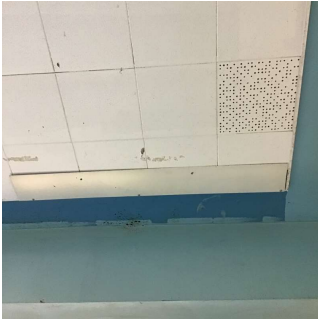
Near sink
Violations	No violations recorded.
Deficiency	ACOUSTIC TILES ON PLASTER: DAMAGED/MISSING
Deficiency Location/Instance	Near center, windows
Deficiency Quantity	50
Quantity Uom	S.F.
Potential Action	REPLACE
Urgency of Action	PRIORITY 3
Purpose of Action	LEVEL 2
Deficiency Photo1

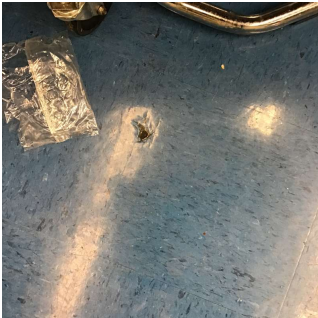
Near Windows
Violations	No violations recorded.
Instance on 1st Floor - Student	Inspected
Condition	2 - Between Good and Fair
Deficiency	VINYL TILES: BROKEN/DETERIORATED/MISSING TILES
Deficiency Location/Instance	Near kitchen, windows, center
Deficiency Quantity	20
Quantity Uom	S.F.
Potential Action	REPLACE
Urgency of Action	PRIORITY 3
Purpose of Action	LEVEL 2
Deficiency Photo1

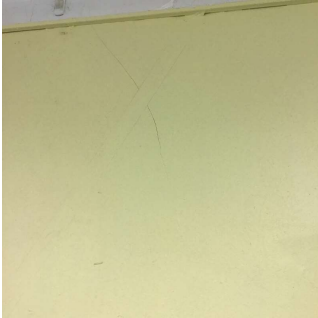
Deficiency	PLASTER: CRACKS/SPALLING
Deficiency Location/Instance	Rear, Near Windows
Deficiency Quantity	20
Quantity Uom	S.F.
Potential Action	REPLACE

Question	Response
<b>INTERIOR</b>	
<b>CAFETERIA</b>	
<b>Walls</b>	
Urgency of Action	PRIORITY 3
Purpose of Action	LEVEL 2
Deficiency Photo1

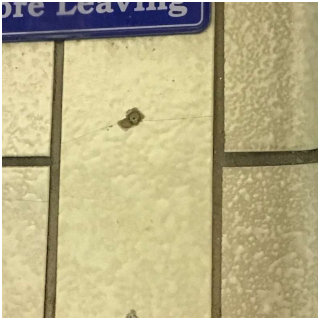
Rear
Violations	No violations recorded.
Instance on 1st Floor - Student	Inspected
Condition	2 - Between Good and Fair
Deficiency	GLAZED BLOCK: CRACKS/SPALLING
Deficiency Location/Instance	Near Entrance, windows, kitchen, sink
Deficiency Quantity	50
Quantity Uom	S.F.
Potential Action	REPLACE
Urgency of Action	PRIORITY 3
Purpose of Action	LEVEL 2
Deficiency Photo1

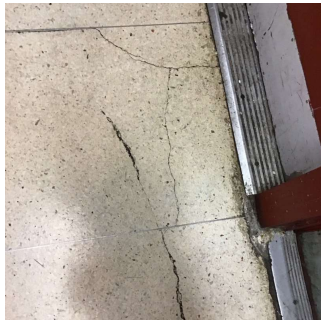
Question	Response
<b>INTERIOR</b>	
<b>CLASSROOMS/CORRIDORS/ADMIN SPACES</b>	
<b>Door(s)</b>	Inspected
	Room 313
Violations	No violations recorded.
<b>Floor Finish</b>	Inspected
Condition	2 - Between Good and Fair
Deficiency	TERRAZZO: CRACKS
Deficiency Location/Instance	Exit 5, Corridor near Room 172,134,130,129, and others
Deficiency Quantity	150
Quantity Uom	S.F.
Potential Action	REPLACE
Urgency of Action	PRIORITY 3
Purpose of Action	LEVEL 2
Deficiency Photo1

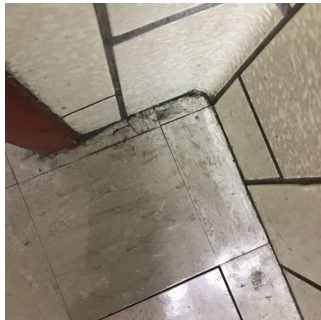
Violations	Exit 5 No violations recorded.
Deficiency	VINYL TILES: BROKEN/DETERIORATED/MISSING TILES
Deficiency Location/Instance	Corridor near Room 329,308,305,304,303, and others
Deficiency Quantity	200
Quantity Uom	S.F.
Potential Action	REPLACE
Urgency of Action	PRIORITY 3
Purpose of Action	LEVEL 2
Deficiency Photo1

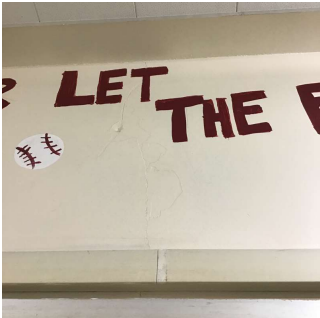
Question	Response
<b>INTERIOR</b>	
<b>CLASSROOMS/CORRIDORS/ADMIN SPACES</b>	
<b>Walls</b>	
Urgency of Action	PRIORITY 3
Purpose of Action	LEVEL 2
Deficiency Photo1	 
	Corridor near Room 306
Violations	No violations recorded.
Deficiency	PLASTER: CRACKS/SPALLING
Deficiency Location/Instance	Corridor near Room 330,313,312,225,212, and others
Deficiency Quantity	150
Quantity Uom	S.F.
Potential Action	REPLACE
Urgency of Action	PRIORITY 3
Purpose of Action	LEVEL 2
Deficiency Photo1

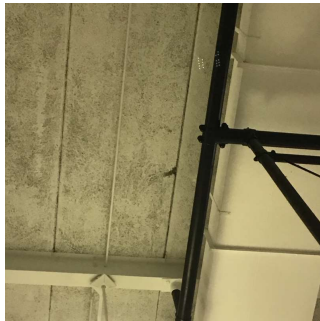
Corridor near Room 312
Violations	No violations recorded.
<b>Specialties</b>	Does not Exist
<b>GYMNASIUM</b>	Inspected
Instance on 1st Floor	Inspected
<b>Ceiling</b>	
Instance on 1st Floor	Inspected
Condition	2 - Between Good and Fair
Deficiency	TECTUM: DAMAGED/MISSING
Deficiency Location/Instance	Near Entrance
Deficiency Quantity	20
Quantity Uom	S.F.
Potential Action	REPLACE
Urgency of Action	PRIORITY 3
Purpose of Action	LEVEL 2

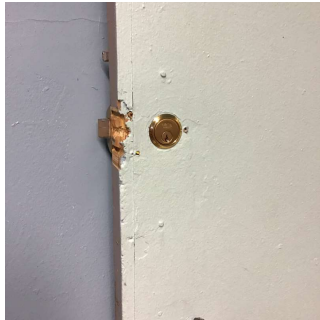
Violations	Near Entrance No violations recorded.
<b>Door(s)</b>	
Instance on 1st Floor	Inspected
Condition	4 - Between Fair and Poor
Deficiency	WOOD: DETERIORATED DOOR
Deficiency Location/Instance	Office, storage
Deficiency Quantity	2
Quantity Uom	EACH
Potential Action	MAINTENANCE
Urgency of Action	PRIORITY 3
Purpose of Action	LEVEL 2
Deficiency Photo1

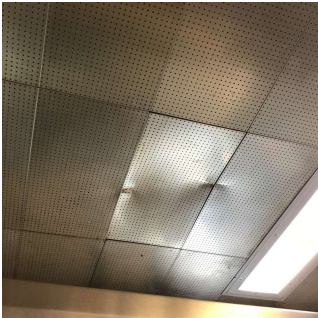
<b>Question</b>	<b>Response</b>
<b>INTERIOR</b>	
<b>GYMNASIUM</b>	Inspected
<b>Walls</b>	
Violations	No violations recorded.
<b>Window Curtains/Shades/Blinds</b>	
Instance on 1st Floor	Does not Exist
<b>INTERIOR DOOR HARDWARE</b>	Inspected
Condition	3 - Fair
Deficiency	No deficiencies recorded
<b>INTERIOR GUARDS</b>	Inspected
Condition	2 - Between Good and Fair
Deficiency	No deficiencies recorded
<b>KITCHEN</b>	Inspected
Instance on 1st Floor	Inspected
<b>Ceiling</b>	
Instance on 1st Floor	Inspected
Condition	2 - Between Good and Fair
Deficiency	METAL PAN: DAMAGED/MISSING
Deficiency Location/Instance	Near Windows, center
Deficiency Quantity	10
Quantity Uom	S.F.
Potential Action	REPLACE
Urgency of Action	PRIORITY 3
Purpose of Action	LEVEL 2
Deficiency Photo1

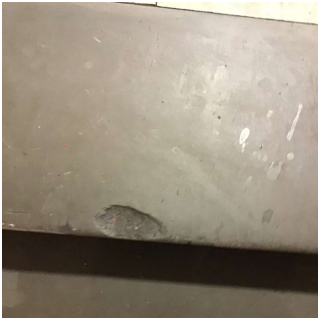
Stair E/1
Violations	No violations recorded.
<b>Walls</b>	Inspected
Condition	2 - Between Good and Fair
Deficiency	GLAZED BLOCK: CRACKS/SPALLING
Deficiency Location/Instance	Stair E/1,2,3, BC/1, 3, and others
Deficiency Quantity	50
Quantity Uom	S.F.
Potential Action	REPLACE
Urgency of Action	PRIORITY 3
Purpose of Action	LEVEL 2
Deficiency Photo1

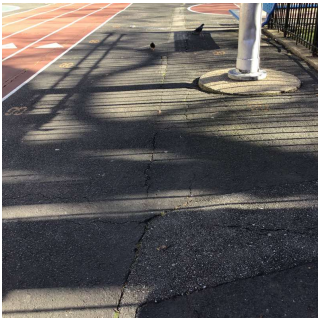
Schoolyard Near exit 1
Violations	No violations recorded.

Schoolyard north
Violations	No violations recorded.
<b>Deficiency</b>	<b>CRACKS - MAJOR</b>
Deficiency Location/Instance	Schoolyard Near exit 1, Schoolyard north
Deficiency Quantity	4,000
Quantity Uom	S.F.
Potential Action	<b>REPLACE</b>
Urgency of Action	<b>PRIORITY 3</b>

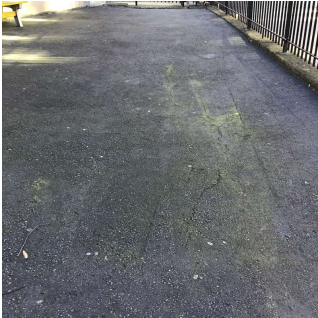
Violations	Schoolyard Near exit 1 No violations recorded.
<b>Pavers</b>	Does not Exist
<b>Site Sidewalks &amp; Walkways</b>	Inspected
<b>Asphalt</b>	Inspected
Condition	3 - Fair
Deficiency	CRACKS - MAJOR
Deficiency Location/Instance	Near exit 9
Deficiency Quantity	100
Quantity Uom	S.F.
Potential Action	REPLACE
Urgency of Action	PRIORITY 3
Purpose of Action	LEVEL 2
Deficiency Photo1

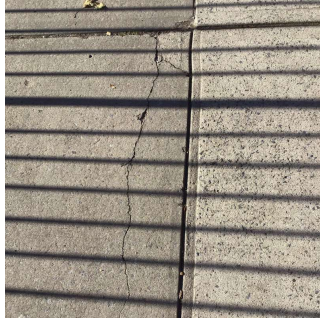
No	Tripping Hazard	Severely damaged DOT sidewalk is a potential tripping hazard.	SITE   PAVING   DOT Sidewalk   Concrete	Along Park Place	Denis Wanamaker	Custodian

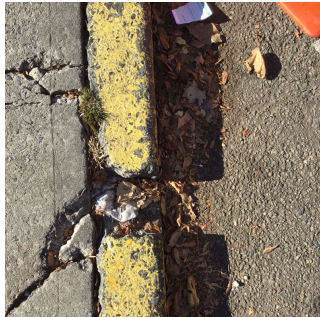
Violations	Along Park Place 50284
Deficiency	DAMAGED CURBS
Deficiency Location/Instance	Along Park Place, Classon Avenue, Sterling Place
Deficiency Quantity	180
Quantity Uom	L.F.
Potential Action	REPLACE
Urgency of Action	PRIORITY 4
Purpose of Action	LEVEL 4
Deficiency Photo1
