**NYC Department of Education**  
**Building Condition Assessment Survey 2023 - 2024**

Architectural Inspection

**K317**

**Asset: P.S. 133 WILLIAM A. BUTLER - BROOKLYN, 610 BALTIC STREET, New York, 11217**

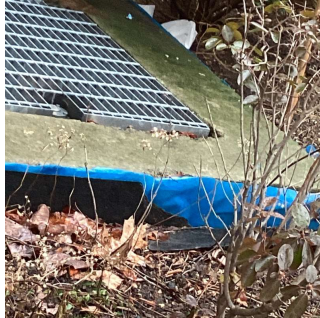
Question	Response
<b>Architectural</b>	
<b>EXTERIOR</b>	Inspected
<b>AREAWAY</b>	Inspected
Instance on AW1	Inspected
Instance Condition	2 - Between Good and Fair
Instance Quantity	1
Instance Quantity Uom	EACH
Deficiency	AREAWAY WALLS: CRACKS AND SPALLING
Roof Plan reference	
Deficiency Quantity	10
Quantity Uom	S.F.

Question	Response
<b>EXTERIOR</b>	
<b>AREAWAY</b>	
Potential Action	REPAIR
Urgency of Action	PRIORITY 3
Purpose of Action	LEVEL 2
Deficiency Photo1

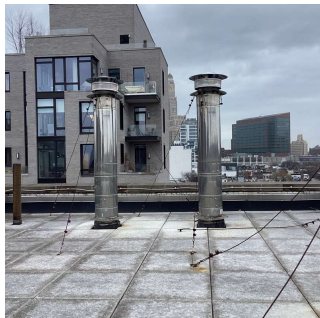
Violations	AW1 No violations recorded.
<b>AWNINGS AND CANOPIES</b>	
	Does not Exist
<b>CHIMNEY</b>	
Material Type(s)	Inspected Metal
Condition	3 - Fair
Deficiency	METAL: LOOSE OR MISSING SUPPORTS
Roof Plan reference

Deficiency Quantity	1
Quantity Uom	EACH
Potential Action	REPLACE
Urgency of Action	PRIORITY 4
Purpose of Action	LEVEL 2
Deficiency Photo1

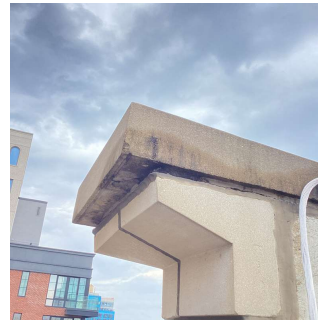
Roof 2

Violations	CH2 No violations recorded.
<b>COPING</b>	
Condition	Inspected 2 - Between Good and Fair
Deficiency	CAST STONE: DETERIORATED BED JOINT

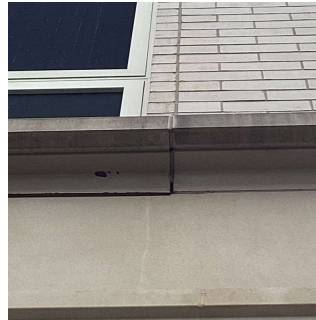
Facade E

PRE-CAST CONCRETE: DETERIORATED JOINTS

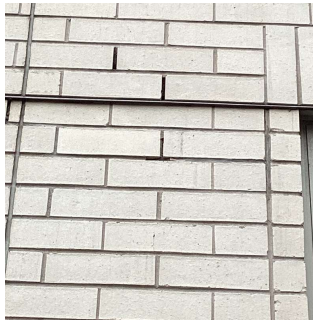
Facade C

Deficiency	<b>BRICK: DETERIORATED JOINTS</b>
------------	-----------------------------------

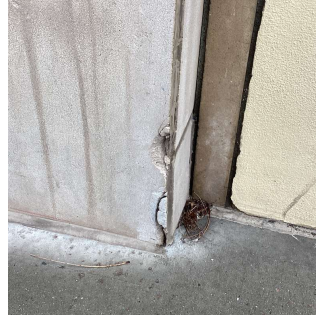
Facade G

**CAST IN PLACE / PRE-CAST CONCRETE: MAJOR  
CRACKS/SPALLING**

Potential Action	REPLACE
Urgency of Action	PRIORITY 4
Purpose of Action	LEVEL 2
Deficiency Photo1

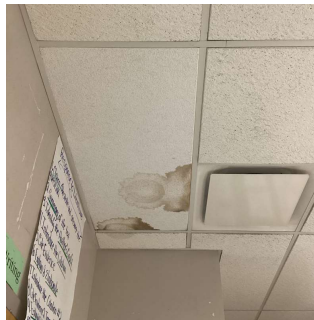
Roof 1 - Room 511B (shown), Rooms 509, 518, 520 (similar)

Sustainable Roof Type	White Roof
Sustainable Roof Location (Roof Number)	Roofs 1,2,5
Do solar panels exist on these roofs?	No
Is/Are the roof(s) suitable for Solar Panel installation?	Yes
Installation Year	2013
Source of Installation	Custodial Staff
Deficiency	IRMA: ROOFING: MAJOR ACTIVE ROOF LEAKS IN INSTRUCTIONAL SPACE

400  
S.F.  
REPLACE ROOFING WITH MAJOR EQUIPMENT REMOVAL  
PRIORITY 5  
LEVEL 2

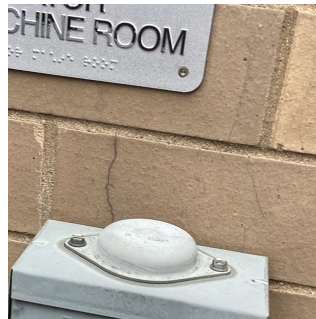
PH

**BULKHEAD/PENTHOUSE WALLS/EXTERIOR:  
CRACKS/SPALLING - MINOR**

REPAIR

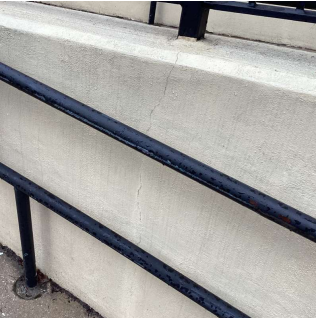
Question	Response
<b>EXTERIOR</b>	
<b>ROOF</b>	Inspected
<b>Specialties</b>	Inspected
<b>SKYLIGHT/ROOF VENT</b>	Does not Exist
<b>ROOF/GRAVITY TANK</b>	Does not Exist
<b>STAIRS/RAMPS: EXTERIOR</b>	Inspected
<b>BUILDING CHEEK/FLANK WALLS</b>	Inspected
Condition	3 - Fair
Deficiency	CAST IN PLACE CONCRETE: CRACKS/SPALLING - MINOR
Roof Plan reference

Deficiency Quantity	30
Quantity Uom	S.F.
Potential Action	REPAIR
Urgency of Action	PRIORITY 3
Purpose of Action	LEVEL 2
Deficiency Photo1

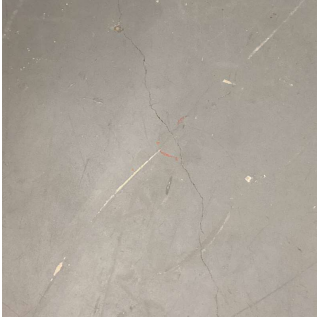
CONCRETE SLAB ON GRADE: THRU CRACKS

Question	Response
<b>INTERIOR</b>	
<b>STRUCTURAL</b>	
<b>FLOOR STRUCTURE</b>	
Potential Action	REPAIR
Urgency of Action	PRIORITY 3
Purpose of Action	LEVEL 5
Deficiency Photo1

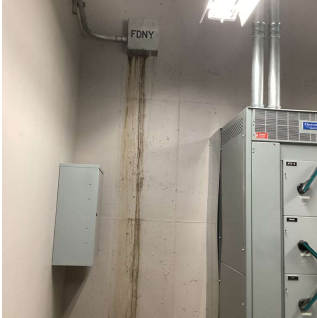
Cellar - Room C16
Violations	No violations recorded.
<b>FOUNDATION WALLS</b>	
Material Type(s)	Inspected Concrete
Condition	4 - Between Fair and Poor
Deficiency	CONCRETE: WATER INFILTRATION IN ELECTRICAL PANEL ROOM
Deficiency Location/Instance	Cellar - Room C16
Deficiency Quantity	100
Quantity Uom	S.F.
Potential Action	INSTALL WATERPROOFING
Urgency of Action	PRIORITY 5
Purpose of Action	LEVEL 6
Deficiency Photo1

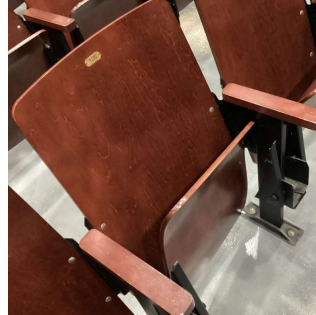
Question	Response
<b>INTERIOR</b>	
<b>AUDITORIUM</b>	
<b>Ceiling</b>	
Deficiency Quantity	10
Quantity Uom	S.F.
Potential Action	REPLACE
Urgency of Action	PRIORITY 3
Purpose of Action	LEVEL 2
Deficiency Photo1	 
	Room 106C
Violations	No violations recorded.
<b>Door(s)</b>	
Instance on 1st Floor (338 Seats)	Inspected
Condition	3 - Fair
Deficiency	WOOD: DETERIORATED DOOR
Deficiency Location/Instance	Storage Room 106C
Deficiency Quantity	1
Quantity Uom	EACH
Potential Action	MAINTENANCE
Urgency of Action	PRIORITY 3
Purpose of Action	LEVEL 2
Deficiency Photo1	 
	Storage Room 106C
Violations	No violations recorded.
<b>Fixed H/C Lift</b>	
Instance on 1st Floor (338 Seats)	Does not Exist
<b>Fixed Seating</b>	
Instance on 1st Floor (338 Seats)	Inspected
Condition	2 - Between Good and Fair
Deficiency	DAMAGED/BROKEN/INOPERABLE
Deficiency Location/Instance	Seat F/106
Deficiency Quantity	1
Quantity Uom	EACH
Potential Action	REPLACE

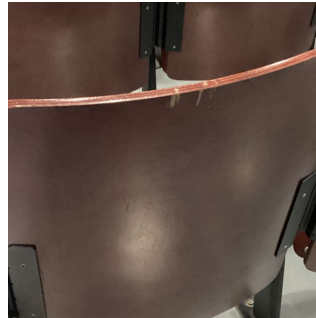
Seat L/112

DAMAGED/BROKEN/INOPERABLE

REPLACE

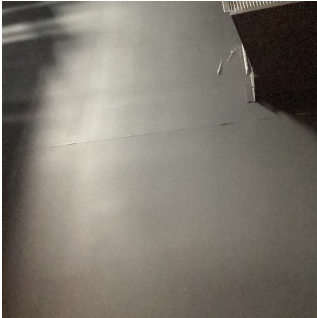
Question	Response
<b>INTERIOR</b>	
<b>AUDITORIUM</b>	
<b>Walls</b>	
Deficiency	GYP SUM BOARD: DETERIORATED
Deficiency Location/Instance	Stage
Deficiency Quantity	10
Quantity Uom	S.F.
Potential Action	REPLACE
Urgency of Action	PRIORITY 3
Purpose of Action	LEVEL 2
Deficiency Photo1

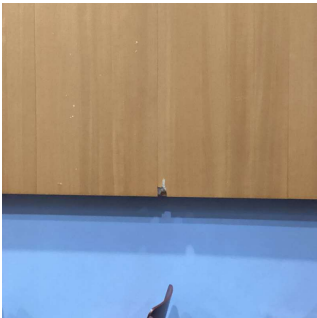
Violations	Stage No violations recorded.
Deficiency	WOOD PANELING: DETERIORATED
Deficiency Location/Instance	Near Windows, near seat M/11
Deficiency Quantity	20
Quantity Uom	S.F.
Potential Action	REPLACE
Urgency of Action	PRIORITY 3
Purpose of Action	LEVEL 2
Deficiency Photo1

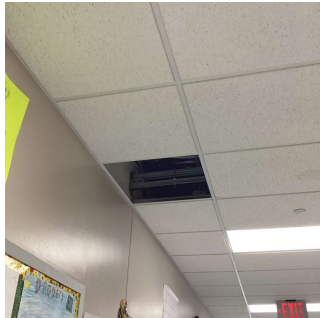
Question	Response
<b>INTERIOR</b>	
<b>CAFETERIA</b>	
<b>Ceiling</b>	
Violations	No violations recorded.
<b>Door(s)</b>	
Instance on Cellar	Inspected
Condition	2 - Between Good and Fair
Deficiency	No deficiencies recorded
<b>Fixed Equipment</b>	
Instance on Cellar	Does not Exist
<b>Floor Finish</b>	
Instance on Cellar	Inspected
Condition	2 - Between Good and Fair
Deficiency	No deficiencies recorded
<b>Sliding-folding Partition</b>	
Instance on Cellar	Does not Exist
<b>Stage</b>	
Instance on Cellar	Does not Exist
<b>Walls</b>	
Instance on Cellar	Inspected
Condition	2 - Between Good and Fair
Deficiency	No deficiencies recorded
<b>Window Curtains/Shades/Blinds</b>	
Instance on Cellar	Does not Exist
<b>CLASSROOMS/CORRIDORS/ADMIN SPACES</b>	Inspected
<b>Ceiling</b>	Inspected
Condition	2 - Between Good and Fair
Deficiency	ACOUSTIC TILES: DAMAGED/MISSING
Deficiency Location/Instance	Corridor near Room 531, 520, B/5, 207
Deficiency Quantity	20

Quantity Uom	S.F.
Potential Action	REPLACE
Urgency of Action	PRIORITY 3
Purpose of Action	LEVEL 2
Deficiency Photo1

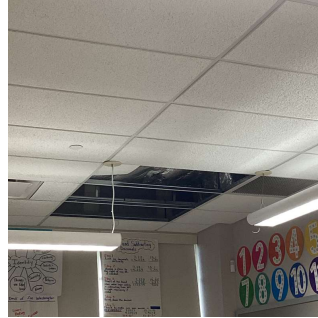
Room 511B

Violations	Corridor near Room 520 No violations recorded.
Deficiency	ACOUSTIC TILES: DAMAGED/MISSING - ACTIVE LEAK
Deficiency Location/Instance	Room 520, 518, 511B, 509
Deficiency Quantity	80
Quantity Uom	S.F.
Potential Action	REPLACE

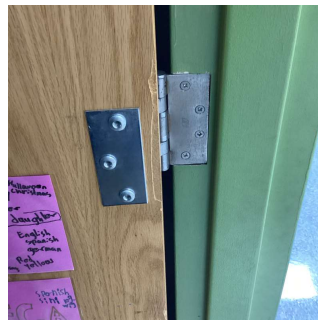
WOOD: DETERIORATED DOOR  
Room 420  
1  
EACH  
MAINTENANCE  
PRIORITY 3  
LEVEL 2

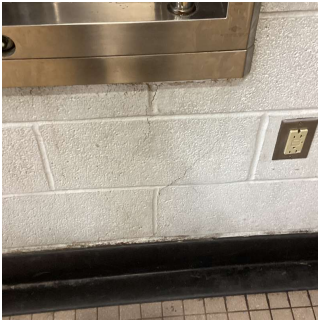
Yes	Tripping Hazard	Severely rotted floor is a potential tripping hazard.	INTERIOR   GYMNASIUM   Floor Finish	Near water fountain	Hector Serrano	Fireman
-----	-----------------	---	-------------------------------------	---------------------	----------------	---------

Question	Response
<b>INTERIOR</b>	
<b>GYMNASIUM</b>	
<b>Sliding-folding Partition</b>	
Deficiency	No deficiencies recorded
<b>Stage</b>	
Instance on 3rd Floor	Does not Exist
<b>Walls</b>	
Instance on 3rd Floor	Inspected
Condition	2 - Between Good and Fair
Deficiency	MASONRY: CRACKS/SPALLING
Deficiency Location/Instance	Near water fountain
Deficiency Quantity	10
Quantity Uom	S.F.
Potential Action	REPLACE
Urgency of Action	PRIORITY 3
Purpose of Action	LEVEL 2
Deficiency Photo1

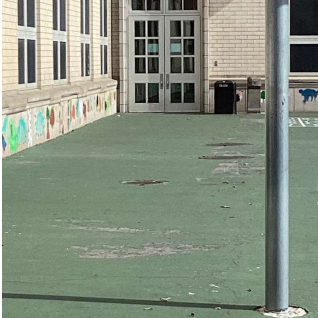
Question	Response
<b>SITE</b>	
<b>PAVING</b>	
<b>Student Use</b>	
<b>Asphalt</b>	
Deficiency Location/Instance	Near Building Exit
Deficiency Quantity	300
Quantity Uom	S.F.
Potential Action	REPAIR
Urgency of Action	PRIORITY 3
Purpose of Action	LEVEL 2
Deficiency Photo1

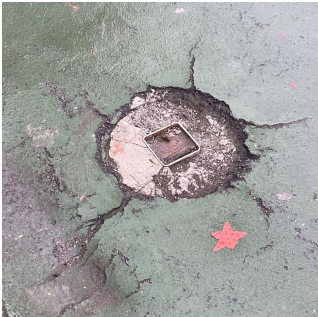
Priority Condition Exist Last Year?	Priority Category	Condition Description	Component Affected	Location Description	Person(s) Notified	Person(s) Title	PhotoImage
No	Tripping Hazard	Pothole is a potential tripping hazard.	SITE   PAVING   Student Use   Asphalt	Schoolyard	Hector Serrano	Fireman

Violations	Near Building Exit No violations recorded.
Deficiency	POTHOLES
Deficiency Location/Instance	Schoolyard
Deficiency Quantity	10
Quantity Uom	S.F.
Potential Action	REPAIR
Urgency of Action	PRIORITY 5
Purpose of Action	LEVEL 6
Deficiency Photo1
