NYC Department of Education
Building Condition Assessment Survey 2023 - 2024

Architectural Inspection

Asset: P.S. 319 - BROOKLYN, 360 KEAP STREET, New York, 11211

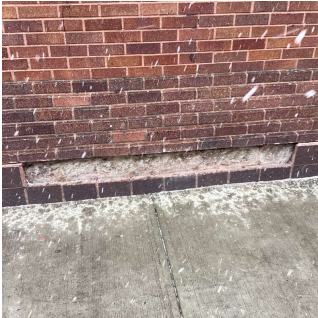
Question	Response
EXTERIOR	
DOORS	
DOOR HARDWARE	
Condition	1 - Good
Deficiency	No deficiencies recorded
LINTELS	Inspected
Condition	1 - Good
Deficiency	No deficiencies recorded
TRANSOM/SIDE LIGHT	Inspected
Condition	1 - Good
Deficiency	No deficiencies recorded
EXTERIOR WALLS	Inspected
Material Type(s)	Masonry
Replacement Quantity	12,000
Replacement Uom	S.F.
Instance on All Facades	Inspected
Instance Condition	3 - Fair
Instance Quantity	12,000
Instance Quantity Uom	S.F.
Deficiency	BRICK: MAJOR / THRU CRACKS
Roof Plan reference	 
Elevation	 
Deficiency Quantity	80
Quantity Uom	S.F.
Potential Action	REMOVE AND REBUILD
Urgency of Action	PRIORITY 4
Purpose of Action	LEVEL 2

Violations	Facade B No violations recorded.
EXTERIOR SOFFITS	Under Construction
LOADING DOCK	Does not Exist
LOUVER	Inaccessible
PARAPETS	Does not Exist
PLAZA DECK	Does not Exist
ROOF	Inspected
Roofing	Inspected
Replacement Quantity	12,000
Replacement Uom	S.F.
ROOF HATCH/SMOKE HATCH	Inspected
Condition	2 - Between Good and Fair
Deficiency	No deficiencies recorded
LEADERS, GUTTERS, DOWNSPOUTS, SCUPPERS	Does not Exist
ROOF BARRIER/FENCE	Does not Exist
ROOF CAGE	Does not Exist
ROOFING	Inspected
Instance on Modified Bitumen: Roof 1	Inspected
Instance Condition	1 - Good
Instance Photo

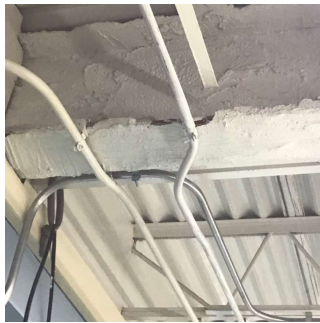
Condition	2 - Between Good and Fair
Deficiency	STEEL COLUMNS/BEAMS: DETERIORATED CONCRETE FIREPROOFING
Deficiency Location/Instance	Room 126A
Deficiency Quantity	10
Quantity Uom	S.F.
Potential Action	REPLACE
Urgency of Action	PRIORITY 3
Purpose of Action	LEVEL 5

Violations	Room 126A No violations recorded.
FLOOR STRUCTURE	
Condition	Inspected
Deficiency	3 - Fair
Deficiency Location/Instance	CONCRETE SLAB ON GRADE: THRU CRACKS
Deficiency Quantity	Gas Service Room
Quantity Uom	30
Potential Action	S.F.
Urgency of Action	REPAIR
Purpose of Action	PRIORITY 3
Deficiency Photo1	LEVEL 5

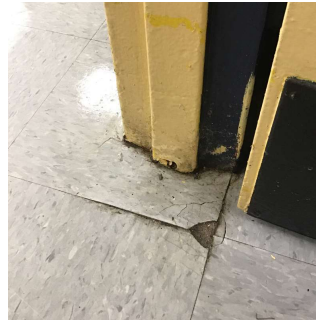
Question	Response
INTERIOR	
CLASSROOMS/CORRIDORS/ADMIN SPACES	
Door(s)	
Deficiency	WOOD: DETERIORATED DOOR
Deficiency Location/Instance	Room 126A
Deficiency Quantity	1
Quantity Uom	EACH
Potential Action	MAINTENANCE
Urgency of Action	PRIORITY 3
Purpose of Action	LEVEL 2
Deficiency Photo1	 
Violations	Room 126A No violations recorded.
Deficiency	METAL: DETERIORATED DOOR
Deficiency Location/Instance	Rooms 118, 131
Deficiency Quantity	2
Quantity Uom	EACH
Potential Action	MAINTENANCE
Urgency of Action	PRIORITY 3
Purpose of Action	LEVEL 2
Deficiency Photo1	 
Violations	Room 118 No violations recorded.
Deficiency	METAL: DETERIORATED DOOR AND FRAME
Deficiency Location/Instance	Teachers Lounge
Deficiency Quantity	1
Quantity Uom	EACH
Potential Action	MAINTENANCE
Urgency of Action	PRIORITY 3
Purpose of Action	LEVEL 2

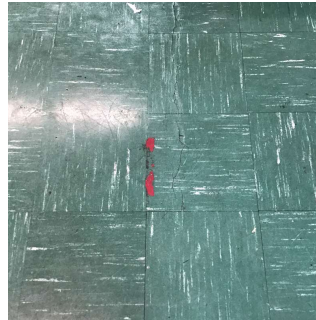
Room 120

VINYL TILES: DETERIORATED SUBSTRATE

Rooms 113A, 120, 126, Corridor near Rooms 101, 110

REPLACE

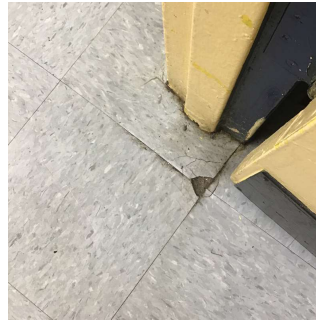
Teachers Lounge

VINYL TILES: BROKEN/DETERIORATED/MISSING TILES

Teachers Lounge, Rooms 110, 113A, 130, Corridor near Room 106, Room 110 Vestibule

REPLACE

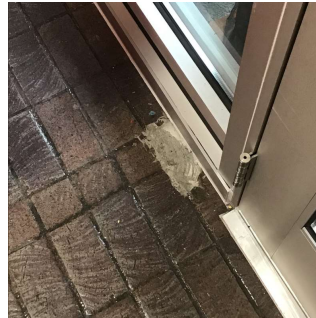
QUARRY TILE: BROKEN/MISSING TILES

Main Entrance Lobby

REPLACE

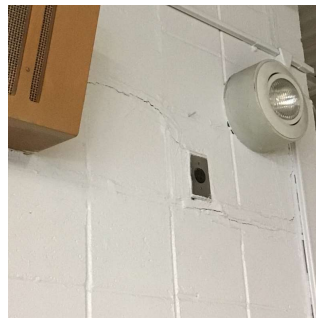
MASONRY: CRACKS/SPALLING

Rooms 110, 130

Question	Response
INTERIOR	
CLASSROOMS/CORRIDORS/ADMIN SPACES	
Walls	
Violations	Room 131 No violations recorded.
Deficiency	PLASTER: CRACKS/SPALLING
Deficiency Location/Instance	Corridor near Room 110
Deficiency Quantity	20
Quantity Uom	S.F.
Potential Action	REPLACE
Urgency of Action	PRIORITY 3
Purpose of Action	LEVEL 2
Deficiency Photo1	 
Violations	Corridor near Room 110 No violations recorded.
Specialties	Does not Exist
GYMNASIUM	Does not Exist
INTERIOR DOOR HARDWARE	Inspected
Condition	3 - Fair
Deficiency	No deficiencies recorded
INTERIOR GUARDS	Does not Exist
KITCHEN	Inspected
Instance on 1st Floor (300 SF)	Inspected
Ceiling	
Instance on 1st Floor (300 SF)	Inspected
Condition	4 - Between Fair and Poor
Deficiency	METAL PAN: DAMAGED/MISSING
Deficiency Location/Instance	Center
Deficiency Quantity	25
Quantity Uom	S.F.
Potential Action	REPLACE
Urgency of Action	PRIORITY 3
Purpose of Action	LEVEL 2
Deficiency Photo1

REPLACE

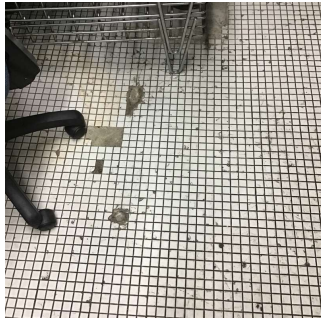
Question	Response
INTERIOR	
KITCHEN	
Ceiling	
Violations	Center No violations recorded.
Door(s)	
Instance on 1st Floor (300 SF)	Inspected
Condition	2 - Between Good and Fair
Deficiency	No deficiencies recorded
Floor Finish	
Instance on 1st Floor (300 SF)	Inspected
Condition	5 - Poor
Deficiency	CERAMIC TILE: BROKEN/MISSING TILES
Deficiency Location/Instance	Left Side, Right Side
Deficiency Quantity	50
Quantity Uom	S.F.
Potential Action	REPLACE
Urgency of Action	PRIORITY 3
Purpose of Action	LEVEL 2
Deficiency Photo1

Violations	Left Side No violations recorded.
Walls	
Instance on 1st Floor (300 SF)	Inspected
Condition	2 - Between Good and Fair
Deficiency	No deficiencies recorded
LIBRARY	Does not Exist
LOCKER ROOM	Does not Exist
MULTI-PURPOSE ROOM	Does not Exist
SCIENCE DEMO ROOM	Does not Exist
SCIENCE LAB	Does not Exist
SCIENCE PREP ROOM	Does not Exist
SHOWER ROOM	Does not Exist
STAIRS/RAMPS: INTERIOR	Does not Exist
TOILET ROOMS - STAFF	Inspected

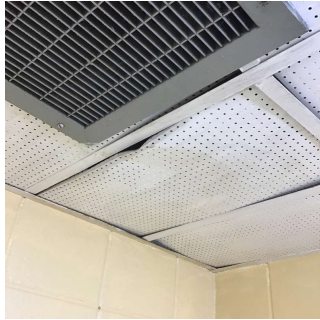
Ceiling	Inspected
Condition	5 - Poor
Deficiency	METAL PAN: DAMAGED/MISSING
Deficiency Location/Instance	1st Floor Men, 1st Floor Women
Deficiency Quantity	20
Quantity Uom	S.F.

Question	Response
INTERIOR	
TOILET ROOMS - STAFF	
Ceiling	
Potential Action	REPLACE
Urgency of Action	PRIORITY 3
Purpose of Action	LEVEL 2
Deficiency Photo1

1st Floor Men
Violations	No violations recorded.
Door(s)	Inspected
Condition	2 - Between Good and Fair
Deficiency	No deficiencies recorded
Floor Finish	Inspected
Condition	4 - Between Fair and Poor
Deficiency	CERAMIC TILE: BROKEN/MISSING TILES
Deficiency Location/Instance	1st Floor Women
Deficiency Quantity	10
Quantity Uom	S.F.
Potential Action	REPLACE
Urgency of Action	PRIORITY 3
Purpose of Action	LEVEL 2
Deficiency Photo1

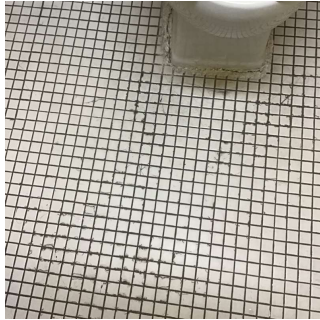
1st Floor Women
Violations	No violations recorded.
Stalls	Does not Exist
Walls	Inspected
Condition	2 - Between Good and Fair
Deficiency	MASONRY: CRACKS/SPALLING
Deficiency Location/Instance	1st Floor Men
Deficiency Quantity	10
Quantity Uom	S.F.
Potential Action	REPLACE
Urgency of Action	PRIORITY 3
Purpose of Action	LEVEL 2

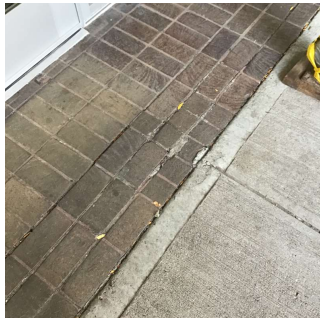
Question	Response
SITE	
PAVING	
Student Use	
Asphalt	
Deficiency Photo1	 
	Schoolyard
Violations	No violations recorded.
Concrete	Does not Exist
Pavers	Does not Exist
Site Sidewalks & Walkways	Inspected
Asphalt	Does not Exist
Concrete	Does not Exist
Pavers	Inspected
Condition	2 - Between Good and Fair
Deficiency	DAMAGED/MISSING
Deficiency Location/Instance	Keap Street
Deficiency Quantity	10
Quantity Uom	S.F.
Potential Action	REPLACE
Urgency of Action	PRIORITY 3
Purpose of Action	LEVEL 2
Deficiency Photo1

Keap Street
Violations	No violations recorded.
DOT Sidewalk	Inspected
Asphalt	Does not Exist
Concrete	Inspected
Condition	3 - Fair
Deficiency	DAMAGED CURBS
Deficiency Location/Instance	South 3rd Street
Deficiency Quantity	10
Quantity Uom	L.F.
Potential Action	REPLACE

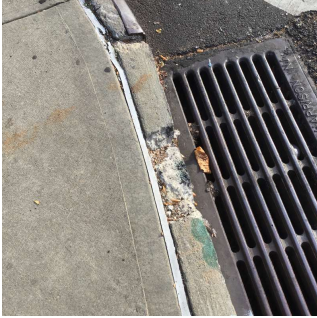
Question	Response
SITE	
PAVING	
DOT Sidewalk	
Concrete	
Urgency of Action	PRIORITY 3
Purpose of Action	LEVEL 2
Deficiency Photo1

South 3rd Street
Violations	No violations recorded.
Deficiency	DAMAGED/DETERIORATED/MISSING SECTIONS
Deficiency Location/Instance	South 3rd Street
Deficiency Quantity	175
Quantity Uom	S.F.
Potential Action	REPLACE
Urgency of Action	PRIORITY 3
Purpose of Action	LEVEL 2
Deficiency Photo1

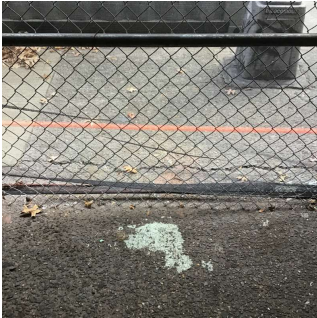
South 3rd Street
Violations	No violations recorded.
Deficiency	HEAVING
Deficiency Location/Instance	South 3rd Street
Deficiency Quantity	100
Quantity Uom	S.F.
Potential Action	REPLACE
Urgency of Action	PRIORITY 3
Purpose of Action	LEVEL 2
