**NYC Department of Education**  
**Building Condition Assessment Survey 2023 - 2024**

Architectural Inspection

**K328**

**Asset:** P.S. 328 - BROOKLYN, 330 ALABAMA AVENUE, New York, 11207

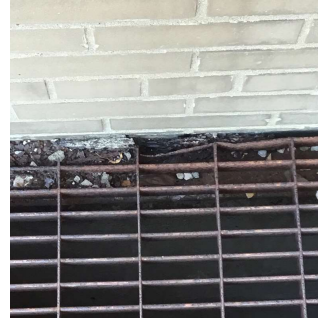
AW4

AREAWAY STAIRS: DETERIORATED TREADS/RISERS/NOSINGS

REPAIR

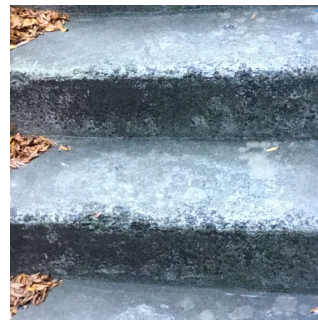
AW2

AREAWAY STAIRS: DETERIORATED MATERIAL SLIDE

REPLACE

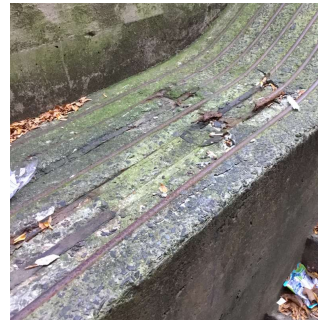
AW2

BRICK: DETERIORATED CAP

REPLACE

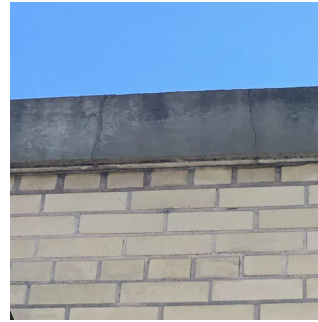
Chimney

**BRICK: DETERIORATED JOINTS**

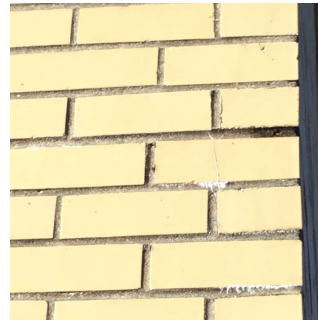
Chimney  
No violations recorded.

CAST STONE: DETERIORATED BED JOINT

80  
L.F.  
REPOINT  
PRIORITY 3  
LEVEL 2

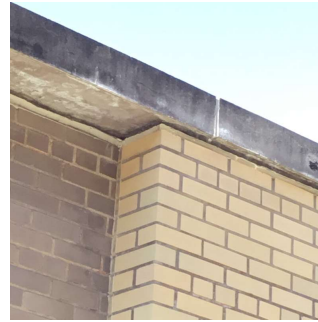
Roof 2 - Facade M

**CAST STONE: DETERIORATED TRANSVERSE JOINTS**

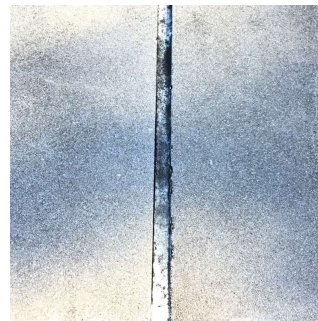
Roof 2

**CAST STONE: CRACKED/BROKEN PIECES**

10  
L.F.  
REPLACE-IN-KIND  
PRIORITY 4  
LEVEL 2

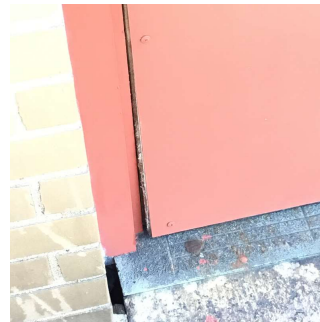
Facade K

**METAL: DETERIORATED DOOR AND FRAME - MAJOR DETERIORATION**

Deficiency Quantity	9
Quantity Uom	EACH
Potential Action	REPLACE
Urgency of Action	PRIORITY 4
Purpose of Action	LEVEL 2
Deficiency Photo1

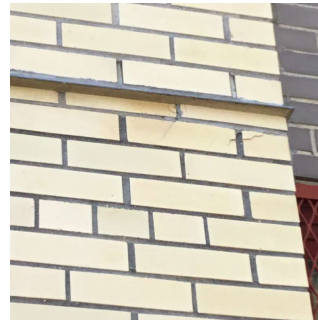
Facade A

**BRICK: DETERIORATED JOINTS**

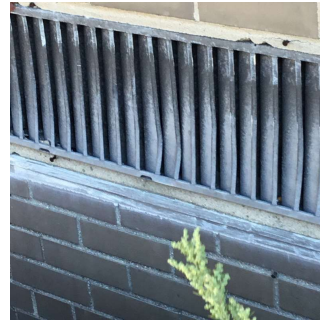
Facade K - Courtyard

MISSING/DAMAGED SCREEN

REPLACE

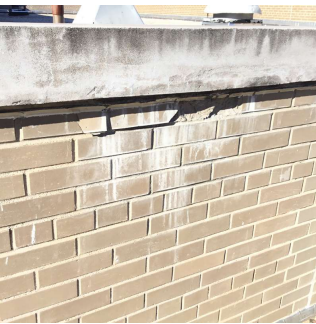
Question	Response
<b>EXTERIOR</b>	
<b>PARAPETS</b>	
Material Type(s)	Masonry, Metal
Replacement Quantity	1,600
Replacement Uom	C.F.
Instance on All Roofs	Inspected
Instance Condition	4 - Between Fair and Poor
Instance Quantity	1,600
Instance Quantity Uom	C.F.
Deficiency	BRICK: EFFLORESCENCE
Roof Plan reference

Deficiency Quantity	25
Quantity Uom	S.F.
Potential Action	MAINTENANCE
Urgency of Action	PRIORITY 1
Purpose of Action	LEVEL 1
Deficiency Photo1

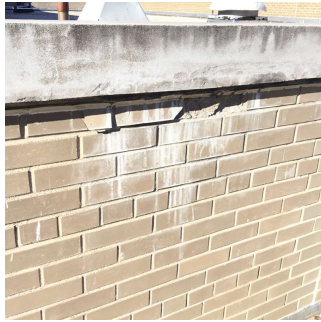
Violations	Roof 4 No violations recorded.
Deficiency	BRICK: MAJOR DETERIORATION/CRACKS
Roof Plan reference

Deficiency Quantity	25
Quantity Uom	S.F.
Potential Action	REMOVE AND REBUILD

Question	Response
<b>EXTERIOR</b>	
<b>PARAPETS</b>	
Urgency of Action	PRIORITY 4
Purpose of Action	LEVEL 2
Deficiency Photo1

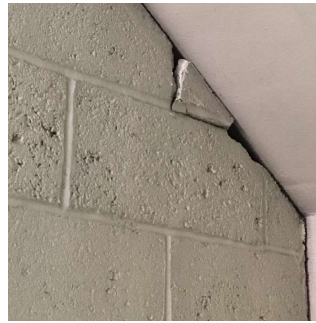
BH1

Inspected  
3 - Fair  
BULKHEAD/PENTHOUSE WALLS/INTERIOR: CMU  
CRACKS/SPALLING

10  
S.F.  
REPLACE

PRIORITY 4  
LEVEL 2

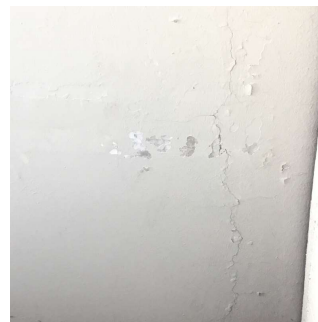
BH3  
No violations recorded.

**BULKHEAD/PENTHOUSE CEILING: PLASTER DAMAGED/DETERIORATED**

25  
S.F.  
REPLACE  
PRIORITY 3  
LEVEL 2

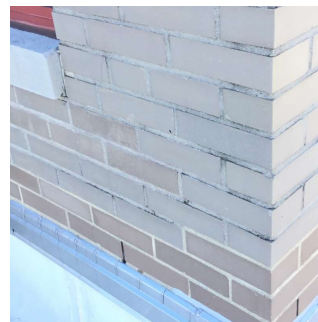
BH2  
No violations recorded.

**BULKHEAD/PENTHOUSE WALLS/EXTERIOR: DETERIORATED JOINTS**

30  
S.F.  
REPOINT  
PRIORITY 3  
LEVEL 2

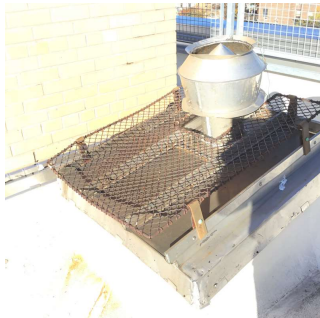
Violations	BH1 No violations recorded.
<b>CUPOLA/ SPIRES/ TOWERS</b>	Does not Exist
<b>DORMER</b>	Does not Exist
<b>DUNNAGE STEEL</b>	Does not Exist
<b>SKYLIGHT/ROOF VENT</b>	Inspected
Material Type(s)	Glass
Condition	3 - Fair
Deficiency	<b>DAMAGED GUARDS</b>
Roof Plan reference	K328

Deficiency Quantity	20
Quantity Uom	S.F.
Potential Action	MAINTENANCE
Urgency of Action	PRIORITY 3
Purpose of Action	LEVEL 2
Deficiency Photo1

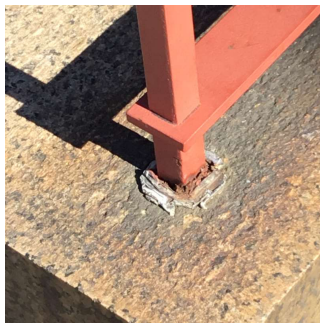
Violations	<p>Facade A</p> <p>No violations recorded.</p>
<b>RAILINGS</b>	
Condition	Inspected
Deficiency	3 - Fair
Roof Plan reference

Deficiency Quantity	10
Quantity Uom	L.F.
Potential Action	REPLACE
Urgency of Action	PRIORITY 4
Purpose of Action	LEVEL 2

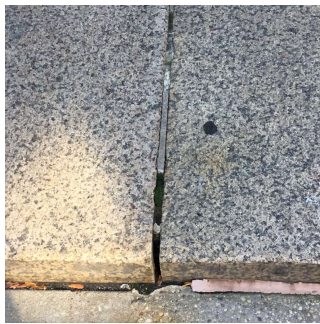
Violations	Facade K No violations recorded.
<b>STAIRS/RAMPS</b>	
Condition	Inspected 3 - Fair
Deficiency	<b>STONE: DETERIORATED JOINTS</b>
Roof Plan reference	K328

Deficiency Quantity	10
Quantity Uom	L.F.
Potential Action	REPOINT
Urgency of Action	PRIORITY 4
Purpose of Action	LEVEL 2
Deficiency Photo1

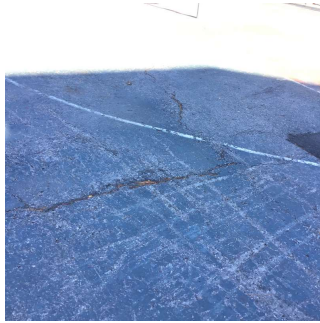
Violations	Schoolyard No violations recorded.
Deficiency	HEAVING
Deficiency Location/Instance	Schoolyard
Deficiency Quantity	250
Quantity Uom	S.F.
Potential Action	REPLACE
Urgency of Action	PRIORITY 5
Purpose of Action	LEVEL 6
Deficiency Photo1
