NYC Department of Education
Building Condition Assessment Survey 2023 - 2024

Architectural Inspection

Asset: P.S. 156 - BROOKLYN, 104 SUTTER AVENUE, New York, 11212

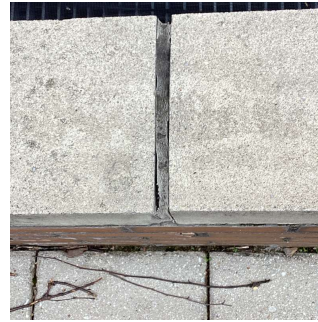
AW1

AREAWAY WALLS: DETERIORATED COPING STONE

REPLACE

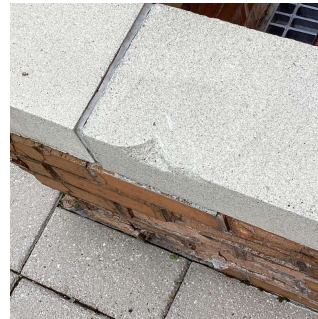
AW1

AREAWAY WALLS: CRACKS AND SPALLING

REPLACE

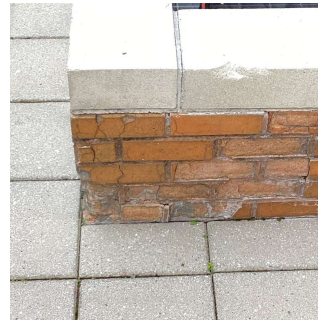
AW1

AREAWAY WALLS: DETERIORATED JOINTS AT COPING STONES

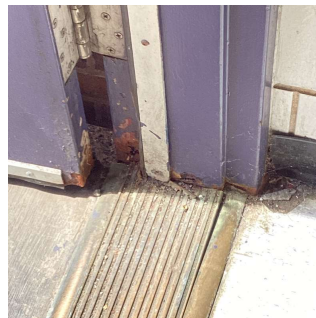
METAL: DETERIORATED DOOR AND FRAME - MAJOR DETERIORATION

REPLACE

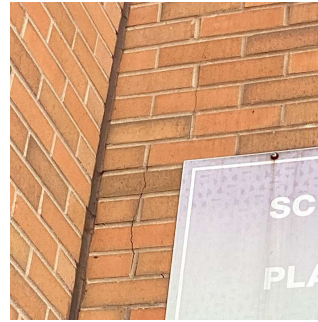
Facade H

Question	Response
EXTERIOR	
DOORS	
DOORS AND FRAMES	Inspected
	Facade C
Violations	No violations recorded.
DOOR HARDWARE	Inspected
Condition	3 - Fair
Deficiency	No deficiencies recorded
LINTELS	Inspected
Condition	2 - Between Good and Fair
Deficiency	No deficiencies recorded
TRANSOM/SIDE LIGHT	Inspected
Condition	2 - Between Good and Fair
Deficiency	No deficiencies recorded
EXTERIOR WALLS	Inspected
Material Type(s)	Masonry, Steel
Replacement Quantity	50,000
Replacement Uom	S.F.
Instance on All Facades	Inspected
Instance Condition	3 - Fair
Instance Quantity	50,000
Instance Quantity Uom	S.F.
Deficiency	BRICK: MINOR CRACKS AND SPALLING
Roof Plan reference

Deficiency Quantity	35
Quantity Uom	S.F.
Potential Action	RESTITCH
Urgency of Action	PRIORITY 3
Purpose of Action	LEVEL 2

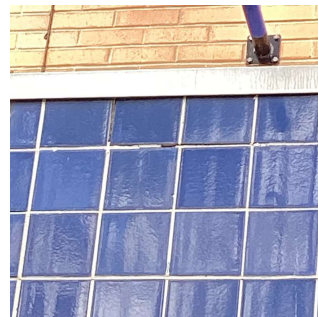
Facade B

CERAMIC TILE: DETERIORATED JOINTS

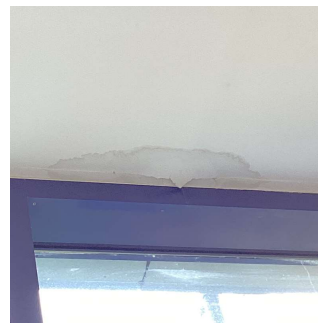
Facade A - Corridor near Room 223

METAL/GLASS CURT WALL: WATER INFILTRATION IN INSTRUCTIONAL SPACE

REPAIR

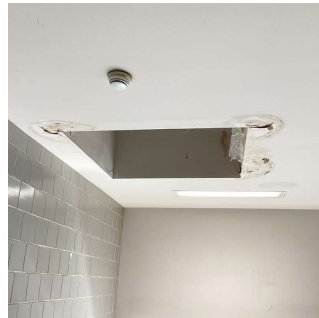
Question	Response
EXTERIOR	
PARAPETS	
Instance on All Roofs	Inspected
Instance Condition	2 - Between Good and Fair
Instance Quantity	10,000
Instance Quantity Uom	C.F.
Deficiency	No deficiencies recorded
PLAZA DECK	
	Does not Exist
ROOF	
	Inspected
Roofing	
	Inspected
Replacement Quantity	40,000
Replacement Uom	S.F.
ROOF HATCH/SMOKE HATCH	
	Inspected
Condition	5 - Poor
Deficiency	WATER INFILTRATION
Roof Plan reference

Violations	BH2 (BH1 similar) 35671911X
LEADERS, GUTTERS, DOWNSPOUTS, SCUPPERS	
	Inspected
Condition	2 - Between Good and Fair
Deficiency	No deficiencies recorded
ROOF BARRIER/FENCE	
	Inspected
Condition	2 - Between Good and Fair
Deficiency	No deficiencies recorded
ROOF CAGE	
	Does not Exist
ROOFING	
	Inspected
Instance on Built-Up: All Roofs except Roof 7	Inspected

Deficiency Quantity	2
Quantity Uom	EACH
Potential Action	REPAIR
Urgency of Action	PRIORITY 5
Purpose of Action	LEVEL 4
Deficiency Photo1

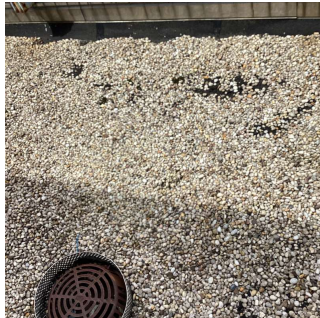
Roof 5
Violations	No violations recorded.
Deficiency	BUILT-UP: FLASHING: PITCH POCKET DETERIORATED - MINOR

Deficiency Quantity	50
Quantity Uom	S.F.
Potential Action	REPLACE ROOFING WITHOUT MAJOR EQUIPMENT REMOVAL
Urgency of Action	PRIORITY 4
Purpose of Action	LEVEL 2
Deficiency Photo1

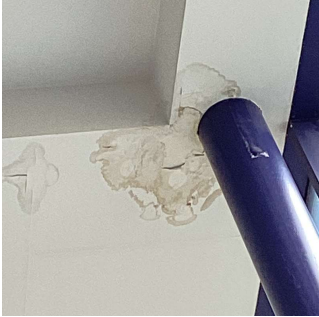
Roof 5 - Corridor near Room 223 (Roof 1 - Rooms 401B, 421, 422, Roof 2 - Auditorium, Stairwell C/2 similar)	No violations recorded.
Violations	
Instance on Metal: Roof 7	Inspected
Instance Condition	2 - Between Good and Fair

Deficiency Quantity	700
Quantity Uom	S.F.
Potential Action	REPLACE ROOFING WITHOUT MAJOR EQUIPMENT REMOVAL
Urgency of Action	PRIORITY 5
Purpose of Action	LEVEL 2
Deficiency Photo1

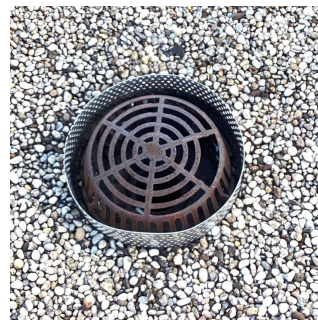
Roof 1

DETERIORATED

REPLACE

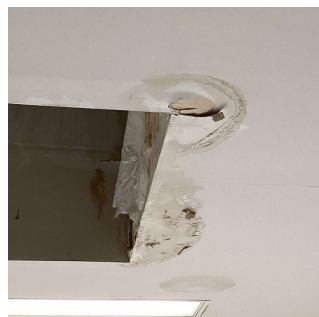
Question	Response
EXTERIOR	
ROOF	
Specialties	
BULKHEAD/PENTHOUSE	Inspected
Condition	5 - Poor
Deficiency	BULKHEAD/PENTHOUSE CEILING: GYPSUM BOARD DAMAGED/DETERIORATED
Roof Plan reference

Violations	BH2 No violations recorded.
Deficiency	BULKHEAD/PENTHOUSE ROOF: MAJOR LEAKAGE
Roof Plan reference

Deficiency Quantity	100
Quantity Uom	S.F.
Potential Action	REPLACE
Urgency of Action	PRIORITY 4
Purpose of Action	LEVEL 2
Deficiency Photo1

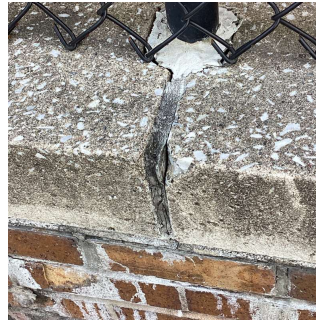
Facade B

BRICK: DETERIORATED COPING STONE

REPAIR

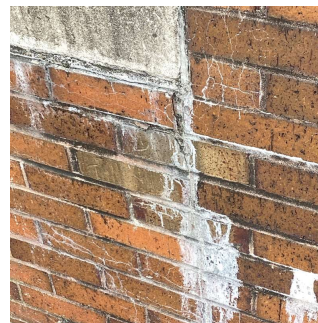
Facade B

BRICK: CRACKS/SPALLING - MINOR

REPAIR

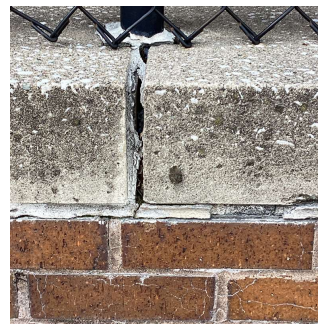
Facade B

BRICK: DETERIORATED JOINTS AT COPING STONES

25
 L.F.
 MAINTENANCE
 PRIORITY 3
 LEVEL 2

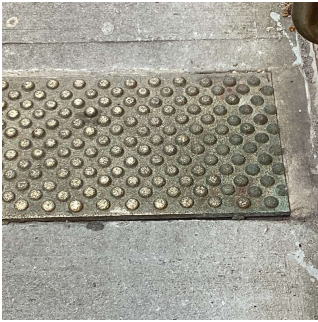
Violations	Facade B No violations recorded.
RAILINGS	Inspected
Condition	2 - Between Good and Fair
Deficiency	No deficiencies recorded
STAIRS/RAMPS	Inspected
Condition	3 - Fair
Deficiency	CONCRETE: WORN-OUT TREAD/RISER/NOSING
Roof Plan reference

Violations	Main Entrance Ramp No violations recorded.
Deficiency	STONE: DETERIORATED JOINTS

Deficiency Quantity	10
Quantity Uom	S.F.
Potential Action	REPLACE
Urgency of Action	PRIORITY 4
Purpose of Action	LEVEL 2
Deficiency Photo1

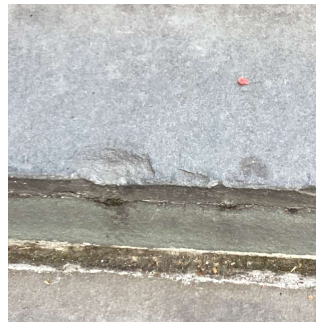
Facade A

STONE: CRACKS/SPALLING - MINOR

10
S.F.
REPAIR
PRIORITY 3
LEVEL 2

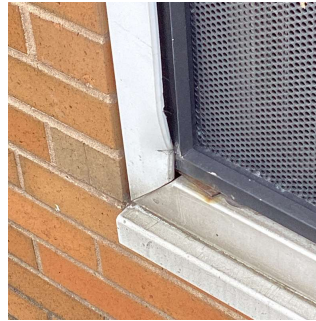
Facade G

DETERIORATED/TORN-OUT/MISSING

REPLACE

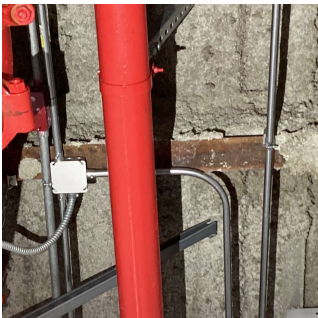
Question	Response
INTERIOR	
STRUCTURAL	Inspected
COLUMNS/BEAMS/BEARING WALLS	Inspected
Condition	3 - Fair
Deficiency	STEEL COLUMNS/BEAMS: DETERIORATED/MISSING SPRAY-ON FIREPROOFING
Deficiency Location/Instance	Basement, 1st Floor
Deficiency Quantity	40
Quantity Uom	S.F.
Potential Action	REPLACE
Urgency of Action	PRIORITY 3
Purpose of Action	LEVEL 5
Deficiency Photo1

Violations	Room 139 (Boiler Room similar) No violations recorded.
FLOOR STRUCTURE	Inspected
Condition	3 - Fair
Deficiency	CONCRETE SLAB ON GRADE: THRU CRACKS
Deficiency Location/Instance	Basement, 1st Floor
Deficiency Quantity	290
Quantity Uom	S.F.
Potential Action	REPAIR
Urgency of Action	PRIORITY 3
Purpose of Action	LEVEL 5
Deficiency Photo1

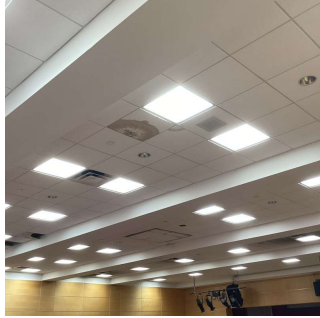
Question	Response
INTERIOR	
AUDITORIUM	
Ceiling	
Potential Action	REPLACE
Urgency of Action	PRIORITY 5
Purpose of Action	LEVEL 2
Deficiency Photo1

Center
Violations	No violations recorded.
Deficiency	GYPSON BOARD: DAMAGED/DETERIORATED
Deficiency Location/Instance	Near Windows, Right Side Stage, Center
Deficiency Quantity	50
Quantity Uom	S.F.
Potential Action	REPLACE
Urgency of Action	PRIORITY 3
Purpose of Action	LEVEL 2
Deficiency Photo1

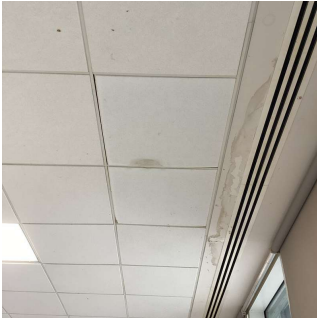
Question	Response
INTERIOR	
CAFETERIA	
Ceiling	
Deficiency	ACOUSTIC TILES: DAMAGED/MISSING
Deficiency Location/Instance	Near Windows
Deficiency Quantity	20
Quantity Uom	S.F.
Potential Action	REPLACE
Urgency of Action	PRIORITY 3
Purpose of Action	LEVEL 2
Deficiency Photo1

Violations	Near Windows No violations recorded.
Instance on Room 130	Inspected
Condition	2 - Between Good and Fair
Deficiency	ACOUSTIC TILES: DAMAGED/MISSING
Deficiency Location/Instance	Center
Deficiency Quantity	10
Quantity Uom	S.F.
Potential Action	REPLACE
Urgency of Action	PRIORITY 3
Purpose of Action	LEVEL 2
Deficiency Photo1	 
Violations	Center No violations recorded.
Instance on Room 131	Inspected
Condition	2 - Between Good and Fair
Deficiency	GYPSON BOARD: DAMAGED/DETERIORATED
Deficiency Location/Instance	Near Windows
Deficiency Quantity	30
Quantity Uom	S.F.
Potential Action	REPLACE
Urgency of Action	PRIORITY 3
Purpose of Action	LEVEL 2

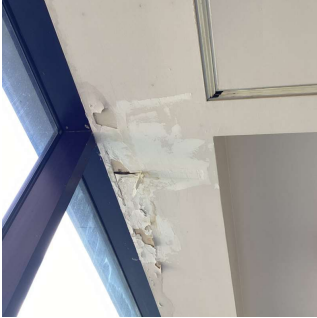
Question	Response
INTERIOR	
CLASSROOMS/CORRIDORS/ADMIN SPACES	
Ceiling	
Condition	2 - Between Good and Fair
Deficiency	GYPSUM BOARD: DAMAGED/DETERIORATED - ACTIVE LEAK
Deficiency Location/Instance	Corridor near Room 223
Deficiency Quantity	80
Quantity Uom	S.F.
Potential Action	REPLACE
Urgency of Action	PRIORITY 5
Purpose of Action	LEVEL 2
Deficiency Photo1

Violations	Corridor near Room 223 No violations recorded.
Deficiency	ACOUSTIC TILES: DAMAGED/MISSING
Deficiency Location/Instance	Room 422
Deficiency Quantity	20
Quantity Uom	S.F.
Potential Action	REPLACE
Urgency of Action	PRIORITY 5
Purpose of Action	LEVEL 6
Deficiency Photo1	 
Violations	Room 422 No violations recorded.
Deficiency	ACOUSTIC TILES: DAMAGED/MISSING - ACTIVE LEAK
Deficiency Location/Instance	Rooms 422, 421, 401B
Deficiency Quantity	50
Quantity Uom	S.F.
Potential Action	REPLACE
Urgency of Action	PRIORITY 5
Purpose of Action	LEVEL 2

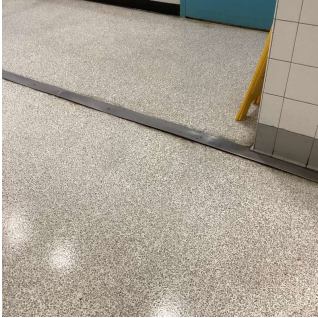
Violations	Corridor near Exit 3 No violations recorded.
Door(s)	Inspected
Condition	2 - Between Good and Fair
Deficiency	No deficiencies recorded
Floor Finish	Inspected
Condition	2 - Between Good and Fair
Deficiency	TERRAZZO: CRACKS
Deficiency Location/Instance	Corridor near Exit 2
Deficiency Quantity	10
Quantity Uom	S.F.
Potential Action	REPLACE
Urgency of Action	PRIORITY 5
Purpose of Action	LEVEL 6
Deficiency Photo1

Violations	Corridor near Exit 2 No violations recorded.
Deficiency	VINYL TILES: BROKEN/DETERIORATED/MISSING TILES
Deficiency Location/Instance	Room 221, Corridor near Room 313

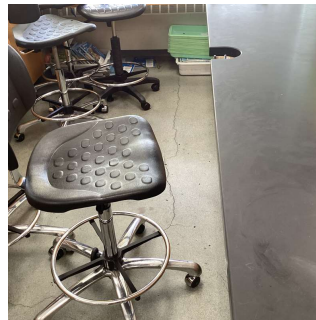
EPOXY FLOORING: CRACKS/SPALLING
Room 421
150
S.F.
REPLACE
PRIORITY 3
LEVEL 2

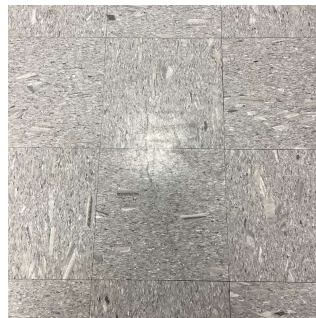
VINYL TILES: DETERIORATED SUBSTRATE
Rooms 116, 105, 102, Corridor near Rooms 418, 105 and others
220
S.F.
REPLACE
PRIORITY 3
LEVEL 2
