**NYC Department of Education**  
**Building Condition Assessment Survey 2023 - 2024**

Architectural Inspection

**Asset: I.S. 364 - BROOKLYN, 1426 FREEPORT LOOP, New York, 11239**

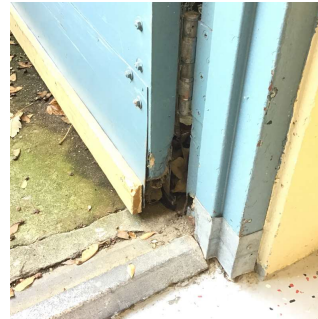
Facade A

METAL CLAD: DETERIORATED DOOR AND FRAME - MAJOR DETERIORATION

REPLACE

PRIORITY 4

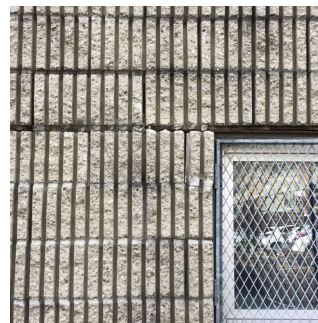
Facade B

CAST IN PLACE / PRE-CAST CONCRETE: MAJOR CRACKS/SPALLING

REPLACE

PRIORITY 4

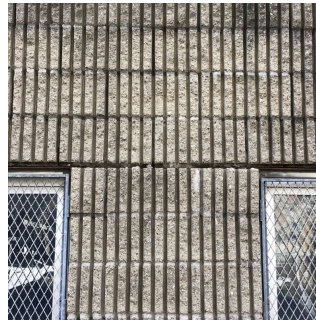
Facade B

CAST IN PLACE / PRE-CAST CONCRETE: DETERIORATED JOINTS

REPOINT

PRIORITY 3

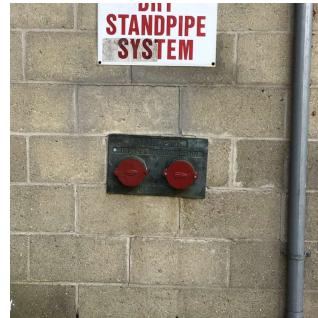
Facade A

CONCRETE MASONRY UNIT: MINOR CRACKS AND SPALLING

10  
S.F.  
RESTITCH  
PRIORITY 3  
LEVEL 2

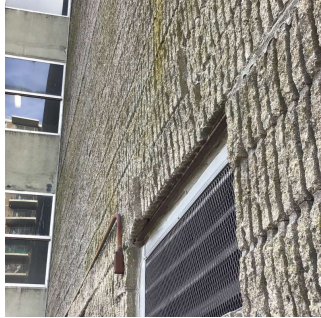
**CAST IN PLACE / PRE-CAST CONCRETE: MAJOR  
CRACKS/SPALLING**

Facade C
Violations	No violations recorded.
<b>EXTERIOR SOFFITS</b>	
Condition	Inspected
Deficiency	2 - Between Good and Fair
	No deficiencies recorded
<b>LOADING DOCK</b>	
	Does not Exist
<b>LOUVER</b>	
Condition	Inspected
Deficiency	3 - Fair
Roof Plan reference	<b>BROKEN/ DENTED BLADES</b>

Question	Response
<b>EXTERIOR</b>	
<b>EXTERIOR WALLS</b>	
Potential Action	REPLACE
Urgency of Action	PRIORITY 4
Purpose of Action	LEVEL 2
Deficiency Photo1

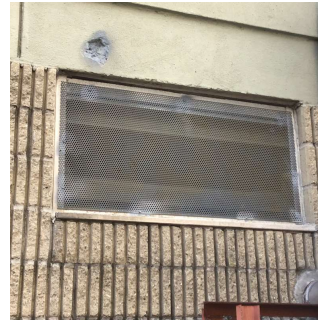
Facade B

**LOUVER**

Deficiency Quantity	20
Quantity Uom	S.F.
Potential Action	REPLACE
Urgency of Action	PRIORITY 4
Purpose of Action	LEVEL 2

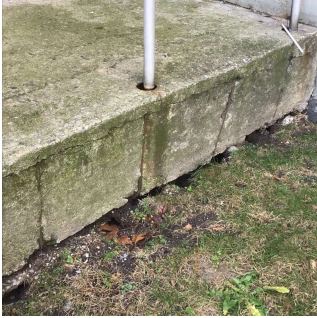
Deficiency	CAST IN PLACE CONCRETE: CRACKS/SPALLING - MAJOR
Roof Plan reference

Violations	Facade C No violations recorded.
Deficiency	CAST IN PLACE CONCRETE: CRACKS/SPALLING - MINOR
Roof Plan reference	K364

Question	Response
<b>EXTERIOR</b>	
<b>STAIRS/RAMPS: EXTERIOR</b>	
<b>BUILDING CHEEK/FLANK WALLS</b>	
Potential Action	REPLACE
Urgency of Action	PRIORITY 4
Purpose of Action	LEVEL 2
Deficiency Photo1

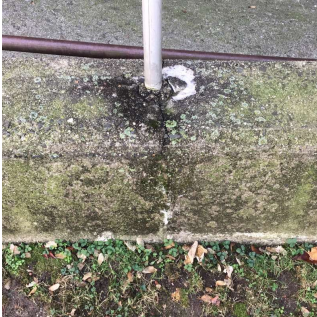
Violations	Facade A No violations recorded.
<b>RAILINGS</b>	
Condition	Inspected
Deficiency	3 - Fair MISSING RAILING

Deficiency Quantity	20
Quantity Uom	S.F.
Potential Action	REPAIR
Urgency of Action	PRIORITY 3
Purpose of Action	LEVEL 2
Deficiency Photo1

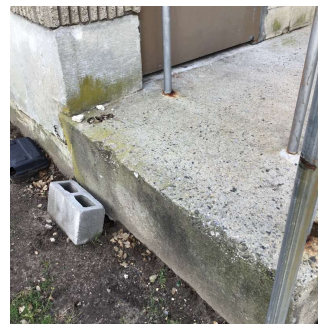
Facade A  
No violations recorded.

10  
L.F.  
REPLACE  
PRIORITY 5  
LEVEL 6

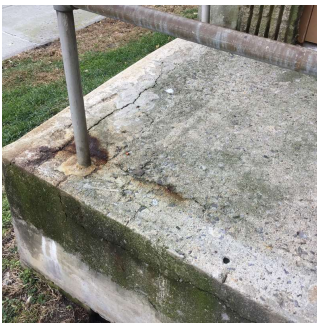
CONCRETE: CRACKS/SPALLING - MAJOR

Violations	Facade C No violations recorded.
<b>WINDOWS</b>	Inspected
Replacement Quantity	1,100
Replacement Uom	S.F.
<b>EXTERIOR GUARDS</b>	Inspected
Condition	2 - Between Good and Fair
Deficiency	No deficiencies recorded
<b>LINTELS</b>	Inspected
Condition	2 - Between Good and Fair
Deficiency	No deficiencies recorded
<b>WINDOWS</b>	Inspected
Material Type(s)	Aluminum
Instance on Aluminum - Other: Leased Spaces	Inspected
Instance Condition	1 - Good
Instance Quantity	400
Instance Quantity Uom	S.F.
Are these windows insulated	Yes
Installation Year	2016
Source of Installation	Custodial Staff
Deficiency	No deficiencies recorded
Instance on Aluminum - Other: Stairwells	Inspected
Instance Condition	3 - Fair
Instance Quantity	700
Instance Quantity Uom	S.F.
Are these windows insulated	No
Installation Year	1975
Source of Installation	Custodial Staff

100  
S.F.  
REPLACE  
PRIORITY 4  
LEVEL 2

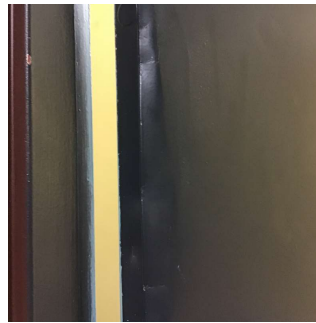
Room 120

Question	Response
<b>INTERIOR</b>	
<b>CAFETERIA</b>	
<b>Walls</b>	
Purpose of Action	LEVEL 2
Deficiency Photo1	 
	Near Entrance
Violations	No violations recorded.
<b>Window Curtains/Shades/Blinds</b>	
Instance on 1st Floor - Students (1,700 SF)	Does not Exist
Instance on 1st Floor - Staff (900 SF)	Does not Exist
<b>CLASSROOMS/CORRIDORS/ADMIN SPACES</b>	
<b>Ceiling</b>	Inspected
Condition	2 - Between Good and Fair
Deficiency	ACOUSTIC TILES: DAMAGED/MISSING
Deficiency Location/Instance	Corridor near cafeteria, 127,118,104, Room 119, and others
Deficiency Quantity	80
Quantity Uom	S.F.
Potential Action	REPLACE
Urgency of Action	PRIORITY 3
Purpose of Action	LEVEL 2
Deficiency Photo1	 
	Corridor near cafeteria
Violations	No violations recorded.
<b>Door(s)</b>	
Condition	5 - Poor
Deficiency	METAL: DETERIORATED DOOR
Deficiency Location/Instance	Room 120,116,101
Deficiency Quantity	3
Quantity Uom	EACH
Potential Action	MAINTENANCE

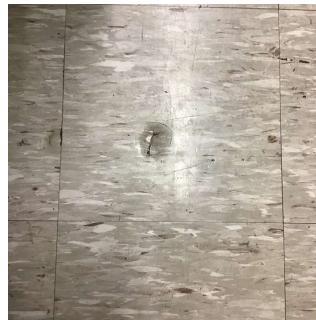
Room 120

VINYL TILES: BROKEN/DETERIORATED/MISSING TILES

REPLACE

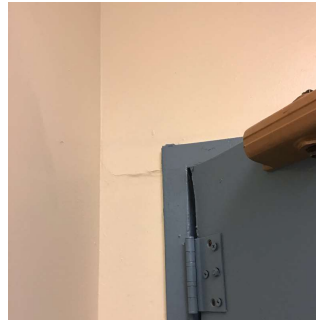
Exit 1

PLASTER: CRACKS/SPALLING

REPLACE

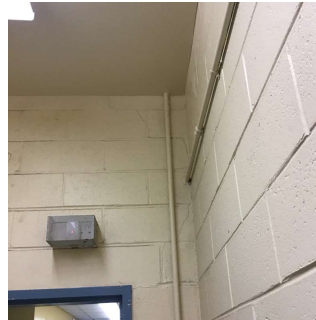
Exit 2

MASONRY: CRACKS/SPALLING

REPLACE

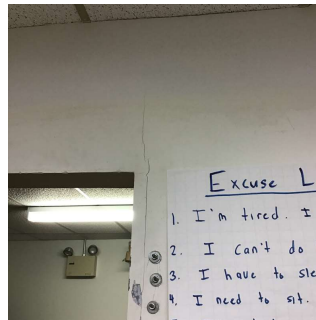
Near cafeteria

GYPSUM BOARD: DETERIORATED

REPLACE

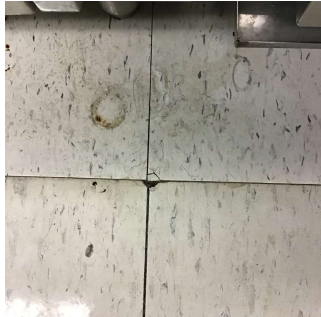
Instance on 1st Floor (600 SF)	Inspected
Condition	2 - Between Good and Fair
Deficiency	VINYL TILES: BROKEN/DETERIORATED/MISSING TILES
Deficiency Location/Instance	Near center
Deficiency Quantity	10
Quantity Uom	S.F.
Potential Action	REPLACE
Urgency of Action	PRIORITY 3
Purpose of Action	LEVEL 2
Deficiency Photo1

Violations	Near center No violations recorded.
------------	--

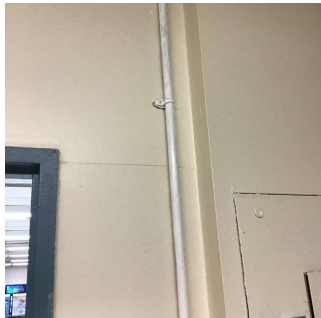
Instance on 1st Floor (600 SF)	Inspected
Condition	2 - Between Good and Fair
Deficiency	GYPSUM BOARD: DETERIORATED
Deficiency Location/Instance	Near Entrance
Deficiency Quantity	10
Quantity Uom	S.F.
Potential Action	REPLACE
Urgency of Action	PRIORITY 3
Purpose of Action	LEVEL 2
Deficiency Photo1

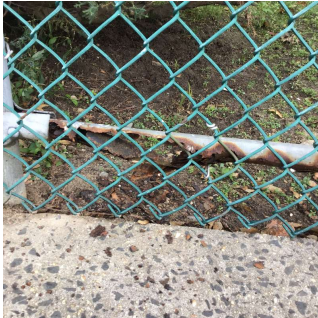
<b>Culverts - Soil Covering</b>	Does not Exist
<b>DRINKING FOUNTAINS</b>	Does not Exist
<b>FENCES</b>	Inspected
Condition	4 - Between Fair and Poor
Deficiency	CHAIN LINK: DAMAGED POST/RAIL
Deficiency Location/Instance	Along Freeport Loop
Deficiency Quantity	30
Quantity Uom	L.F.
Potential Action	REPLACE
Urgency of Action	PRIORITY 3
Purpose of Action	LEVEL 2

Violations	Along Freeport Loop No violations recorded.
Deficiency	CHAIN LINK: DAMAGED/DETERIORATED
Deficiency Location/Instance	Schoolyard
Deficiency Quantity	600
Quantity Uom	S.F.
Potential Action	REPLACE
Urgency of Action	PRIORITY 3
Purpose of Action	LEVEL 2
Deficiency Photo1

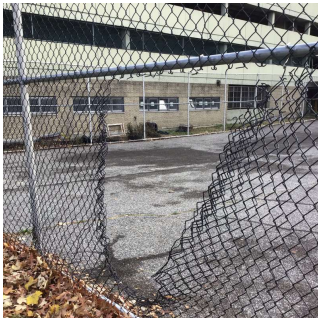
Violations	Schoolyard No violations recorded.
<b>IRRIGATION SYSTEM</b>	Does not Exist
<b>PAVING</b>	Inspected
<b>Student Non-Use</b>	Does not Exist
<b>Student Use</b>	Inspected
Gravel Exists?	No
<b>Asphalt</b>	Inspected
Condition	4 - Between Fair and Poor
Deficiency	CRACKS - MAJOR
Deficiency Location/Instance	Schoolyard
Deficiency Quantity	4,000
Quantity Uom	S.F.
Potential Action	REPLACE
Urgency of Action	PRIORITY 3
Purpose of Action	LEVEL 2
