**NYC Department of Education**  
**Building Condition Assessment Survey 2023 - 2024**

Architectural Inspection

**K366**

**Asset:**            **SHIRLEY CHISHOLM CAMPUS - K, 965 EAST 107TH STREET, New York, 11236**

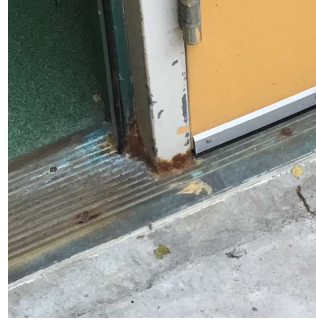
Facade F

Question	Response
<b>Architectural</b>	
<b>EXTERIOR</b>	Inspected
<b>AREAWAY</b>	Does not Exist
<b>AWNINGS AND CANOPIES</b>	Inspected
Condition	2 - Between Good and Fair
Deficiency	No deficiencies recorded
<b>CHIMNEY</b>	Inspected
Material Type(s)	Metal
Condition	2 - Between Good and Fair
Deficiency	No deficiencies recorded
<b>COPING</b>	Inspected
Condition	2 - Between Good and Fair
Deficiency	No deficiencies recorded
<b>CORNICE</b>	Does not Exist
<b>DOORS</b>	Inspected
<b>DOORS AND FRAMES</b>	Inspected
Condition	3 - Fair
Deficiency	METAL: DETERIORATED DOOR AND FRAME - MINOR DETERIORATION
Roof Plan reference

MAINTENANCE  
 PRIORITY 3  
 LEVEL 2

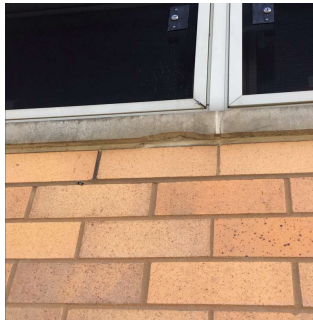
Facade A

BRICK: DETERIORATED MASONRY SILLS - MINOR

REPAIR

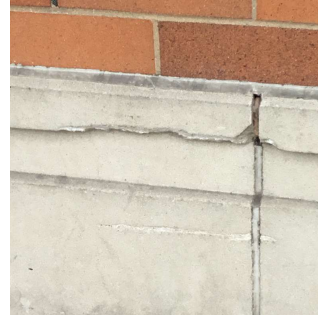
Facade A

CAST IN PLACE / PRE-CAST CONCRETE: MAJOR  
 CRACKS/SPALLING

REPLACE  
PRIORITY 4  
LEVEL 2

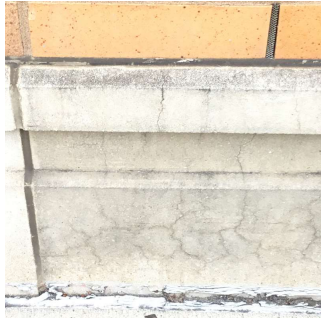
CAST IN PLACE / PRE-CAST CONCRETE: MINOR  
CRACKS/SPALLING

130  
S.F.  
REPAIR  
PRIORITY 3  
LEVEL 2

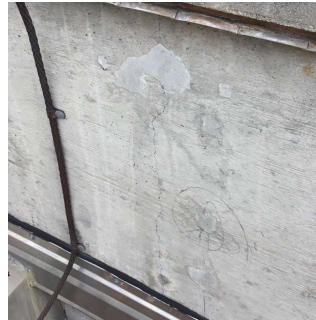
Roof 4

Facade A
Violations	No violations recorded.
<b>EXTERIOR SOFFITS</b>	Inspected
Condition	2 - Between Good and Fair
Deficiency	No deficiencies recorded
<b>LOADING DOCK</b>	Does not Exist
<b>LOUVER</b>	Inspected
Condition	2 - Between Good and Fair
Deficiency	No deficiencies recorded
<b>PARAPETS</b>	Inspected
Material Type(s)	Concrete
Replacement Quantity	2,200
Replacement Uom	C.F.
Instance on All Roofs	Inspected
Instance Condition	3 - Fair
Instance Quantity	2,200
Instance Quantity Uom	C.F.
Deficiency	CONCRETE: MINOR CRACKS, SPALLING
Roof Plan reference

Deficiency Quantity	325
Quantity Uom	S.F.
Potential Action	REPAIR
Urgency of Action	PRIORITY 3
Purpose of Action	LEVEL 2

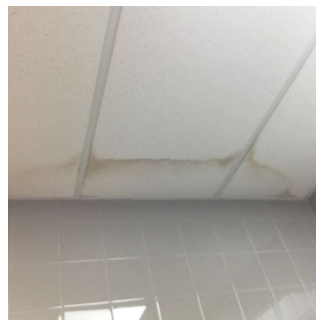
Roof 3 - Room B21B

CONCRETE: MAJOR ACTIVE PLAZA DECK LEAKS IN INSTRUCTIONAL SPACE

REPLACE

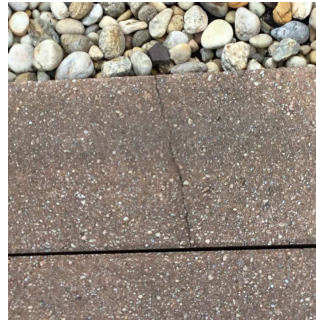
Roof 1

Instance Quantity	7,500
Instance Quantity Uom	S.F.
Installation Year	2009
Source of Installation	Custodial Staff
Deficiency	PAVERS: PAVERS IN POOR CONDITION
Roof Plan reference	K366

Deficiency Quantity	10
Quantity Uom	S.F.
Potential Action	REPLACE
Urgency of Action	PRIORITY 4
Purpose of Action	LEVEL 2
Deficiency Photo1

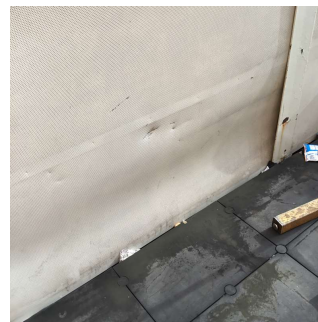
Deficiency	RAILINGS/PANELS: DETERIORATED, MAJOR RUSTING
------------	--

35  
S.F.  
REPLACE  
PRIORITY 4  
LEVEL 2

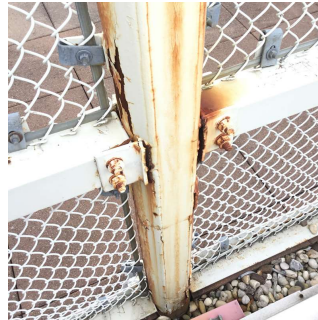
Roof 1 -Plaza Deck

STEEL FRAME: MAJOR RUSTING

100  
S.F.  
REPAIR  
PRIORITY 4  
LEVEL 2

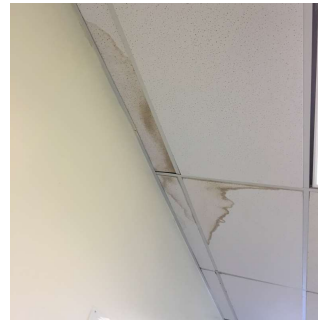
Roof 4 - Room 417 (Roof 4 - Library, Rooms 420, Roof 5 - Room 401, Roof 6 - Room 402 similar)

IRMA: ROOFING: MAJOR ACTIVE ROOF LEAKS IN INSTRUCTIONAL SPACE

REPLACE ROOFING WITHOUT MAJOR EQUIPMENT REMOVAL

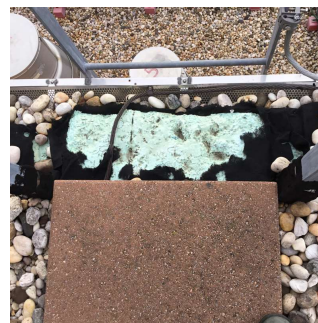
BH1

IRMA: ROOFING: DAMAGED INSULATION

REPLACE

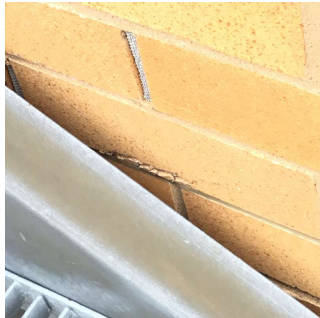
Violations	Roof 5 No violations recorded.
<b>Specialties</b>	Inspected
<b>BULKHEAD/PENTHOUSE</b>	Inspected
Condition	2 - Between Good and Fair
Deficiency	BULKHEAD/PENTHOUSE WALLS/EXTERIOR: CRACKS/SPALLING - MINOR
Roof Plan reference	K366

Deficiency Quantity	10
Quantity Uom	S.F.
Potential Action	REPAIR
Urgency of Action	PRIORITY 3
Purpose of Action	LEVEL 2
Deficiency Photo1

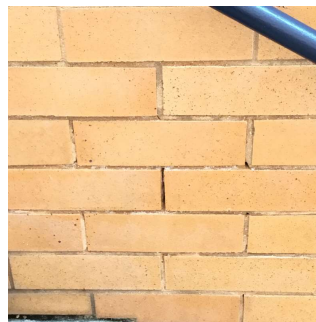
Facade F

BRICK: DETERIORATED JOINTS

10  
 S.F.  
 REPOINT  
 PRIORITY 4  
 LEVEL 2

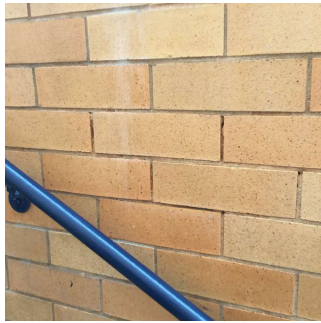
BRICK: DETERIORATED JOINTS

25  
 S.F.  
 REPOINT  
 PRIORITY 3  
 LEVEL 2

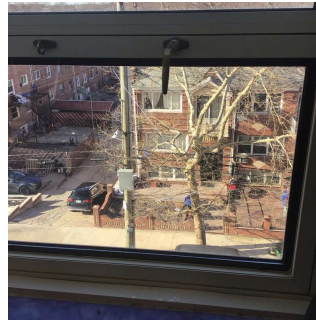
Facade A - Room 321

Question	Response
<b>EXTERIOR</b>	
<b>WINDOWS</b>	
<b>EXTERIOR GUARDS</b>	Inspected
Condition	2 - Between Good and Fair
Deficiency	No deficiencies recorded
<b>LINTELS</b>	Inspected
Condition	2 - Between Good and Fair
Deficiency	No deficiencies recorded
<b>WINDOWS</b>	Inspected
Material Type(s)	Aluminum
Instance on Aluminum - Other: All Facades	Inspected
Instance Condition	3 - Fair
Instance Quantity	3,500
Instance Quantity Uom	S.F.
Are these windows insulated	Yes
Installation Year	2009
Source of Installation	Custodial Staff
Deficiency	ALUMINUM - OTHER: BROKEN PANE
Roof Plan reference	K366

30  
S.F.  
MAINTENANCE  
PRIORITY 3  
LEVEL 2

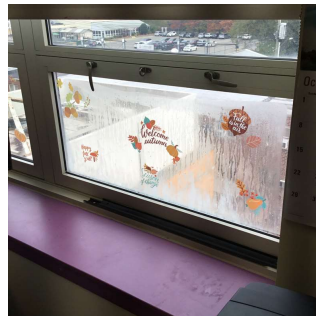
Facade E - Room 318

ALUMINUM - OTHER: DETERIORATED

REPLACE WINDOW

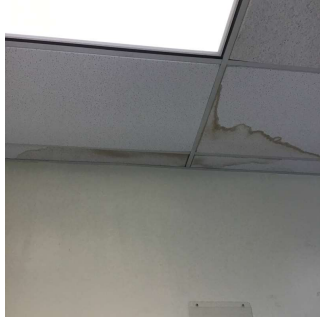
Violations	Corridor near Room 404 No violations recorded.
Deficiency	ACOUSTIC TILES: DAMAGED/MISSING - ACTIVE LEAK
Deficiency Location/Instance	Room 401, 417
Deficiency Quantity	40
Quantity Uom	S.F.
Potential Action	REPLACE
Urgency of Action	PRIORITY 5
Purpose of Action	LEVEL 2
Deficiency Photo1

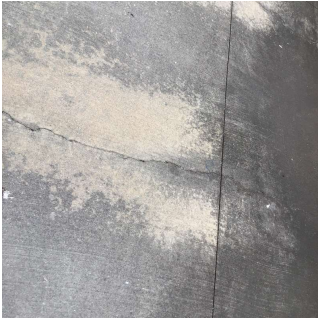
Question	Response
<b>SITE</b>	
<b>FENCES</b>	Inspected
Deficiency	No deficiencies recorded
<b>IRRIGATION SYSTEM</b>	Does not Exist
<b>PAVING</b>	Inspected
<b>Student Non-Use</b>	Inspected
Gravel Exists?	No
<b>Asphalt</b>	Does not Exist
<b>Concrete</b>	Inspected
Condition	2 - Between Good and Fair
Deficiency	No deficiencies recorded
<b>Pavers</b>	Does not Exist
<b>Student Use</b>	Does not Exist
<b>Site Sidewalks &amp; Walkways</b>	Inspected
<b>Asphalt</b>	Does not Exist
<b>Concrete</b>	Inspected
Condition	3 - Fair
Deficiency	CRACKS - MAJOR
Deficiency Location/Instance	Near 1st Floor Plaza Deck
Deficiency Quantity	100
Quantity Uom	S.F.
Potential Action	REPLACE
Urgency of Action	PRIORITY 3
Purpose of Action	LEVEL 2
Deficiency Photo1
