NYC Department of Education
Building Condition Assessment Survey 2023 - 2024

Architectural Inspection

Asset: P.S. 369 (COY COX SCHOOL) - K, 383 STATE STREET, New York, 11217

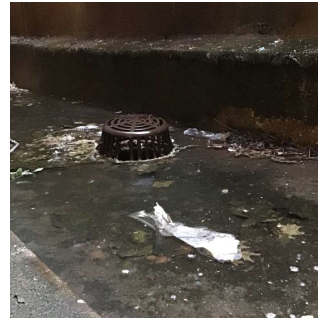
AW1

Question	Response
Architectural	
EXTERIOR	Inspected
AREAWAY	Inspected
Instance on AW1-3	Inspected
Instance Condition	4 - Between Fair and Poor
Instance Quantity	3
Instance Quantity Uom	EACH
Deficiency	AREAWAY DRAINS: CLOGGED
Roof Plan reference	K369
Deficiency Quantity	2
Quantity Uom	EACH
Potential Action	MAINTENANCE

PRIORITY 5
LEVEL 2

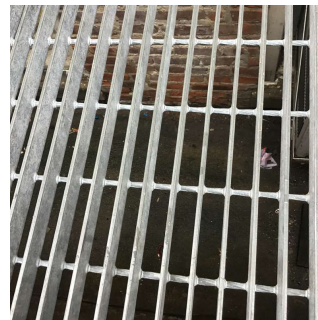
AW1, AW2 water Infiltration

AREAWAY WALLS: DETERIORATED JOINTS

150
S.F.
REPAIR
PRIORITY 3
LEVEL 2

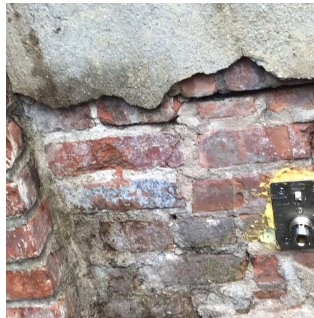
Facade D

Question	Response
EXTERIOR	
DOORS	
DOORS AND FRAMES	
Roof Plan reference	
Deficiency Quantity	2
Quantity Uom	EACH
Potential Action	REPLACE
Urgency of Action	PRIORITY 4
Purpose of Action	LEVEL 2
Deficiency Photo1	
Violations	Doors 1, 5 No violations recorded.
DOOR HARDWARE	Inspected
Condition	3 - Fair
Deficiency	No deficiencies recorded
LINTELS	Inspected
Condition	2 - Between Good and Fair
Deficiency	No deficiencies recorded
TRANSOM/SIDE LIGHT	Inspected
Condition	2 - Between Good and Fair
Deficiency	No deficiencies recorded
EXTERIOR WALLS	Inspected
Material Type(s)	Masonry
Replacement Quantity	27,000
Replacement Uom	S.F.
Instance on All Facades Except Facade A	Inspected
Instance Condition	3 - Fair
Instance Quantity	20,000
Instance Quantity Uom	S.F.
Deficiency	BRICK: MINOR CRACKS AND SPALLING

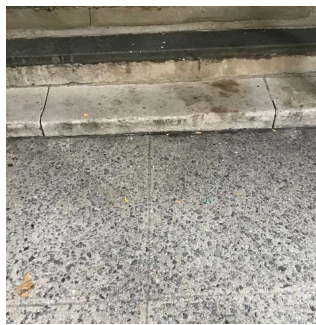
Facade A Door 3

Question	Response
EXTERIOR	
ROOF	
Specialties	
BULKHEAD/PENTHOUSE	
Condition	3 - Fair
Deficiency	BULKHEAD/PENTHOUSE CEILING: PLASTER DAMAGED/DETERIORATED
Roof Plan reference	<p>K369</p> <p>Schermerhorn Street</p> <p>State Street</p> <p>Main Entrance</p> <p>AW1, AW2, CH1, CH2, BH1, BH2, J, K, A, ZW3, 1922, 1938</p>
Deficiency Quantity	50
Quantity Uom	S.F.
Potential Action	REPLACE
Urgency of Action	PRIORITY 3
Purpose of Action	LEVEL 2
Deficiency Photo1	<p>Bulk Head 2 - Ceiling</p>
Violations	No violations recorded.
CUPOLA/ SPIRES/ TOWERS	Does not Exist
DORMER	Does not Exist
DUNNAGE STEEL	Does not Exist
SKYLIGHT/ROOF VENT	Does not Exist
ROOF/GRAVITY TANK	Does not Exist
STAIRS/RAMPS: EXTERIOR	Inspected
BUILDING CHEEK/FLANK WALLS	Does not Exist
RAILINGS	Does not Exist
STAIRS/RAMPS	Inspected
Condition	3 - Fair
Deficiency	STONE: DETERIORATED JOINTS

10
L.F.
REPOINT
PRIORITY 3
LEVEL 2

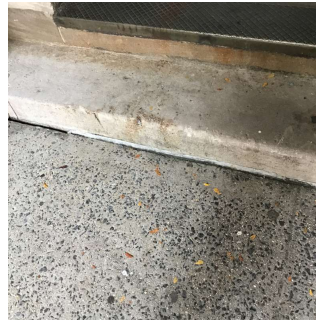
facade A Main Entry Door, Doors 2, 3
No violations recorded.

STONE: WORN-OUT TREAD/RISER/NOSING

10
S.F.
REPLACE
PRIORITY 4
LEVEL 2

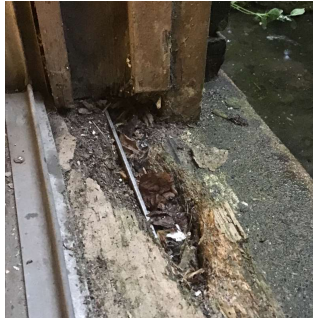
Facade G

WOOD: DETERIORATED

REPLACE WINDOW

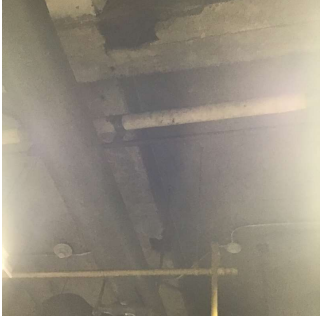
Question	Response
INTERIOR	
STRUCTURAL	
COLUMNS/BEAMS/BEARING WALLS	
Violations	Boiler Room 2 No violations recorded.
Deficiency	STEEL COLUMNS/BEAMS: DETERIORATED CONCRETE FIREPROOFING
Deficiency Location/Instance	Boiler Room 2
Deficiency Quantity	30
Quantity Uom	S.F.
Potential Action	REPLACE
Urgency of Action	PRIORITY 3
Purpose of Action	LEVEL 5
Deficiency Photo1

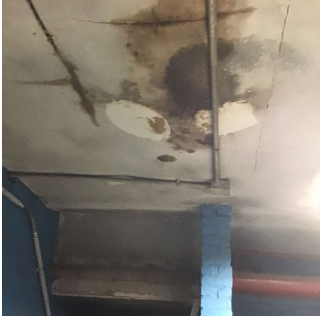
Violations	Boiler Room 2 No violations recorded.
FLOOR STRUCTURE	
Condition	Inspected 4 - Between Fair and Poor
Deficiency	WOOD: DETERIORATED/DAMAGED
Deficiency Location/Instance	Boiler Room 1
Deficiency Quantity	100
Quantity Uom	S.F.
Potential Action	REPLACE
Urgency of Action	PRIORITY 3
Purpose of Action	LEVEL 5
Deficiency Photo1

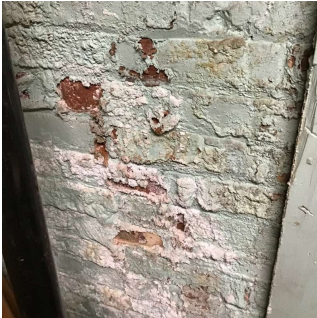
Violations	Cafeteria No violations recorded.
FOUNDATION WALLS	
Material Type(s)	Inspected Masonry
Condition	4 - Between Fair and Poor
Deficiency	BRICK: WATER INFILTRATION IN NON- INSTRUCTIONAL SPACE
Deficiency Location/Instance	Basement Storage Room
Deficiency Quantity	100
Quantity Uom	S.F.
Potential Action	INSTALL WATERPROOFING
Urgency of Action	PRIORITY 5
Purpose of Action	LEVEL 5
Deficiency Photo1

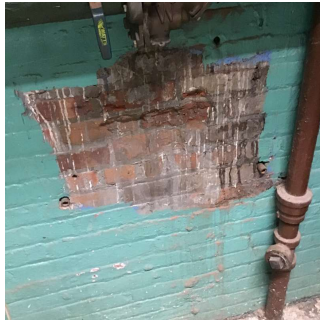
Violations	Basement Storage Room No violations recorded.
Deficiency	BRICK: CRACKED/SPALLED
Deficiency Location/Instance	Boiler Room 1
Deficiency Quantity	100
Quantity Uom	S.F.
Potential Action	RESTITCH
Urgency of Action	PRIORITY 3
Purpose of Action	LEVEL 5
Deficiency Photo1

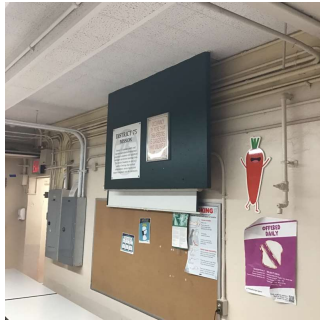
Question	Response
INTERIOR	
CAFETERIA	
Fixed Equipment	
Instance on Basement (2000sf)	Inspected
Condition	3 - Fair
Deficiency	DAMAGED/MISSING
Deficiency Location/Instance	Rear
Deficiency Quantity	1
Quantity Uom	EACH
Potential Action	MAINTENANCE
Urgency of Action	PRIORITY 3
Purpose of Action	LEVEL 2
Deficiency Photo1

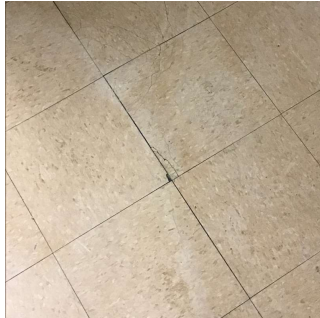
Violations	Rear No violations recorded.
Floor Finish	
Instance on Basement (2000sf)	Inspected
Condition	2 - Between Good and Fair
Deficiency	VINYL TILES: BROKEN/DETERIORATED/MISSING TILES
Deficiency Location/Instance	Center
Deficiency Quantity	10
Quantity Uom	S.F.
Potential Action	REPLACE
Urgency of Action	PRIORITY 3
Purpose of Action	LEVEL 2
Deficiency Photo1

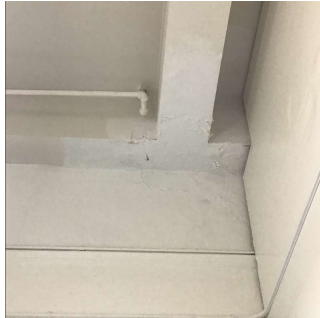
Violations	Center No violations recorded.
Window Curtains/Shades/Blinds	
Instance on Basement (2000sf)	Does not Exist
CLASSROOMS/CORRIDORS/ADMIN SPACES	
Ceiling	Inspected
Condition	2 - Between Good and Fair
Deficiency	PLASTER: CRACKS/SPALLING
Deficiency Location/Instance	Room 103, 201, 307
Deficiency Quantity	35
Quantity Uom	S.F.
Potential Action	REPLACE
Urgency of Action	PRIORITY 3
Purpose of Action	LEVEL 2
Deficiency Photo1

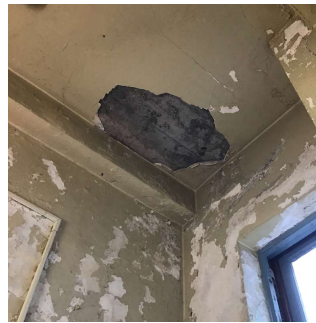
No	Potential Falling Debris	Loose plaster ceiling creates a potential hazardous condition	INTERIOR CLASSROOMS /CORRIDORS/ ADMIN SPACES Ceiling	Room 301- Storage Room	Rohan Depunt	Handyman
No	Potential Falling Debris	Loose plaster creates a potential hazardous condition.	INTERIOR STAIRS/RAMP S: INTERIOR Ceiling	Stair B/1	Rohan Depunt	Handyman
No	Protruding Elements	Missing seat crates a potential hazardous condition.	SITE PLAYGROUN DS Play Equipment	Schoolyard	Rohan Depunt	Handyman
No	Tripping Hazard	Heaving DOT sidewalk creates a potential hazardous condition.	SITE PAVING DOT Sidewalk Concrete	State Street	Rohan Depunt	Handyman
Yes	Damaged/Deteriorated Railings	Broken Bracket at end of Handrail creates a potential hazardous condition	INTERIOR STAIRS/RAMP S: INTERIOR Railings	Stair A/2	Rohan Depunt	Handyman
Yes	Potential Falling Debris	Severely damaged fence creates a potential hazardous condition.	SITE FENCES	Schoolyard East side	Rohan Depunt	Handyman

Violations	Room 103 No violations recorded.
Deficiency	PLASTER: CRACKS/SPALLING
Deficiency Location/Instance	Room 301 - Storage Room
Deficiency Quantity	20
Quantity Uom	S.F.
Potential Action	REPLACE
Urgency of Action	PRIORITY 5
Purpose of Action	LEVEL 6

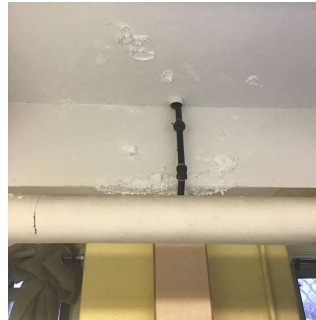
Near Windows

PLASTER: CRACKS/SPALLING - ACTIVE LEAK

REPLACE

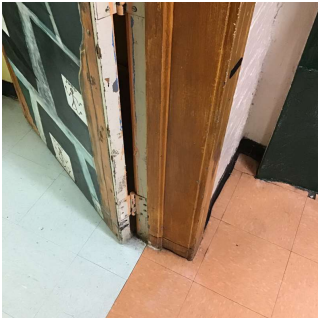
Question	Response
INTERIOR	
CLASSROOMS/CORRIDORS/ADMIN SPACES	
Door(s)	
Violations	Room B1 No violations recorded.
Deficiency	WOOD: DETERIORATED DOOR AND FRAME
Deficiency Location/Instance	Room B1, 103
Deficiency Quantity	2
Quantity Uom	EACH
Potential Action	MAINTENANCE
Urgency of Action	PRIORITY 3
Purpose of Action	LEVEL 2
Deficiency Photo1

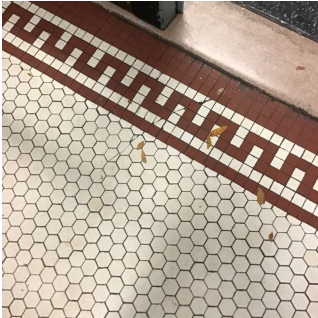
Violations	Room B1 No violations recorded.
Floor Finish	Inspected
Condition	5 - Poor
Deficiency	CERAMIC TILE: BROKEN/MISSING TILES
Deficiency Location/Instance	Main Entrance Vestibule
Deficiency Quantity	50
Quantity Uom	S.F.
Potential Action	REPLACE
Urgency of Action	PRIORITY 3
Purpose of Action	LEVEL 2
Deficiency Photo1

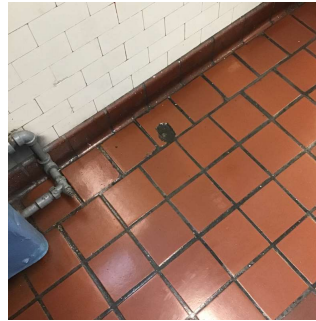
Violations	Me No violations recorded.
Deficiency	QUARRY TILE: BROKEN/MISSING TILES
Deficiency Location/Instance	Corridor near Room 301 , 202
Deficiency Quantity	50
Quantity Uom	S.F.
Potential Action	REPLACE
Urgency of Action	PRIORITY 3
Purpose of Action	LEVEL 2

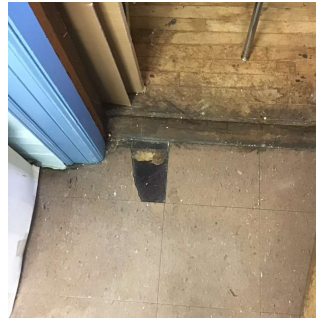
Room 301

VINYL TILES: BROKEN/DETERIORATED/MISSING TILES

REPLACE

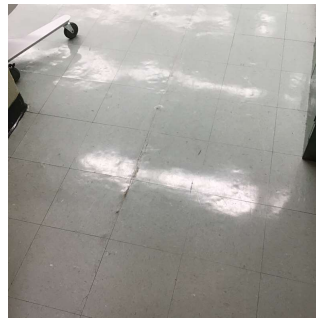
Room B1

VINYL TILES: DETERIORATED SUBSTRATE

REPLACE

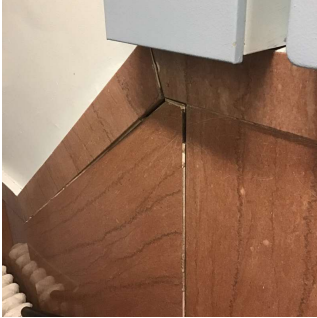
Question	Response
INTERIOR	
CLASSROOMS/CORRIDORS/ADMIN SPACES	
Walls	Inspected
Condition	2 - Between Good and Fair
Deficiency	STONE: CRACKS/SPALLING
Deficiency Location/Instance	Main Entrance Vestibule
Deficiency Quantity	25
Quantity Uom	S.F.
Potential Action	REPLACE
Urgency of Action	PRIORITY 3
Purpose of Action	LEVEL 2
Deficiency Photo1

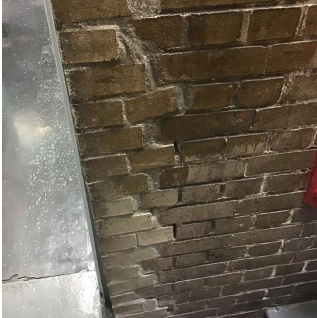
Violations	Main Entrance Vestibule No violations recorded.
Deficiency	BRICK: CRACKS/SPALLING
Deficiency Location/Instance	Corridor near Room 200
Deficiency Quantity	15
Quantity Uom	S.F.
Potential Action	REPLACE
Urgency of Action	PRIORITY 3
Purpose of Action	LEVEL 2
Deficiency Photo1

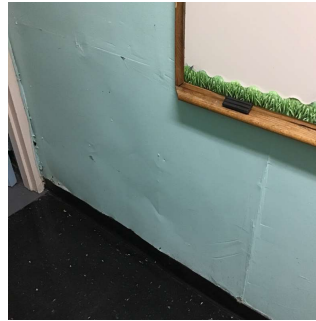
Violations	Corridor near Room 200 No violations recorded.
Deficiency	GYPSUM BOARD: DETERIORATED
Deficiency Location/Instance	Corridor near Room 200
Deficiency Quantity	50
Quantity Uom	S.F.
Potential Action	REPLACE
Urgency of Action	PRIORITY 3
Purpose of Action	LEVEL 2

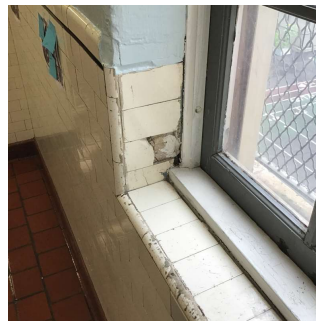
Corridor near Room 304

CERAMIC TILE: BROKEN/ MISSING

REPLACE

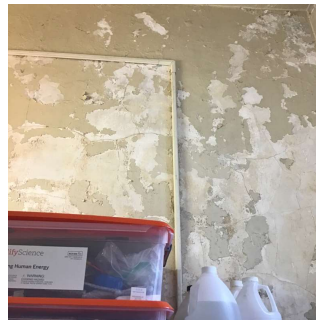
Room 301 - Storage Room

PLASTER: CRACKS/SPALLING

REPLACE

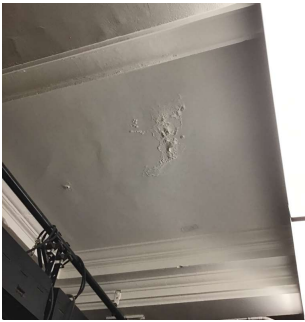
Question	Response
INTERIOR	
CLASSROOMS/CORRIDORS/ADMIN SPACES	Inspected
Specialties	Does not Exist
GYMNASIUM	Inspected
Instance on 1st Floor (2000sf)	Inspected
Ceiling	
Instance on 1st Floor (2000sf)	Inspected
Condition	2 - Between Good and Fair
Deficiency	PLASTER: CRACKS/SPALLING
Deficiency Location/Instance	Center
Deficiency Quantity	15
Quantity Uom	S.F.
Potential Action	REPLACE
Urgency of Action	PRIORITY 3
Purpose of Action	LEVEL 2
Deficiency Photo1

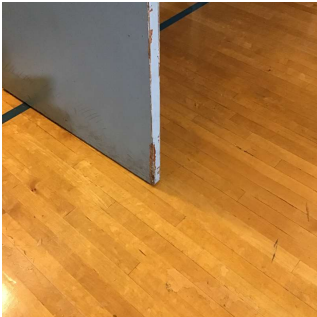
Center
Violations	No violations recorded.
Door(s)	
Instance on 1st Floor (2000sf)	Inspected
Condition	4 - Between Fair and Poor
Deficiency	WOOD: DETERIORATED DOOR
Deficiency Location/Instance	Office
Deficiency Quantity	2
Quantity Uom	EACH
Potential Action	MAINTENANCE
Urgency of Action	PRIORITY 3
Purpose of Action	LEVEL 2
Deficiency Photo1

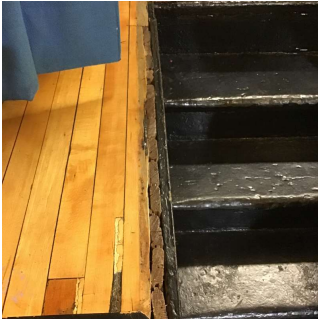
Question	Response
INTERIOR	
GYMNASIUM	
Stage	
Stage	
Violations	Left side No violations recorded.
Deficiency	DAMAGED FLOOR
Deficiency Location/Instance	Right side
Deficiency Quantity	25
Quantity Uom	S.F.
Potential Action	REPLACE
Urgency of Action	PRIORITY 3
Purpose of Action	LEVEL 2
Deficiency Photo1

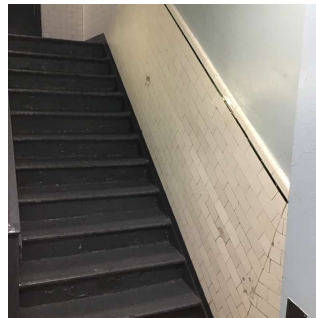
Yes	Tripping Hazard	Severely damaged and rusted metal stair support creates a potential hazardous condition.	INTERIOR STAIRS/RAMP S: INTERIOR Stairs and Landings	Stair A/Basement	Rohan Depunt	Handyman

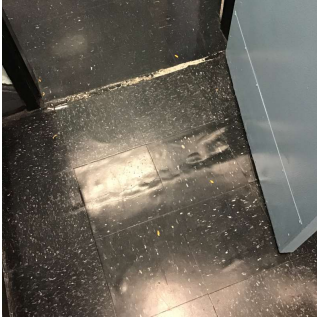
Question	Response
INTERIOR	
STAIRS/RAMPS: INTERIOR	
Stairs and Landings	Inspected
Condition	5 - Poor
Deficiency	VINYL TILES: DETERIORATED SUBSTRATE
Deficiency Location/Instance	Stair C/2
Deficiency Quantity	10
Quantity Uom	S.F.
Potential Action	REPLACE
Urgency of Action	PRIORITY 3
Purpose of Action	LEVEL 2
Deficiency Photo1

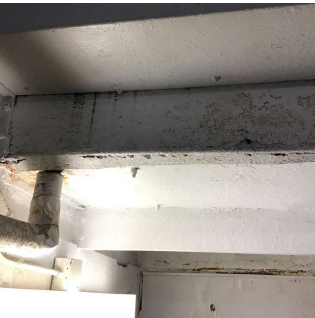
Question	Response
INTERIOR	
STAIRS/RAMPS: INTERIOR	
Stairs and Landings	
Deficiency Photo1 Violations	  Stair A/Basement No violations recorded.
Deficiency Deficiency Location/Instance Deficiency Quantity Quantity Uom Potential Action Urgency of Action Purpose of Action Deficiency Photo1 Violations	METAL: RUST - MAJOR Stair A/Basement 10 S.F. REPLACE PRIORITY 5 LEVEL 6

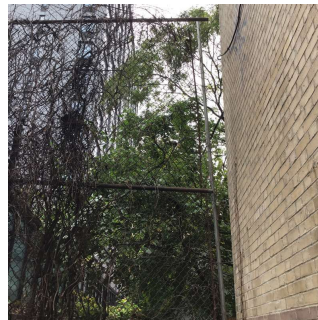
Schoolyard- East side

CHAIN LINK: DAMAGED/DETERIORATED
Schoolyard East side
300
S.F.
REPLACE
PRIORITY 5
LEVEL 6

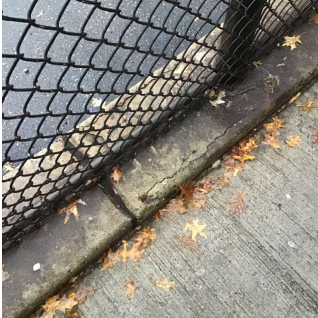
Violations	Near Playground No violations recorded.
Deficiency	CONCRETE CURB: DAMAGED/DETERIORATED
Deficiency Location/Instance	Schermerhorn Street
Deficiency Quantity	60
Quantity Uom	S.F.
Potential Action	REPLACE
Urgency of Action	PRIORITY 3
Purpose of Action	LEVEL 2
Deficiency Photo1

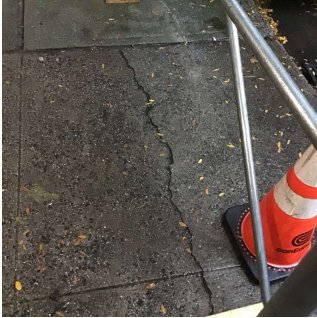
Violations	State Street No violations recorded.
Deficiency	HEAVING
Deficiency Location/Instance	State Street
Deficiency Quantity	50
Quantity Uom	S.F.
Potential Action	REPLACE
Urgency of Action	PRIORITY 3
Purpose of Action	LEVEL 2
Deficiency Photo1

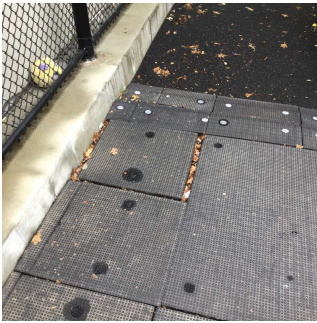
Yes	Protruding Elements	Missing Bench sections creates a potential hazardous condition.	SITE SEATING Benches Metal/Wood/Plastic	Schoolyard	Rohan Depunt	Handyman
Yes	Tripping Hazard	Large gap in safety surfacing creates a potential tripping hazard.	SITE PLAYGROUN DS Safety Surfacing	Near planter	Rohan Depunt	Handyman
