**NYC Department of Education**  
**Building Condition Assessment Survey 2023 - 2024**

Architectural Inspection

**Asset:** P.S. 377 - BROOKLYN, 200 WOODBINE STREET, New York, 11221

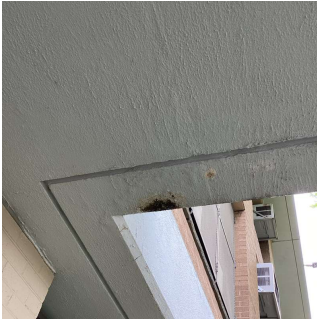
Deficiency Roof Plan reference CONCRETE: MAJOR CRACKS/SPALLING K377

Deficiency Quantity 10  
 Quantity Uom S.F.  
 Potential Action REPAIR  
 Urgency of Action PRIORITY 4  
 Purpose of Action LEVEL 2

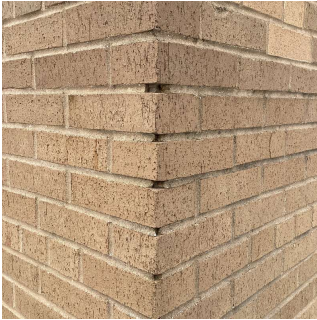
Violations	Facade A No violations recorded.
<b>CHIMNEY</b>	
Material Type(s)	Inspected Masonry
Condition	2 - Between Good and Fair
Deficiency	BRICK: DETERIORATED JOINTS
Roof Plan reference	K377

Deficiency Quantity	10
Quantity Uom	S.F.
Potential Action	REPOINT
Urgency of Action	PRIORITY 3
Purpose of Action	LEVEL 2
Deficiency Photo1

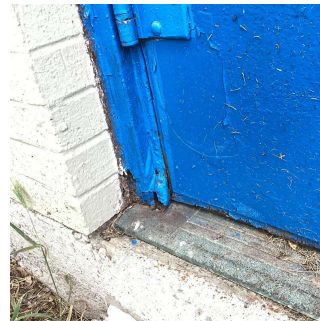
Facade C

METAL CLAD: DETERIORATED DOOR AND FRAME - MAJOR DETERIORATION

REPLACE

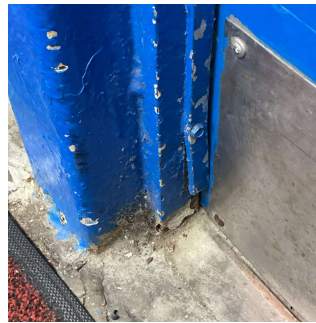
Facade A

METAL CLAD: DETERIORATED DOOR AND FRAME - MINOR DETERIORATION

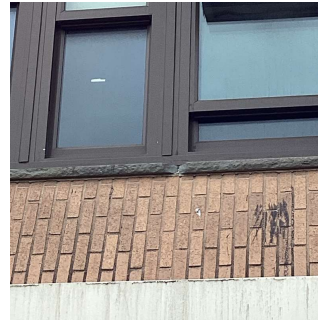
Facade B

BRICK: DETERIORATED MASONRY SILLS - MAJOR

40  
L.F.  
REMOVE AND REPLACE  
PRIORITY 4  
LEVEL 2

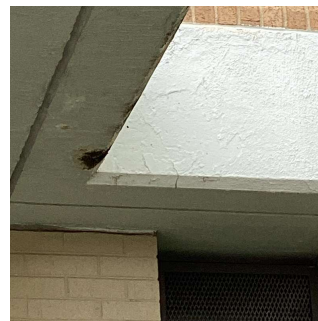
Facade A

CAST IN PLACE / PRE-CAST CONCRETE: MINOR CRACKS/SPALLING

REPAIR

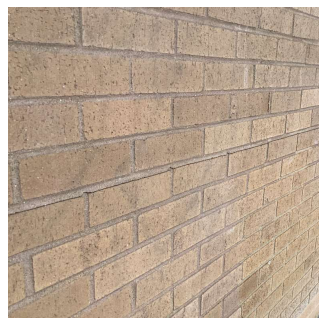
Question	Response
<b>EXTERIOR</b>	
<b>EXTERIOR WALLS</b>	Inspected
	Facade A
Violations	No violations recorded.
<b>EXTERIOR SOFFITS</b>	Inspected
Condition	2 - Between Good and Fair
Deficiency	No deficiencies recorded
<b>LOADING DOCK</b>	Does not Exist
<b>LOUVER</b>	Inspected
Condition	2 - Between Good and Fair
Deficiency	No deficiencies recorded
<b>PARAPETS</b>	Inspected
Material Type(s)	Concrete, Masonry
Replacement Quantity	6,000
Replacement Uom	C.F.
Instance on All Facades	Inspected
Instance Condition	4 - Between Fair and Poor
Instance Quantity	6,000
Instance Quantity Uom	C.F.
Deficiency	<b>BRICK: MINOR CRACKS, SPALLING</b>
Roof Plan reference	<p>K377</p>

Deficiency Quantity	10
Quantity Uom	S.F.
Potential Action	REPAIR
Urgency of Action	PRIORITY 3
Purpose of Action	LEVEL 2
Deficiency Photo1

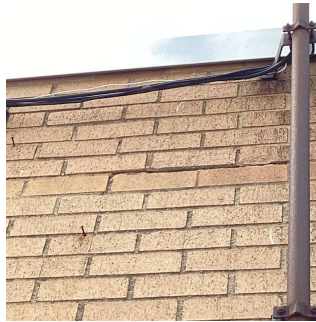
PH Roof

<p>The photograph shows a close-up view of a brick wall. The bricks are light-colored and arranged in a standard running bond pattern. The mortar joints between the bricks are significantly deteriorated, showing crumbling and missing mortar, which is consistent with the 'BRICK: DETERIORATED JOINTS' deficiency noted.</p>
Violations	No violations recorded.
Deficiency	<b>BRICK: DETERIORATED JOINTS</b>

100  
 S.F.  
 REPOINT  
 PRIORITY 4  
 LEVEL 2

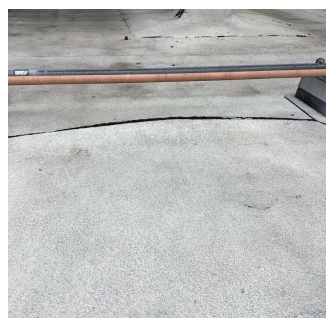
Question	Response
<b>EXTERIOR</b>	
<b>ROOF</b>	
<b>Roofing</b>	
<b>ROOFING</b>	
Instance Quantity	41,000
Instance Quantity Uom	S.F.
Does the roof have major mechanical equipment sitting on Dunnage Steel less than 18" above the Roofing?	Yes
Does this roof instance have a Sustainable Roof System?	Yes
Sustainable Roof Type	White Roof
Sustainable Roof Location (Roof Number)	All Roofs
Do solar panels exist on these roofs?	No
Is/Are the roof(s) suitable for Solar Panel installation?	Yes
Installation Year	2016
Source of Installation	Custodial Staff
Deficiency	MODIFIED BITUMEN: ROOFING: DELAMINATION
Roof Plan reference

Deficiency Quantity	10
Quantity Uom	S.F.
Potential Action	REPLACE ROOFING WITHOUT MAJOR EQUIPMENT REMOVAL
Urgency of Action	PRIORITY 4
Purpose of Action	LEVEL 2
Deficiency Photo1

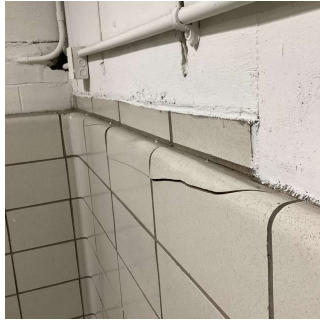
Inspected  
 3 - Fair  
 BULKHEAD/PENTHOUSE WALLS/INTERIOR: GLAZED BLOCK  
 CRACKS/SPALLING

20  
 S.F.  
 REPLACE

Question	Response
<b>EXTERIOR</b>	
<b>ROOF</b>	
<b>Specialties</b>	
<b>BULKHEAD/PENTHOUSE</b>	
Urgency of Action	PRIORITY 4
Purpose of Action	LEVEL 2
Deficiency Photo1

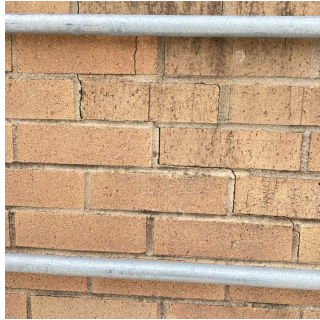
Deficiency Quantity	170
Quantity Uom	S.F.
Potential Action	MAINTENANCE
Urgency of Action	PRIORITY 1
Purpose of Action	LEVEL 1
Deficiency Photo1	No photo recorded
Violations	No violations recorded.
Deficiency	BULKHEAD/PENTHOUSE WALLS/EXTERIOR: CRACKS/SPALLING - MAJOR
Roof Plan reference	K377

Deficiency Quantity	60
Quantity Uom	S.F.
Potential Action	REPLACE

Question	Response
<b>EXTERIOR</b>	
<b>ROOF</b>	
<b>Specialties</b>	
<b>BULKHEAD/PENTHOUSE</b>	
Urgency of Action	PRIORITY 4
Purpose of Action	LEVEL 2
Deficiency Photo1

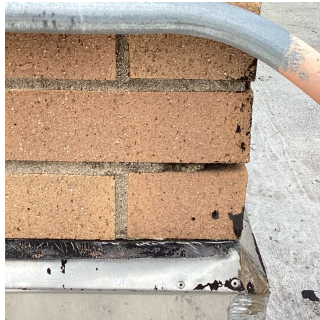
Violations	PH No violations recorded.
Deficiency	BULKHEAD/PENTHOUSE WALLS/EXTERIOR: DETERIORATED JOINTS
Roof Plan reference	K377

Deficiency Quantity	120
Quantity Uom	S.F.
Potential Action	REPOINT
Urgency of Action	PRIORITY 3
Purpose of Action	LEVEL 2
Deficiency Photo1

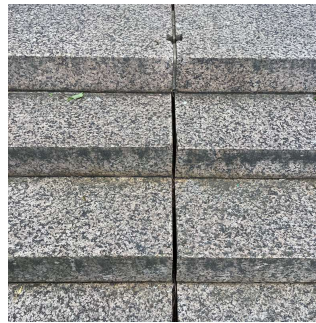
Facade A

STONE: DETERIORATED JOINTS

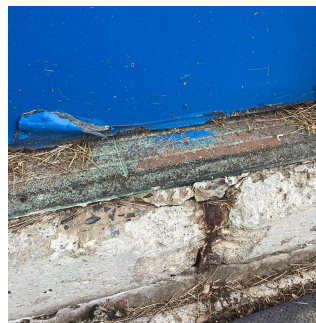
Facade C

**CONCRETE: CRACKS/SPALLING - MAJOR**

REPLACE

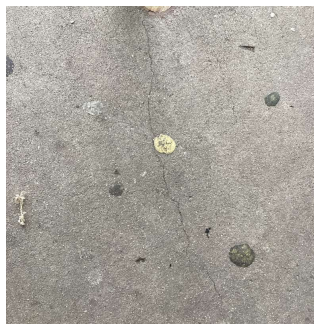
Facade A  
No violations recorded.

**CONCRETE: CRACKS/SPALLING - MINOR**

10  
S.F.  
REPAIR  
PRIORITY 3  
LEVEL 2

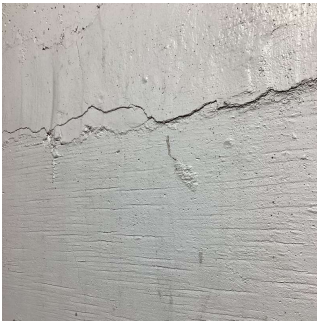
Question	Response
<b>INTERIOR</b>	
<b>STRUCTURAL</b>	
<b>FLOOR STRUCTURE</b>	
Deficiency Photo1	 
Violations	Basement - Mechanical Equipment Room under Stair D No violations recorded.
<b>FOUNDATION WALLS</b>	
Material Type(s)	Inspected Concrete
Condition	4 - Between Fair and Poor
Deficiency	CONCRETE: WATER INFILTRATION IN NON- INSTRUCTIONAL SPACE
Deficiency Location/Instance	Basement - Boiler Room Pit
Deficiency Quantity	100
Quantity Uom	S.F.
Potential Action	INSTALL WATERPROOFING
Urgency of Action	PRIORITY 5
Purpose of Action	LEVEL 5
Deficiency Photo1	 
Violations	Basement - Boiler Room Pit No violations recorded.
Deficiency	CONCRETE: CRACKED/SPALLED/REINFORCEMENT EXPOSED
Deficiency Location/Instance	Basement - Boiler Room Pit, Facade C
Deficiency Quantity	45
Quantity Uom	S.F.
Potential Action	REPAIR
Urgency of Action	PRIORITY 4
Purpose of Action	LEVEL 5

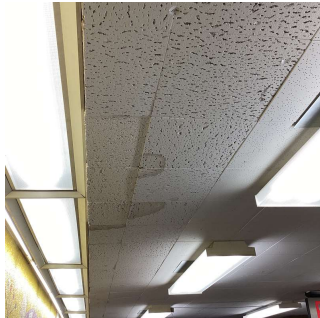
Question	Response
<b>INTERIOR</b>	
<b>CLASSROOMS/CORRIDORS/ADMIN SPACES</b>	
<b>Ceiling</b>	
Deficiency	ACOUSTIC TILES ON PLASTER: DAMAGED/MISSING - ACTIVE LEAK
Deficiency Location/Instance	Room 120
Deficiency Quantity	20
Quantity Uom	S.F.
Potential Action	REPLACE
Urgency of Action	PRIORITY 5
Purpose of Action	LEVEL 2
Deficiency Photo1	 
Violations	Room 120 No violations recorded.
Deficiency	ACOUSTIC TILES ON PLASTER: DAMAGED/MISSING
Deficiency Location/Instance	Main Entrance Lobby, Rooms 367B, 357B, 249A, 321A and others
Deficiency Quantity	400
Quantity Uom	S.F.
Potential Action	REPLACE
Urgency of Action	PRIORITY 3
Purpose of Action	LEVEL 2
Deficiency Photo1

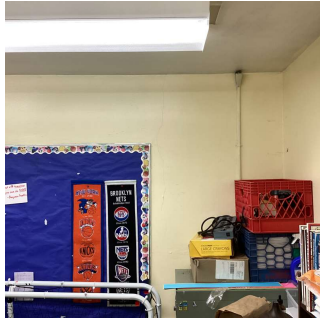
Question	Response
<b>INTERIOR</b>	
<b>GYMNASIUM</b>	
<b>Stage</b>	
Instance on 2nd Floor	Does not Exist
<b>Walls</b>	
Instance on 2nd Floor	Inspected
Condition	2 - Between Good and Fair
Deficiency	PLASTER: CRACKS/SPALLING
Deficiency Location/Instance	Room 219A
Deficiency Quantity	10
Quantity Uom	S.F.
Potential Action	REPLACE
Urgency of Action	PRIORITY 3
Purpose of Action	LEVEL 2
Deficiency Photo1

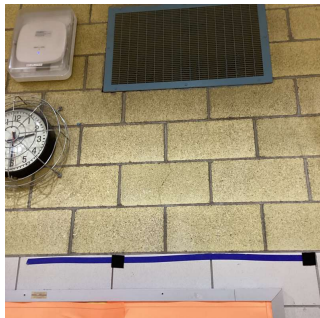
Room 219A
Violations	No violations recorded.
Deficiency	MASONRY: CRACKS/SPALLING
Deficiency Location/Instance	Near Office, Near Entrance, Right and Left Side
Deficiency Quantity	80
Quantity Uom	S.F.
Potential Action	REPLACE
Urgency of Action	PRIORITY 3
Purpose of Action	LEVEL 2
Deficiency Photo1

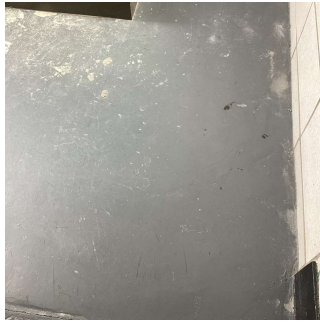
Deficiency Quantity	50
Quantity Uom	S.F.
Potential Action	REPLACE
Urgency of Action	PRIORITY 3
Purpose of Action	LEVEL 2
Deficiency Photo1

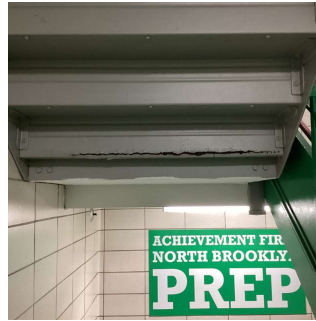
Stair D/Bulkhead	
Violations	No violations recorded.
Deficiency	METAL: RUST - MAJOR
Deficiency Location/Instance	Stair D/2
Deficiency Quantity	10
Quantity Uom	S.F.
Potential Action	REPLACE
Urgency of Action	PRIORITY 3
Purpose of Action	LEVEL 2

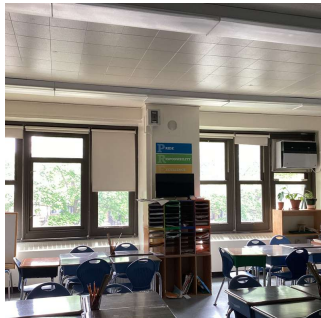
Question	Response
<b>LIFE SAFETY</b>	
<b>F.D. HOLDING AREA</b>	
Condition	5 - Poor
Deficiency	HOLDING AREAS NOT IDENTIFIED
Deficiency Location/Instance	Rooms 263A, 363A
Deficiency Quantity	2
Quantity Uom	EACH
Potential Action	PROVIDE IDENTIFICATION ON EXTERIOR SIDE OF WINDOW
Urgency of Action	PRIORITY 5
Purpose of Action	LEVEL 2
Deficiency Photo1

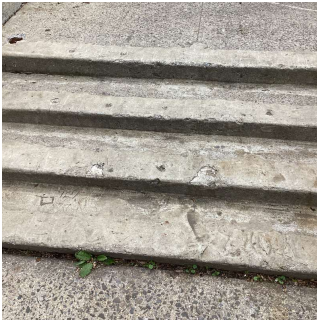
Violations	Madison Street No violations recorded.
<b>Stairs/ramps</b>	Inspected
Condition	3 - Fair
Deficiency	CAST IN PLACE CONCRETE: CRACKS/SPALLING - MAJOR
Deficiency Location/Instance	Madison Street, Near Playground
Deficiency Quantity	60
Quantity Uom	S.F.
Potential Action	REPLACE
Urgency of Action	PRIORITY 3
Purpose of Action	LEVEL 2
Deficiency Photo1
