**NYC Department of Education**  
**Building Condition Assessment Survey 2023 - 2024**

Architectural Inspection

**Asset: I.S. 391 - BROOKLYN, 790 EAST NEW YORK AVENUE, New York, 11203**

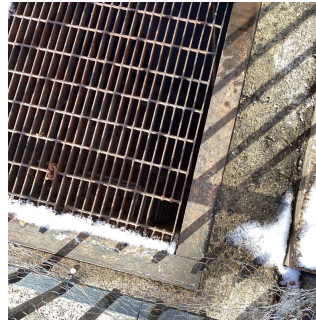
Question	Response
<b>Architectural</b>	
<b>EXTERIOR</b>	Inspected
<b>AREAWAY</b>	Inspected
Instance on AW1	Inspected
Instance Condition	3 - Fair
Instance Quantity	1
Instance Quantity Uom	EACH
Deficiency	AREAWAY GRATINGS: MAJOR RUSTING / OR BROKEN
Roof Plan reference	
Deficiency Quantity	20
Quantity Uom	S.F.
Potential Action	REPLACE
Urgency of Action	PRIORITY 4
Purpose of Action	LEVEL 2

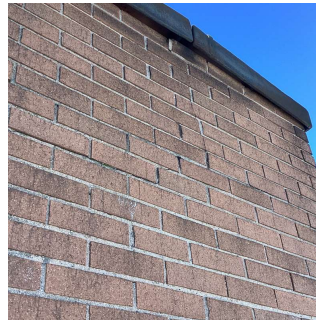
Roof 1  
 No violations recorded.

BRICK: MINOR CRACKS AND SPALLING

10  
 S.F.  
 RESTITCH  
 PRIORITY 3  
 LEVEL 2

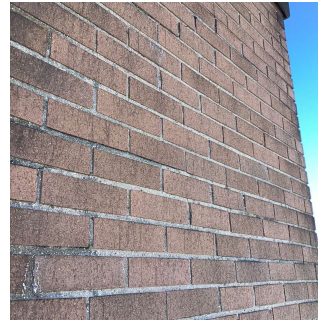
Roof 1

**BRICK: DETERIORATED JOINTS**

80  
 S.F.  
 REPOINT  
 PRIORITY 3  
 LEVEL 2

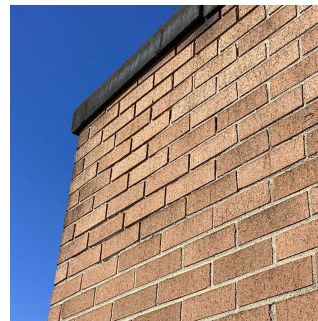
Roof 1

**BRICK: DETERIORATED JOINTS**

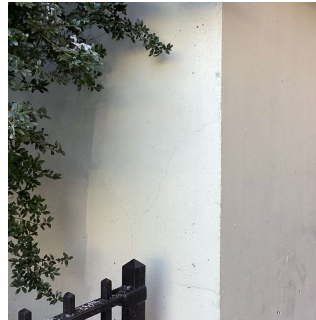
Facade E

CAST IN PLACE / PRE-CAST CONCRETE: MINOR CRACKS/SPALLING

REPAIR

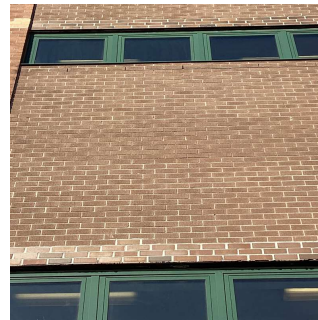
Facade A

**BRICK: DETERIORATED JOINTS**

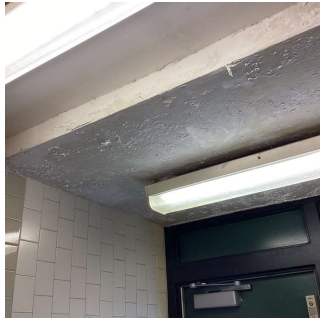
Roof 4 - Stair B/Basement Vestibule (shown), Roof 1 - Corridor near Room 260, 2nd Floor Girls Toilet Room
Violations	No violations recorded.
<b>ROOFING DRAINS</b>	Inspected
Condition	2 - Between Good and Fair
Deficiency	No deficiencies recorded
<b>Specialties</b>	Inspected
<b>BULKHEAD/PENTHOUSE</b>	Inspected
Condition	4 - Between Fair and Poor
Deficiency	BULKHEAD/PENTHOUSE WALLS/INTERIOR: CMU CRACKS/SPALLING
Roof Plan reference

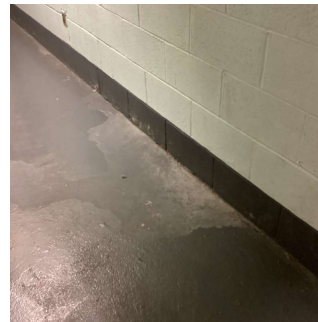
PH  
 No violations recorded.

**BULKHEAD/PENTHOUSE WALLS/EXTERIOR: WATER INFILTRATION**

200  
 S.F.  
 REPAIR  
 PRIORITY 5  
 LEVEL 2

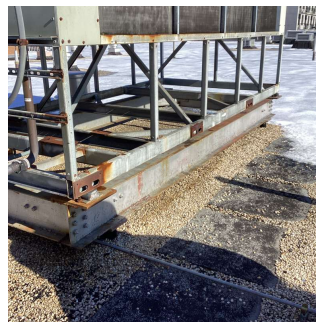
Roof 1  
No violations recorded.

60  
L.F.  
REPLACE  
PRIORITY 3  
LEVEL 2

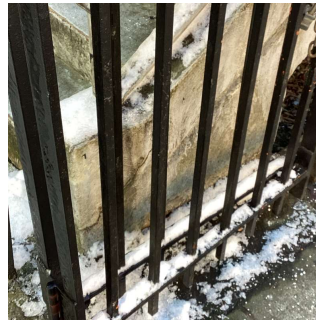
Facade F

CONCRETE: CRACKS/SPALLING - MAJOR

Deficiency Quantity	10
Quantity Uom	S.F.
Potential Action	REPLACE
Urgency of Action	PRIORITY 4
Purpose of Action	LEVEL 2
Deficiency Photo1

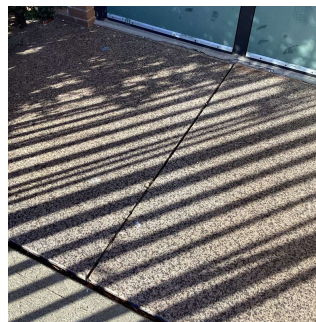
Facade A

**STONE: DETERIORATED JOINTS**

Deficiency Quantity	70
Quantity Uom	L.F.
Potential Action	REPOINT
Urgency of Action	PRIORITY 3
Purpose of Action	LEVEL 2
Deficiency Photo1

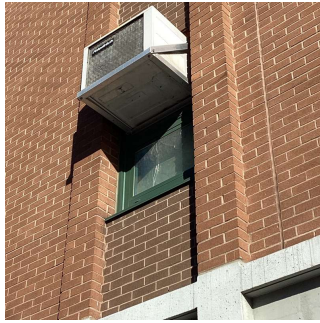
Instance on Aluminum - Double Hung: All Facades	Inspected
Instance Condition	2 - Between Good and Fair
Instance Quantity	3,500
Instance Quantity Uom	S.F.
Are these windows insulated	Yes
Installation Year	2010
Source of Installation	Custodial Staff
Deficiency	No deficiencies recorded
Instance on Aluminum - Other: All Facades	Inspected
Instance Condition	2 - Between Good and Fair
Instance Quantity	500
Instance Quantity Uom	S.F.
Are these windows insulated	Yes
Installation Year	2010
Source of Installation	Custodial Staff
Deficiency	ALUMINUM - OTHER: BROKEN PANE

Deficiency Quantity	30
Quantity Uom	S.F.
Potential Action	MAINTENANCE
Urgency of Action	PRIORITY 3
Purpose of Action	LEVEL 2

Violations	Facade C No violations recorded.
<b>INTERIOR</b>	Inspected
<b>POOLS</b>	Does not Exist
<b>STRUCTURAL</b>	Inspected
<b>COLUMNS/BEAMS/BEARING WALLS</b>	Inspected
Condition	2 - Between Good and Fair
Deficiency	STEEL COLUMNS/BEAMS: DETERIORATED/MISSING SPRAY-ON FIREPROOFING
Deficiency Location/Instance	Auditorium Fan Room
Deficiency Quantity	20
Quantity Uom	S.F.
Potential Action	REPLACE
Urgency of Action	PRIORITY 3
Purpose of Action	LEVEL 5
Deficiency Photo1

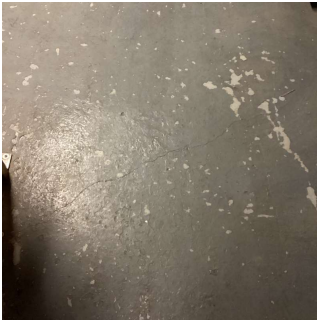
Violations	Auditorium Fan Room No violations recorded.
<b>FLOOR STRUCTURE</b>	Inspected
Condition	3 - Fair
Deficiency	CONCRETE SLAB ON GRADE: THRU CRACKS
Deficiency Location/Instance	Cellar - Boiler Room
Deficiency Quantity	40
Quantity Uom	S.F.
Potential Action	REPAIR
Urgency of Action	PRIORITY 3
Purpose of Action	LEVEL 5

Violations	Boiler Room No violations recorded.
Deficiency	CONCRETE: CRACKS/SPALLED/REINFORCEMENT EXPOSED
Deficiency Location/Instance	PH
Deficiency Quantity	30
Quantity Uom	S.F.
Potential Action	REPAIR
Urgency of Action	PRIORITY 3
Purpose of Action	LEVEL 5
Deficiency Photo1

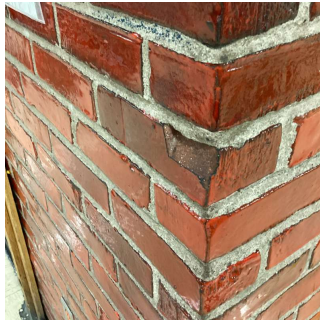
Violations	Near the entrance No violations recorded.
<b>Window Curtains/Shades/Blinds</b>	
Instance on Basement - Students	Does not Exist
Instance on Basement - Staff (600 SF)	Does not Exist

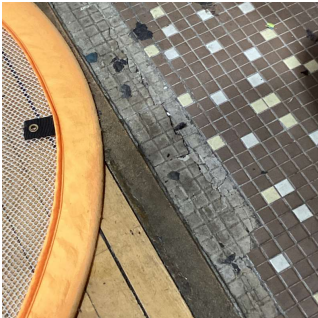
Violations	Near the Drinking Fountain - Side A Gymnasium No violations recorded.

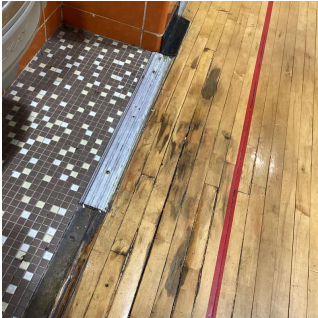
Question	Response
<b>INTERIOR</b>	
<b>GYMNASIUM</b>	
<b>Floor Finish</b>	
Deficiency	WOOD: DAMAGED/DETERIORATED
Deficiency Location/Instance	Near the Drinking Fountain - Side B Gymnasium
Deficiency Quantity	10
Quantity Uom	S.F.
Potential Action	REPLACE
Urgency of Action	PRIORITY 3
Purpose of Action	LEVEL 2
Deficiency Photo1

Violations	Near the Drinking Fountain - Side B Gymnasium No violations recorded.
Deficiency	CONCRETE: CRACKS
Deficiency Location/Instance	Storage Room - Side B Gymnasium
Deficiency Quantity	20
Quantity Uom	S.F.
Potential Action	REPLACE
Urgency of Action	PRIORITY 3
Purpose of Action	LEVEL 2
Deficiency Photo1

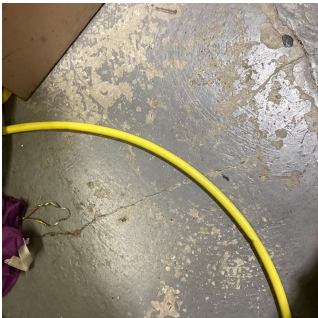
Violations	Storage Room - Side B Gymnasium No violations recorded.
<b>Seating</b>	
Instance on 1st Floor	Inspected
Condition	2 - Between Good and Fair
Deficiency	DAMAGED BLEACHERS
Deficiency Location/Instance	Side B Gymnasium
Deficiency Quantity	20
Quantity Uom	S.F.
Potential Action	REPLACE

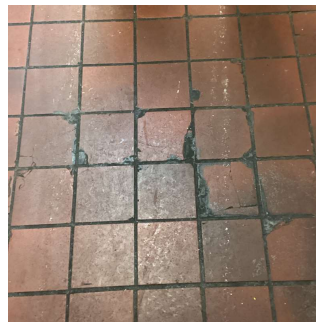
Deficiency	QUARRY TILE: BROKEN/MISSING TILES
Deficiency Location/Instance	Food Preparation Area
Deficiency Quantity	20
Quantity Uom	S.F.
Potential Action	REPLACE
Urgency of Action	PRIORITY 3
Purpose of Action	LEVEL 2
Deficiency Photo1

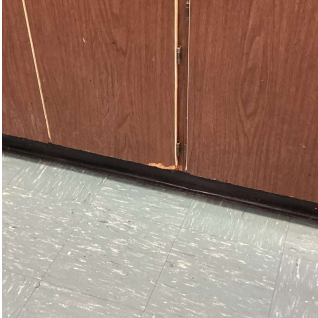
Question	Response
<b>INTERIOR</b>	
<b>SCIENCE LAB</b>	
<b>Fixed Equipment</b>	
Instance on Room B23	Inspected
Condition	3 - Fair
Deficiency	CABINETS: MISSING/DAMAGED
Deficiency Location/Instance	Room B23
Deficiency Quantity	10
Quantity Uom	L.F.
Potential Action	REPLACE
Urgency of Action	PRIORITY 3
Purpose of Action	LEVEL 2
Deficiency Photo1

Violations	Room B23 No violations recorded.
Instance on Room B21, B23	Inspected
Condition	5 - Poor
Deficiency	TRI-FACIAL TABLE: DAMAGED
Deficiency Location/Instance	Room B23
Deficiency Quantity	1
Quantity Uom	EACH
Potential Action	REPLACE
Urgency of Action	PRIORITY 3
Purpose of Action	LEVEL 2
Deficiency Photo1

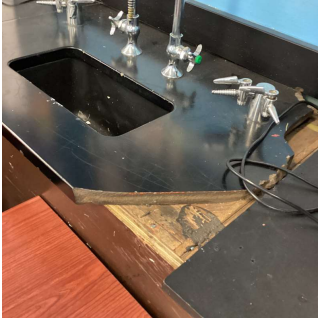
Violations	Room B23 No violations recorded.
Deficiency	DEMO TABLE: DAMAGED/DETERIORATED
Deficiency Location/Instance	Room B21
Deficiency Quantity	1
Quantity Uom	EACH
Potential Action	REPLACE
Urgency of Action	PRIORITY 3
Purpose of Action	LEVEL 2

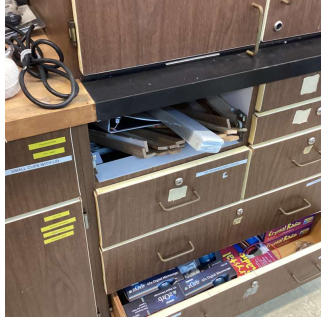
Question	Response
<b>INTERIOR</b>	
<b>SCIENCE PREP ROOM</b>	
<b>Fixed Equipment</b>	
Quantity Uom	L.F.
Potential Action	REPLACE
Urgency of Action	PRIORITY 3
Purpose of Action	LEVEL 2
Deficiency Photo1

Room B21A
Violations	No violations recorded.
<b>SHOWER ROOM</b>	
	Inspected
Instance on Inside Room B82	Inspected
Alternative use	Yes
Instance on Inside Room B70	Inaccessible
<b>Ceiling</b>	
Instance on Inside Room B82	Inspected
Condition	2 - Between Good and Fair
Deficiency	No deficiencies recorded
<b>Door(s)</b>	
Instance on Inside Room B82	Does not Exist
<b>Floor Finish</b>	
Instance on Inside Room B82	Inspected
Condition	2 - Between Good and Fair
Deficiency	No deficiencies recorded
<b>Walls</b>	
Instance on Inside Room B82	Inspected
Condition	2 - Between Good and Fair
Deficiency	CERAMIC TILE: BROKEN/ MISSING
Deficiency Location/Instance	Near the Entrance
Deficiency Quantity	10
Quantity Uom	S.F.
Potential Action	REPLACE

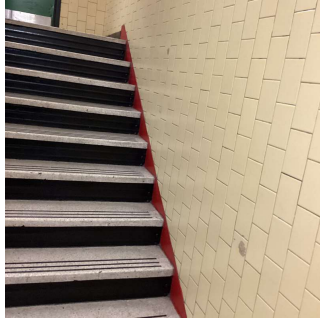
Question	Response
<b>INTERIOR</b>	
<b>STAIRS/RAMPS: INTERIOR</b>	
<b>Railings</b>	
Urgency of Action	PRIORITY 5
Purpose of Action	LEVEL 6
Deficiency Photo1

Violations	Stair F/Basement No violations recorded.
<b>Stairs and Landings</b>	
Condition	Inspected 2 - Between Good and Fair
Deficiency	CONCRETE: CRACKS/SPALLING - MAJOR
Deficiency Location/Instance	Auditorium Dressing Room, Step by Right Stage
Deficiency Quantity	20
Quantity Uom	S.F.
Potential Action	REPLACE
Urgency of Action	PRIORITY 3
Purpose of Action	LEVEL 2
Deficiency Photo1

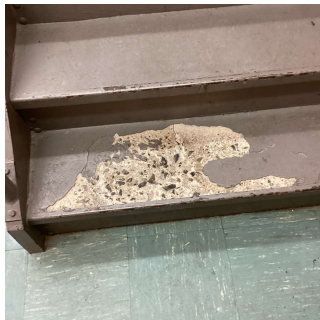
Violations	Auditorium Dressing Room No violations recorded.
Deficiency	TERRAZZO: CRACKS
Deficiency Location/Instance	Stairs B/Basement,1, C/Basement, E/1, F/1, and others
Deficiency Quantity	70
Quantity Uom	S.F.
Potential Action	REPLACE
Urgency of Action	PRIORITY 3
Purpose of Action	LEVEL 2

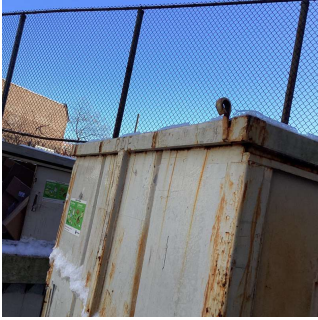
Violations	Parking Lot No violations recorded.
Deficiency	CONTAINER DAMAGED
Deficiency Location/Instance	Parking Lot
Deficiency Quantity	2
Quantity Uom	EACH
Potential Action	REPLACE
Urgency of Action	PRIORITY 3
Purpose of Action	LEVEL 2
Deficiency Photo1

Violations	Parking Lot No violations recorded.
<b>Drainage System for Asphalt</b>	Inspected
<b>Catch Basins/Manhole - Surrounded by asphalt</b>	Inspected
Condition	2 - Between Good and Fair
Deficiency	No deficiencies recorded
<b>Culverts - Asphalt Covering</b>	Does not Exist

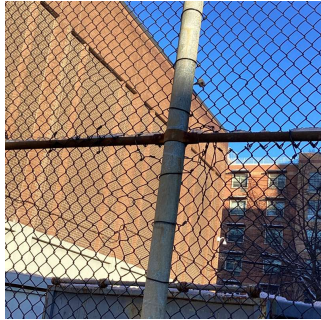
Violations	East New York Avenue No violations recorded.
Deficiency	CHAIN LINK: DAMAGED/DETERIORATED
Deficiency Location/Instance	Schoolyard
Deficiency Quantity	150
Quantity Uom	S.F.
Potential Action	REPLACE
Urgency of Action	PRIORITY 3
Purpose of Action	LEVEL 2
Deficiency Photo1

Violations	Schoolyard No violations recorded.
Deficiency	CHAIN LINK: RUST - MAJOR
Deficiency Location/Instance	Schoolyard
Deficiency Quantity	2,850
Quantity Uom	S.F.
Potential Action	REPLACE
Urgency of Action	PRIORITY 3
Purpose of Action	LEVEL 2

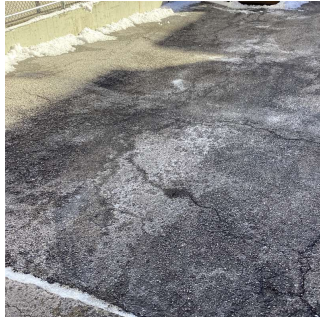
Violations	Parking Lot No violations recorded.
<b>Concrete</b>	Inspected
Condition	3 - Fair
Deficiency	CRACKS - MAJOR
Deficiency Location/Instance	Parking Lot
Deficiency Quantity	400
Quantity Uom	S.F.
Potential Action	REPLACE
Urgency of Action	PRIORITY 3
Purpose of Action	LEVEL 2
Deficiency Photo1

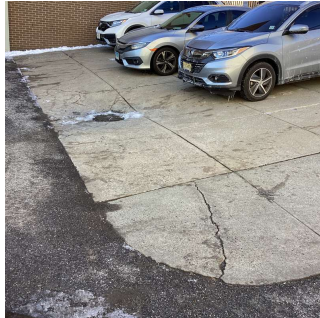
Violations	Parking Lot No violations recorded.
<b>Pavers</b>	Does not Exist
<b>Student Use</b>	Inspected
Gravel Exists?	No
<b>Asphalt</b>	Inspected
Condition	4 - Between Fair and Poor
Deficiency	CRACKS - MAJOR
Deficiency Location/Instance	Schoolyard
Deficiency Quantity	800
Quantity Uom	S.F.
Potential Action	REPLACE
Urgency of Action	PRIORITY 3
Purpose of Action	LEVEL 2
