**NYC Department of Education
Building Condition Assessment Survey 2023 - 2024**

Architectural Inspection

K395

Asset: P.S./I.S. 395 - BROOKLYN, 1001 EAST 45TH STREET, New York, 11203

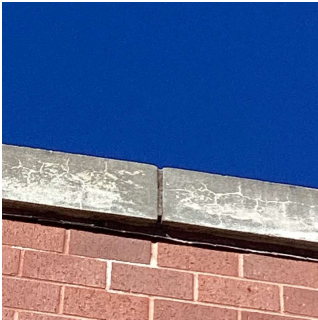
<p>E. 45th Street</p>
Deficiency Quantity	10
Quantity Uom	L.F.
Potential Action	MAINTENANCE
Urgency of Action	PRIORITY 3
Purpose of Action	LEVEL 2
Deficiency Photo1

Violations	Roof 5 No violations recorded.
Deficiency	CAST STONE: CRACKED/BROKEN PIECES

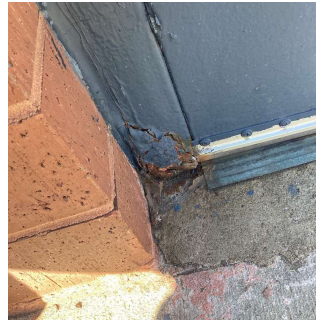
Facade F - Exit 15

METAL: DETERIORATED DOOR - MAJOR DETERIORATION

1
EACH
REPLACE
PRIORITY 4
LEVEL 2

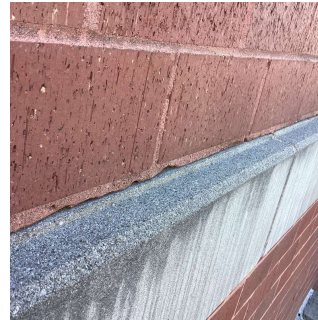
Facade E - Near HC Ramp

BRICK: DETERIORATED JOINTS

PRIORITY 4
LEVEL 2

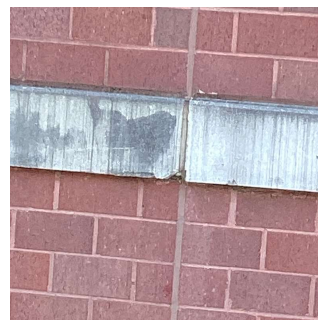
CAST IN PLACE / PRE-CAST CONCRETE: MINOR
CRACKS/SPALLING

Violations
 Facade A - Near Playground
 No violations recorded.

40
S.F.
REPAIR
PRIORITY 3
LEVEL 2

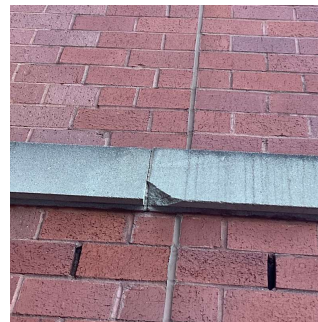
Facade A - Near Main Entrance

Deficiency
 CAST IN PLACE / PRE-CAST CONCRETE: MAJOR CRACKS/SPALLING

REPLACE

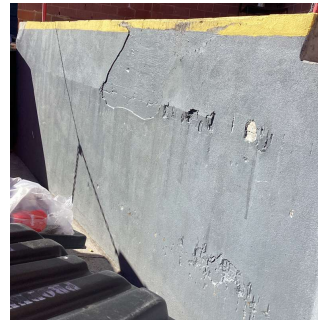
Violations	Facade F - Near Exit 15 No violations recorded.
Deficiency	CHEEK WALL/CRACKS, SPALLING - MINOR

30
 S.F.
 REPAIR
 PRIORITY 3
 LEVEL 2

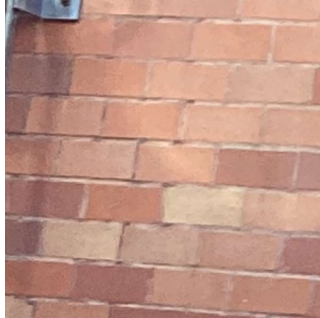
BRICK: DETERIORATED JOINTS

Violations	Roof 7 No violations recorded.
Deficiency	BRICK: EFFLORESCENCE
Roof Plan reference	<p>K395 E. 46th Street</p>

Question	Response
EXTERIOR	
PARAPETS	
Deficiency Quantity	10
Quantity Uom	S.F.
Potential Action	REPOINT
Urgency of Action	PRIORITY 4
Purpose of Action	LEVEL 2
Deficiency Photo1

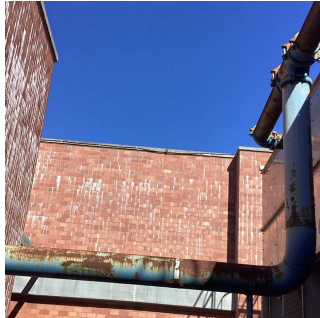
Violations	Roof 7 No violations recorded.
PLAZA DECK	Does not Exist
ROOF	Inspected
Roofing	Inspected
Replacement Quantity	60,000
Replacement Uom	S.F.

<p>E. 45th Street</p>
Deficiency Quantity	1,600
Quantity Uom	S.F.
Potential Action	MAINTENANCE
Urgency of Action	PRIORITY 1
Purpose of Action	LEVEL 1
Deficiency Photo1

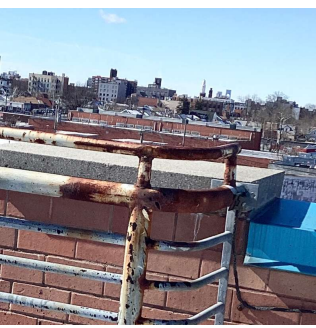
<p>Roof 1 - Near SK1</p>
Violations	No violations recorded.
ROOF CAGE	Does not Exist
ROOFING	Inspected
Instance on Built-Up: Roofs 2, 5, 7-9	Inspected
Instance Condition	3 - Fair
Instance Photo

Question	Response
EXTERIOR	
ROOF	
Roofing	
ROOF HATCH/SMOKE HATCH	Inspected
Condition	2 - Between Good and Fair
Deficiency	No deficiencies recorded
LEADERS, GUTTERS, DOWNSPOUTS, SCUPPERS	Inspected
Condition	2 - Between Good and Fair
Deficiency	No deficiencies recorded
ROOF BARRIER/FENCE	Inspected
Condition	3 - Fair
Deficiency	RAILINGS/PANELS: DETERIORATED, MAJOR RUSTING
Roof Plan reference	<p>K395 E. 46th Street N</p>

<p>E. 45th Street</p>
Deficiency Quantity	20
Quantity Uom	S.F.
Potential Action	REPLACE
Urgency of Action	PRIORITY 4
Purpose of Action	LEVEL 2
Deficiency Photo1

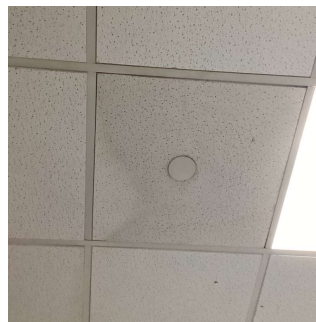
Roof 1 - Corridor near Room 309 (shown), Roof 4 - Room 324 (similar)

Deficiency	MODIFIED BITUMEN: ROOFING: MAJOR ACTIVE ROOF LEAKS IN INSTRUCTIONAL SPACE
------------	---

Deficiency Quantity	200
Quantity Uom	S.F.
Potential Action	REPLACE ROOFING WITH MAJOR EQUIPMENT REMOVAL
Urgency of Action	PRIORITY 5
Purpose of Action	LEVEL 2
Deficiency Photo1

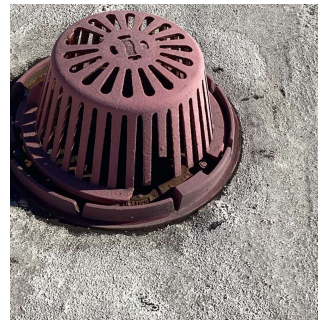
Roof 4
 No violations recorded.

Deficiency	DETERIORATED
------------	--------------

4
 EACH
 REPLACE
 PRIORITY 4
 LEVEL 2

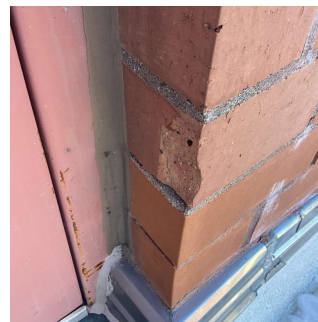
Roof 4 - BH2

**BULKHEAD/PENTHOUSE WALLS/EXTERIOR:
CRACKS/SPALLING - MINOR**

10
 S.F.
 REPAIR
 PRIORITY 3
 LEVEL 2

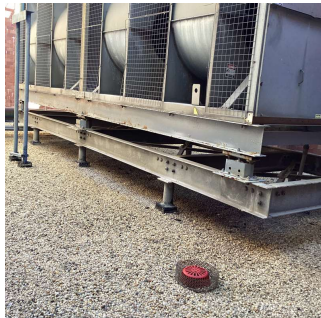
Violations	Roof 7 - PH No violations recorded.
CUPOLA/ SPIRES/ TOWERS	Does not Exist
DORMER	Does not Exist
DUNNAGE STEEL	Inspected
Condition	3 - Fair
Deficiency	HEIGHT LESS THAN 18"
Roof Plan reference

Violations	Roof 7 No violations recorded.
SKYLIGHT/ROOF VENT	Inspected
Material Type(s)	Other
Condition	2 - Between Good and Fair
Deficiency	No deficiencies recorded

Deficiency Quantity	50
Quantity Uom	L.F.
Potential Action	REPLACE
Urgency of Action	PRIORITY 3
Purpose of Action	LEVEL 2
Deficiency Photo1

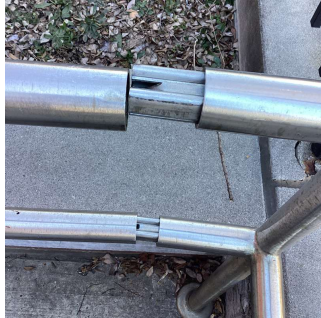
Violations	Facade E - HC Ramp No violations recorded.
STAIRS/RAMPS	Inspected
Condition	5 - Poor
Deficiency	CONCRETE: WORN-OUT TREAD/RISER/NOSING
Roof Plan reference

Question	Response
EXTERIOR	
STAIRS/RAMPS: EXTERIOR	Inspected
RAILINGS	
Urgency of Action	PRIORITY 4
Purpose of Action	LEVEL 2
Deficiency Photo1

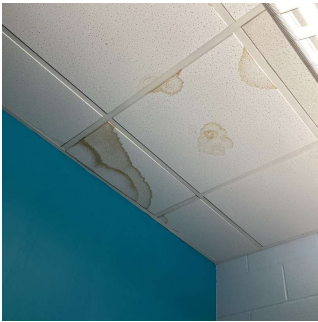
Question	Response
INTERIOR	
CAFETERIA	Inspected
Window Curtains/Shades/Blinds	
CLASSROOMS/CORRIDORS/ADMIN SPACES	Inspected
Ceiling	Inspected
Condition	2 - Between Good and Fair
Deficiency	ACOUSTIC TILES: DAMAGED/MISSING - ACTIVE LEAK
Deficiency Location/Instance	Rooms 324, Corridor near room 309
Deficiency Quantity	15
Quantity Uom	S.F.
Potential Action	REPLACE
Urgency of Action	PRIORITY 5
Purpose of Action	LEVEL 2
Deficiency Photo1

Room 324
Violations	No violations recorded.
Deficiency	ACOUSTIC TILES: DAMAGED/MISSING
Deficiency Location/Instance	Rooms 301, 304
Deficiency Quantity	10
Quantity Uom	S.F.
Potential Action	REPLACE
Urgency of Action	PRIORITY 3
Purpose of Action	LEVEL 2
Deficiency Photo1

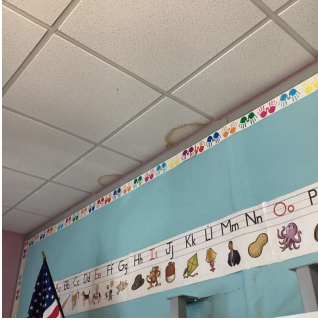
Room 301
Violations	No violations recorded.
Deficiency	GYPSUM BOARD: DAMAGED/DETERIORATED
Deficiency Location/Instance	Lobby
Deficiency Quantity	20
Quantity Uom	S.F.
Potential Action	REPLACE
Urgency of Action	PRIORITY 3

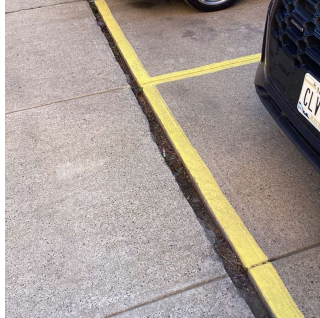
Yes	Tripping Hazard	Large gap in parking lot concrete flags resulting in hazardous conditions	SITE PAVING Student Non-Use Concrete	Parking Lot	Nicholas Geraci	Fireman

Question	Response
SITE	
PAVING	
Student Non-Use	
Concrete	
Purpose of Action	LEVEL 6
Deficiency Photo1

Violations	Parking Lot No violations recorded.
Pavers	Does not Exist
Student Use	Inspected
Gravel Exists?	No
Asphalt	Inspected
Condition	3 - Fair
Deficiency	CRACKS - MAJOR
Deficiency Location/Instance	Schoolyard
Deficiency Quantity	400
Quantity Uom	S.F.
Potential Action	REPLACE
Urgency of Action	PRIORITY 3
Purpose of Action	LEVEL 2
Deficiency Photo1

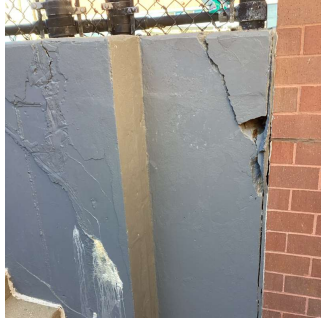
Yes	Potential Falling Debris	Severely damaged retaining wall, resulting in potential hazardous condition	SITE RETAINING WALLS	Parking Lot	Nicholas Geraci	Fireman

Question	Response
SITE	
RETAINING WALLS	Inspected
Deficiency Photo1

Violations	Parking Lot No violations recorded.
SEATING	Does not Exist
SITE WALLS (NOT RETAINING WALLS)	Inspected
Condition	3 - Fair
Deficiency	BRICK: DETERIORATED COPING STONE
Deficiency Location/Instance	E. 45th Street
Deficiency Quantity	75
Quantity Uom	S.F.
Potential Action	REPLACE
Urgency of Action	PRIORITY 3
Purpose of Action	LEVEL 2
Deficiency Photo1
