NYC Department of Education
Building Condition Assessment Survey 2023 - 2024

Architectural Inspection

Asset: P.S. 399 - BROOKLYN, 2707 ALBERMARLE ROAD, New York, 11226

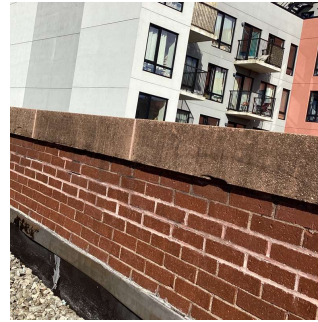
Roof 1 - Facade C

CAST STONE: CRACKED/BROKEN PIECES

30
 L.F.
 REPLACE-IN-KIND
 PRIORITY 4
 LEVEL 2

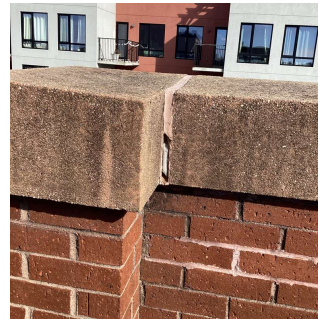
Facade C

CAST STONE: DETERIORATED TRANSVERSE JOINTS

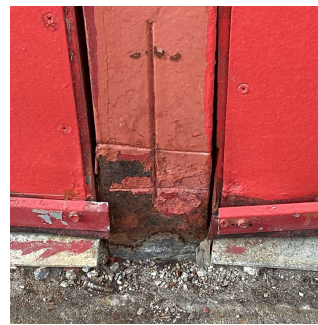
Facade C - Exit 2

METAL CLAD: DETERIORATED DOOR AND FRAME - MINOR DETERIORATION

2
 EACH
 MAINTENANCE
 PRIORITY 3
 LEVEL 2

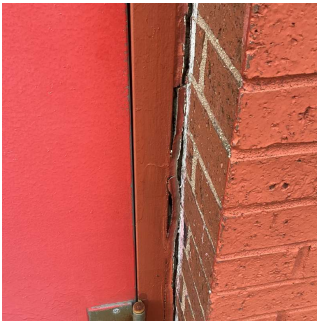
METAL: DETERIORATED DOOR AND FRAME - MINOR DETERIORATION

4
 EACH
 MAINTENANCE
 PRIORITY 3
 LEVEL 2

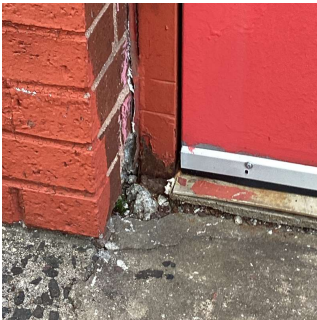
Violations	Facade C No violations recorded.
Deficiency	METAL: AIR/WATER INFILTRATION, DETERIORATED JOINTS WITH DAMAGED CAULKING
Roof Plan reference	K399

Deficiency Quantity	60
Quantity Uom	L.F.
Potential Action	MAINTENANCE
Urgency of Action	PRIORITY 3
Purpose of Action	LEVEL 2
Deficiency Photo1

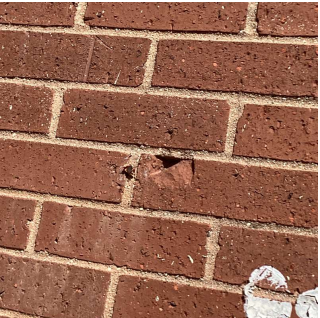
Question	Response
EXTERIOR	
EXTERIOR WALLS	Inspected
Material Type(s)	Masonry, Concrete
Replacement Quantity	17,000
Replacement Uom	S.F.
Instance on All Facades	Inspected
Instance Condition	3 - Fair
Instance Quantity	17,000
Instance Quantity Uom	S.F.
Deficiency	BRICK: MINOR CRACKS AND SPALLING
Roof Plan reference	K399

Deficiency Quantity	10
Quantity Uom	S.F.
Potential Action	RESTITCH
Urgency of Action	PRIORITY 3
Purpose of Action	LEVEL 2
Deficiency Photo1

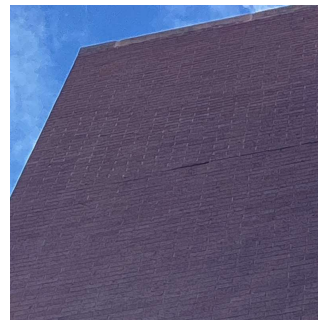
Facade D - Above Exit 3

Violations	Facade A No violations recorded.
Deficiency	BRICK: DETERIORATED JOINTS

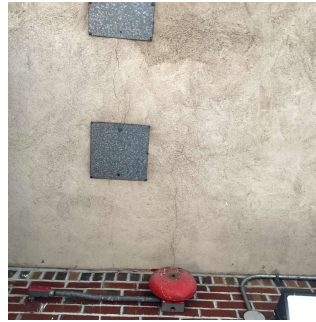
Facade A - Main Entrance

STUCCO/PLASTER: MINOR CRACKS/SPALLING

10
S.F.
REPAIR
PRIORITY 3
LEVEL 2

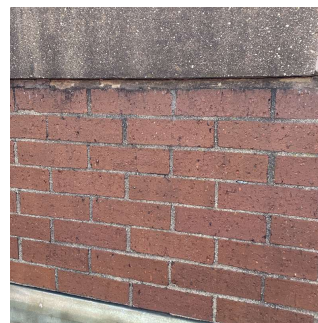
Roof 1 - Facade D

BRICK: DETERIORATED JOINTS

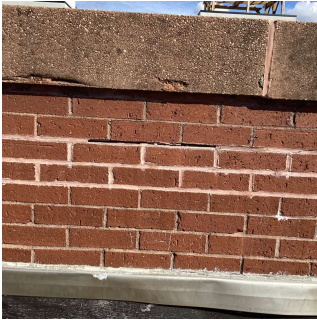
BRICK: DETERIORATED JOINTS

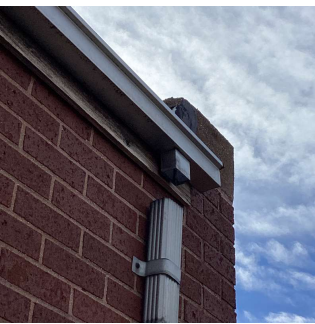
Violations	Facade D No violations recorded.
PLAZA DECK	Does not Exist
ROOF	Inspected
Roofing	Inspected
Replacement Quantity	10,100
Replacement Uom	S.F.
ROOF HATCH/SMOKE HATCH	Does not Exist
LEADERS, GUTTERS, DOWNSPOUTS, SCUPPERS	Inspected
Condition	3 - Fair
Deficiency	DAMAGED/MISSING

Deficiency Quantity	10
Quantity Uom	L.F.
Potential Action	REPLACE
Urgency of Action	PRIORITY 4
Purpose of Action	LEVEL 2
Deficiency Photo1

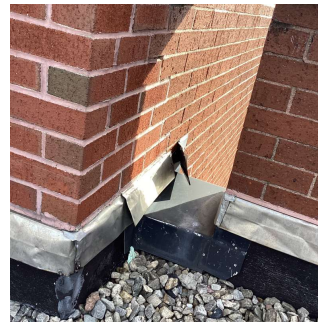
Roof 1 - Near BH

IRMA: FLASHING: CAP FLASHING DAMAGED

REPLACE

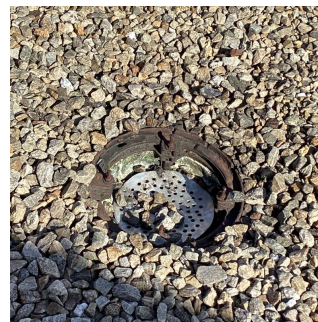
Roof 1

Inspected
Condition	3 - Fair
Deficiency	DETERIORATED

1
 EACH
 REPLACE
 PRIORITY 4
 LEVEL 2

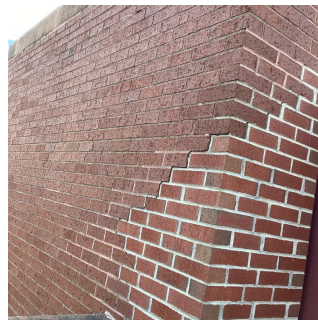
BH

**BULKHEAD/PENTHOUSE WALLS/EXTERIOR:
CRACKS/SPALLING - MAJOR**

REPLACE

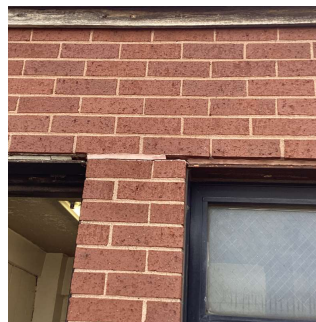
BH
 35673053H

**BULKHEAD/PENTHOUSE WALLS/EXTERIOR: DETERIORATED
JOINTS**

10
 S.F.
 REPOINT
 PRIORITY 4
 LEVEL 4

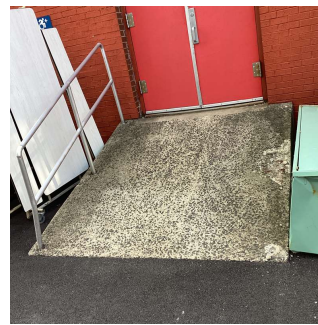
Facade D
No violations recorded.

Deficiency Quantity	10
Quantity Uom	S.F.
Potential Action	REPLACE
Urgency of Action	PRIORITY 4
Purpose of Action	LEVEL 2
Deficiency Photo1	 
Violations	Facade C - Exit 2 No violations recorded.
RAILINGS	Inspected
Condition	3 - Fair
Deficiency	MISSING RAILING

10
L.F.
REPLACE
PRIORITY 5
LEVEL 6

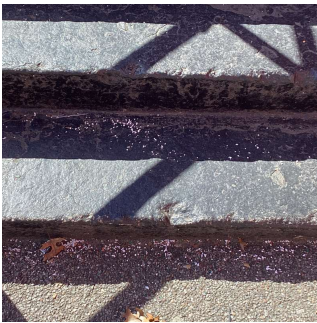
CONCRETE: WORN-OUT TREAD/RISER/NOSING

50
S.F.
REPLACE
PRIORITY 4
LEVEL 2

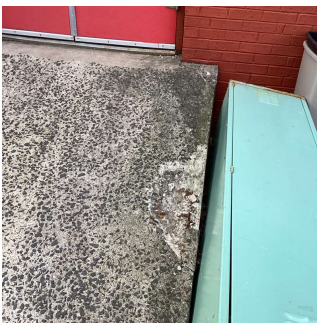
Violations	Facade D - Exit 3 No violations recorded.
Deficiency	CONCRETE: CRACKS/SPALLING - MAJOR
Roof Plan reference	K399

Deficiency Quantity	20
Quantity Uom	S.F.
Potential Action	REPLACE
Urgency of Action	PRIORITY 4
Purpose of Action	LEVEL 2
Deficiency Photo1

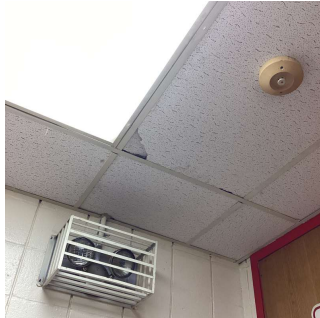
Question	Response
INTERIOR	
CLASSROOMS/CORRIDORS/ADMIN SPACES	
Ceiling	
Deficiency	ACOUSTIC TILES: DAMAGED/MISSING
Deficiency Location/Instance	Rooms 124, 126, 202, 303, Main Entrance Vestibule, and others
Deficiency Quantity	80
Quantity Uom	S.F.
Potential Action	REPLACE
Urgency of Action	PRIORITY 3
Purpose of Action	LEVEL 2
Deficiency Photo1

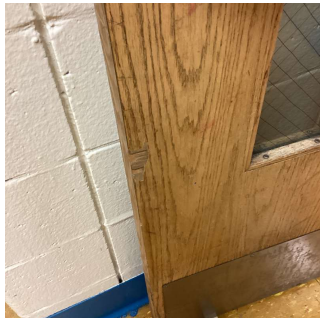
Violations	Main Entrance Vestibule No violations recorded.
Door(s)	Inspected
Condition	5 - Poor
Deficiency	WOOD: DETERIORATED DOOR
Deficiency Location/Instance	Rooms 111, 203, 206, 303, Main Entrance Vestibule, and others
Deficiency Quantity	11
Quantity Uom	EACH
Potential Action	MAINTENANCE
Urgency of Action	PRIORITY 3
Purpose of Action	LEVEL 2
Deficiency Photo1

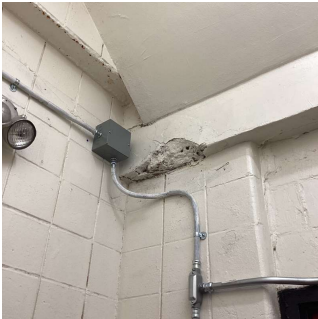
Question	Response
INTERIOR	
SHOWER ROOM	Does not Exist
STAIRS/RAMPS: INTERIOR	Inspected
Do Letter Stair Signs Exist?	Yes
Ceiling	Inspected
Condition	2 - Between Good and Fair
Deficiency	PLASTER: CRACKS/SPALLING
Deficiency Location/Instance	Stair C/1 Vestibule
Deficiency Quantity	10
Quantity Uom	S.F.
Potential Action	REPLACE
Urgency of Action	PRIORITY 3
Purpose of Action	LEVEL 2
Deficiency Photo1

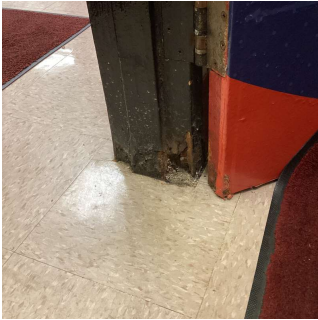
Violations	Stair C/1 Vestibule No violations recorded.
Door(s)	Inspected
Condition	5 - Poor
Deficiency	METAL: DETERIORATED DOOR AND FRAME
Deficiency Location/Instance	Stair C/1
Deficiency Quantity	4
Quantity Uom	EACH
Potential Action	MAINTENANCE
Urgency of Action	PRIORITY 3
Purpose of Action	LEVEL 2
Deficiency Photo1

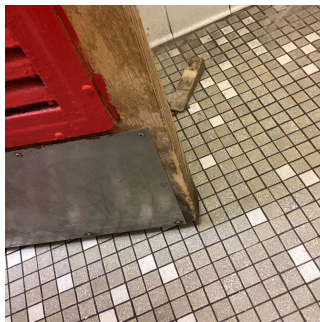
Question	Response
INTERIOR	
STAIRS/RAMPS: INTERIOR	
Walls	
Deficiency Photo1	 
Violations	Stair C/3 No violations recorded.
TOILET ROOMS - STAFF	Inspected
Ceiling	Inspected
Condition	2 - Between Good and Fair
Deficiency	No deficiencies recorded
Door(s)	Inspected
Condition	5 - Poor
Deficiency	WOOD: DETERIORATED DOOR
Deficiency Location/Instance	Rooms 107, 209, 307
Deficiency Quantity	3
Quantity Uom	EACH
Potential Action	MAINTENANCE
Urgency of Action	PRIORITY 3
Purpose of Action	LEVEL 2
Deficiency Photo1

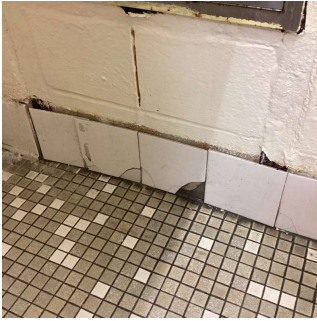
Question	Response
INTERIOR	
TOILET ROOMS - STAFF	
Door(s)	
Deficiency Photo1	 
Violations	Kitchen Staff Toilet No violations recorded.
Floor Finish	Inspected
Condition	2 - Between Good and Fair
Deficiency	No deficiencies recorded
Stalls	Does not Exist
Walls	Inspected
Condition	2 - Between Good and Fair
Deficiency	CERAMIC TILE: BROKEN/ MISSING
Deficiency Location/Instance	Rooms 107, 209
Deficiency Quantity	15
Quantity Uom	S.F.
Potential Action	REPLACE
Urgency of Action	PRIORITY 3
Purpose of Action	LEVEL 2
Deficiency Photo1

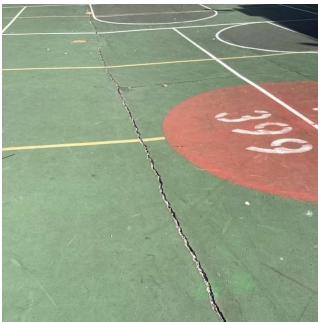
Question	Response
SITE	
FENCES	Inspected
Violations	No violations recorded.
IRRIGATION SYSTEM	Does not Exist
PAVING	Inspected
Student Non-Use	Inspected
Gravel Exists?	No
Asphalt	Does not Exist
Concrete	Inspected
Condition	2 - Between Good and Fair
Deficiency	No deficiencies recorded
Pavers	Does not Exist
Student Use	Inspected
Gravel Exists?	No
Asphalt	Inspected
Condition	4 - Between Fair and Poor
Deficiency	CRACKS - MAJOR
Deficiency Location/Instance	Schoolyard
Deficiency Quantity	600
Quantity Uom	S.F.
Potential Action	REPLACE
Urgency of Action	PRIORITY 3
Purpose of Action	LEVEL 2
Deficiency Photo1
