**NYC Department of Education**  
**Building Condition Assessment Survey 2023 - 2024**

Architectural Inspection

**K401**

**Asset: LAFAYETTE AF - BROOKLYN, 2630 BENSON AVENUE, New York, 11214**

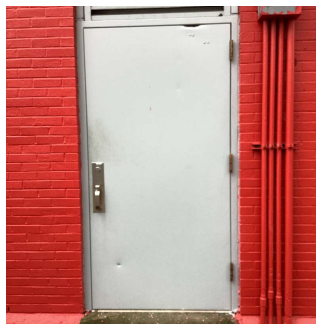
Question	Response
<b>Architectural</b>	
<b>EXTERIOR</b>	Inspected
<b>AREAWAY</b>	Does not Exist
<b>AWNINGS AND CANOPIES</b>	Does not Exist
<b>CHIMNEY</b>	Does not Exist
<b>COPING</b>	Does not Exist
<b>CORNICE</b>	Does not Exist
<b>DOORS</b>	Inspected
<b>DOORS AND FRAMES</b>	Inspected
Condition	5 - Poor
Deficiency	METAL CLAD: DETERIORATED DOOR - MAJOR DETERIORATION

Facade C - Door to Mechanical Equipment Room  
No violations recorded.

1  
EACH  
REPLACE  
PRIORITY 4  
LEVEL 2

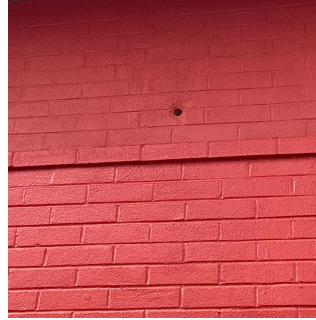
Facade C

Question	Response
<b>EXTERIOR</b>	
<b>DOORS</b>	
<b>DOORS AND FRAMES</b>	
Deficiency Photo1	 
Violations	Facade A - Locker Room Door No violations recorded.
<b>DOOR HARDWARE</b>	Inspected
Condition	2 - Between Good and Fair
Deficiency	No deficiencies recorded
<b>LINTELS</b>	Inspected
Condition	2 - Between Good and Fair
Deficiency	No deficiencies recorded
<b>TRANSOM/SIDE LIGHT</b>	Does not Exist
<b>EXTERIOR WALLS</b>	Inspected
Material Type(s)	Masonry
Replacement Quantity	2,800
Replacement Uom	S.F.
Instance on All Facades	Inspected
Instance Condition	3 - Fair
Instance Quantity	2,800
Instance Quantity Uom	S.F.
Deficiency	<b>BRICK: MINOR CRACKS AND SPALLING</b>
Roof Plan reference	 
Elevation

S.F.  
RESTITCH  
PRIORITY 3  
LEVEL 2

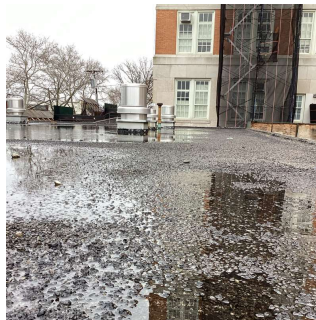
Roof 1  
No violations recorded.

Do solar panels exist on these roofs?	No
Is/Are the roof(s) suitable for Solar Panel installation?	No
Installation Year	2004
Source of Installation	Custodial Staff
Deficiency	BUILT-UP: ROOFING: LOSS OF GRAVEL

100  
S.F.  
INSTALL NEW GRAVEL  
PRIORITY 3  
LEVEL 2

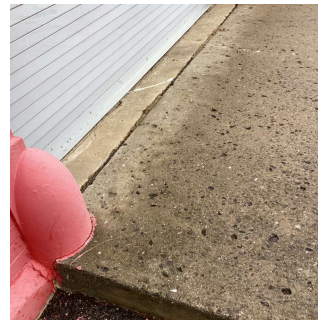
Ramp at Facade B

CONCRETE: CRACKS/SPALLING - MINOR

15  
S.F.  
REPAIR  
PRIORITY 3  
LEVEL 2

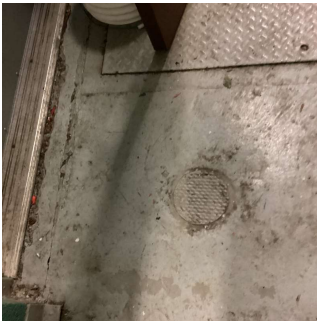
Question	Response
<b>EXTERIOR</b>	
<b>STAIRS/RAMPS: EXTERIOR</b>	
<b>STAIRS/RAMPS</b>	
Deficiency Photo1	 
Violations	Facade A No violations recorded.
<b>WINDOWS</b>	Does not Exist
<b>INTERIOR</b>	Inspected
<b>STRUCTURAL</b>	Inspected
<b>COLUMNS/BEAMS/BEARING WALLS</b>	Inspected
Condition	3 - Fair
Deficiency	CONCRETE COLUMNS/BEAMS: CRACKED/SPALLED/REINFORCEMENT EXPOSED
Deficiency Location/Instance	Corridor next to Mechanical Equipment Room , Equipment Storage Room, Visitors Toilet Room, Storage Room
Deficiency Quantity	80
Quantity Uom	S.F.
Potential Action	REPAIR
Urgency of Action	PRIORITY 3
Purpose of Action	LEVEL 5
Deficiency Photo1	 
Violations	Corridor next to Mechanical Equipment Room No violations recorded.
<b>FLOOR STRUCTURE</b>	Inspected
Condition	2 - Between Good and Fair
Deficiency	CONCRETE SLAB ON GRADE: THRU CRACKS
Deficiency Location/Instance	Mechanical Equipment Room
Deficiency Quantity	10
Quantity Uom	S.F.

Violations	Mechanical Equipment Room No violations recorded.
<b>FOUNDATION WALLS</b>	
Material Type(s)	Inspected Concrete
Condition	2 - Between Good and Fair
Deficiency	No deficiencies recorded
<b>ROOF STRUCTURE</b>	
Condition	Inspected 2 - Between Good and Fair
Deficiency	No deficiencies recorded
<b>VAULTS-BUNKERS</b>	
Does not Exist	
<b>CLASSROOMS/CORRIDORS/ADMIN SPACES</b>	
Inspected	
<b>Ceiling</b>	
Does not Exist	
<b>Door(s)</b>	
Condition	Inspected 2 - Between Good and Fair
Deficiency	No deficiencies recorded
<b>Floor Finish</b>	
Condition	Inspected 2 - Between Good and Fair
Deficiency	No deficiencies recorded
<b>Walls</b>	
Condition	Inspected 2 - Between Good and Fair
Deficiency	No deficiencies recorded
<b>INTERIOR DOOR HARDWARE</b>	
Condition	Inspected 3 - Fair
Deficiency	No deficiencies recorded
<b>LOCKER ROOM</b>

Potential Action	REPAIR
Urgency of Action	PRIORITY 3
Purpose of Action	LEVEL 5

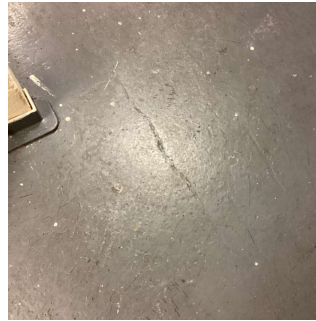
Near Entrance from Exterior

Question	Response
<b>INTERIOR</b>	
<b>LOCKER ROOM</b>	
<b>Door(s)</b>	
Quantity Uom	EACH
Potential Action	MAINTENANCE
Urgency of Action	PRIORITY 3
Purpose of Action	LEVEL 2
Deficiency Photo1	 
Violations	Entrance from South Locker Room No violations recorded.
Instance on 1st Floor - South (51 Lockers)	Inspected
Condition	4 - Between Fair and Poor
Deficiency	METAL: DAMAGED LOUVER
Deficiency Location/Instance	Near Shower Room Area, Uniform Storage Room
Deficiency Quantity	2
Quantity Uom	EACH
Potential Action	MAINTENANCE
Urgency of Action	PRIORITY 3
Purpose of Action	LEVEL 2
Deficiency Photo1	 
Violations	Near Shower Room Area No violations recorded.
<b>Floor Finish</b>	
Instance on 1st Floor - South (51 Lockers)	Inspected
Condition	3 - Fair
Deficiency	CONCRETE: CRACKS
Deficiency Location/Instance	Near Entrance from Exterior, Center
Deficiency Quantity	50
Quantity Uom	S.F.
Potential Action	REPLACE
Urgency of Action	PRIORITY 3

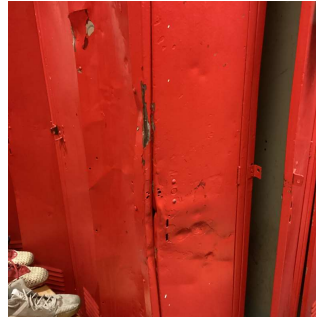
Right Side

Instance on 1st Floor - North (48 Lockers)	Inspected
Condition	5 - Poor
Deficiency	DAMAGED UNITS
Deficiency Location/Instance	Right Side, Left Side
Deficiency Quantity	11
Quantity Uom	EACH
Potential Action	REPLACE
Urgency of Action	PRIORITY 3
Purpose of Action	LEVEL 2
Deficiency Photo1

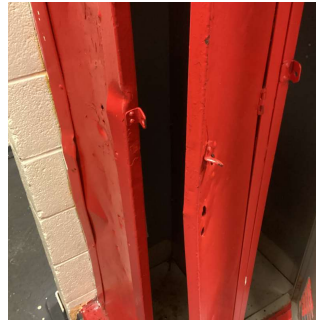
Near Entrance

Instance on 1st Floor - South (51 Lockers)	Inspected
Condition	5 - Poor
Deficiency	DAMAGED UNITS
Deficiency Location/Instance	Near Entrance, Left Side, Right Side
Deficiency Quantity	26
Quantity Uom	EACH
Potential Action	REPLACE
Urgency of Action	PRIORITY 3
Purpose of Action	LEVEL 2

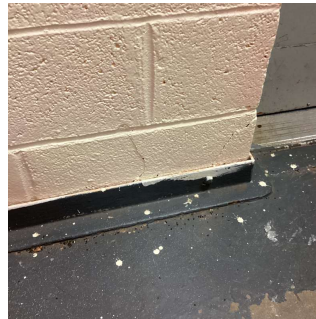
Instance on 1st Floor - North (48 Lockers)	Inspected
Condition	2 - Between Good and Fair
Deficiency	MASONRY: CRACKS/SPALLING
Deficiency Location/Instance	Near Entrance
Deficiency Quantity	10
Quantity Uom	S.F.
Potential Action	REPLACE
Urgency of Action	PRIORITY 3
Purpose of Action	LEVEL 2
Deficiency Photo1

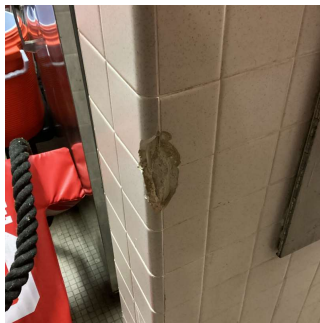
Instance on 1st Floor - South (51 Lockers)	Inspected
Condition	2 - Between Good and Fair
Deficiency	CERAMIC TILE: BROKEN/ MISSING
Deficiency Location/Instance	Near Shower Room
Deficiency Quantity	10
Quantity Uom	S.F.
Potential Action	REPLACE
Urgency of Action	PRIORITY 3
Purpose of Action	LEVEL 2

Violations	Near Shower Room No violations recorded.
<b>SHOWER ROOM</b>	
Instance on 1st Floor - North	Inspected Inaccessible
Instance on 1st Floor - South	Inaccessible
<b>STAIRS/RAMPS: INTERIOR</b>	
Does not Exist	
<b>TOILET ROOMS - STAFF</b>	
Inspected	
<b>Ceiling</b>	Does not Exist
<b>Door(s)</b>	Inaccessible
<b>Floor Finish</b>	Inspected
Condition	3 - Fair
Deficiency	CERAMIC TILE: BROKEN/MISSING TILES
Deficiency Location/Instance	Visitors Toilet South Side
Deficiency Quantity	10
Quantity Uom	S.F.
Potential Action	REPLACE
Urgency of Action	PRIORITY 3
Purpose of Action	LEVEL 2
Deficiency Photo1	 
Violations	Visitors Toilet South Side No violations recorded.
<b>Stalls</b>	
Inspected	
Condition	5 - Poor
Deficiency	RUST - MAJOR
Deficiency Location/Instance	Visitors Toilet South Side
Deficiency Quantity	1
Quantity Uom	EACH
Potential Action	REPLACE

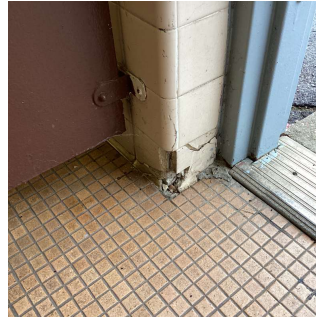
Visitors Toilet South Side  
No violations recorded.

CERAMIC TILE: BROKEN/ MISSING

Visitors Toilet South Side

REPLACE

PRIORITY 3

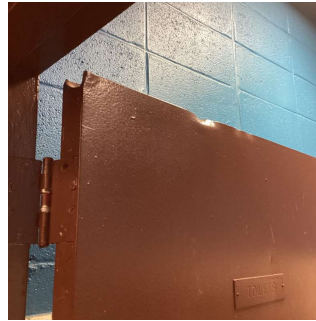
METAL: DETERIORATED DOOR

North Locker Room

MAINTENANCE

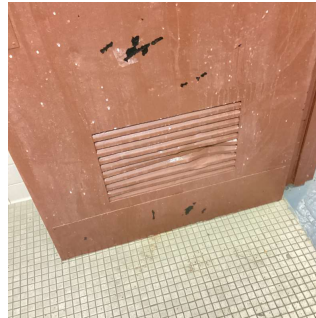
METAL: DAMAGED LOUVER

South Locker Room

MAINTENANCE

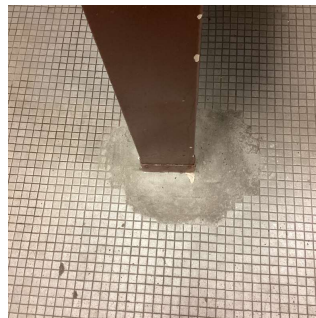
CERAMIC TILE: BROKEN/MISSING TILES

South Locker Room

REPLACE

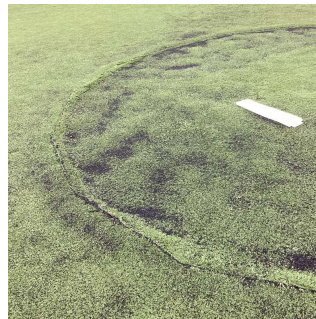
Field  
 No violations recorded.

Replacement Uom	S.F.
Instance on Football/Soccer Field	Inspected
Instance Condition	5 - Poor
Instance Quantity	70,000
Instance Quantity Uom	S.F.

Deficiency **ARTIFICIAL TURF: DAMAGED/WORN OUT**  
 Deficiency Location/Instance **Field**  
 Roof Plan reference

Deficiency Quantity **10,000**  
 Quantity Uom **S.F.**  
 Potential Action **REPLACE**  
 Urgency of Action **PRIORITY 4**  
 Purpose of Action **LEVEL 2**  
 Deficiency Photo1

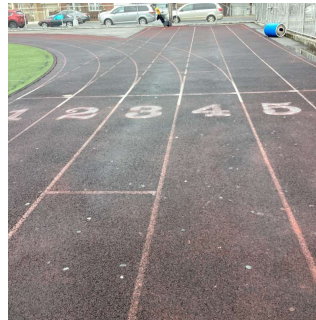
Perimeter Track  
No violations recorded.

Violations	No violations recorded.
Instance on Running Track	Inspected
Instance Condition	5 - Poor
Instance Quantity	27,000
Instance Quantity Uom	S.F.
Deficiency	<b>ATHLETIC WEARING SURFACE: DAMAGED/DETERIORATED</b>
Deficiency Location/Instance	<b>Perimeter Track</b>

5,000  
S.F.  
REPLACE  
PRIORITY 4  
LEVEL 2

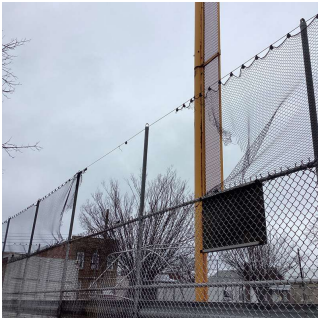
Condition	4 - Between Fair and Poor
Deficiency	CHAIN LINK: MISSING SECTIONS
Deficiency Location/Instance	27th Avenue, Bath Avenue
Deficiency Quantity	200
Quantity Uom	S.F.
Potential Action	REPLACE
Urgency of Action	PRIORITY 3
Purpose of Action	LEVEL 2
Deficiency Photo1
