NYC Department of Education
Building Condition Assessment Survey 2023 - 2024

Architectural Inspection

Asset: 3K CENTER @ 1326 EAST 57 STREET - BROOKLYN, 1326 EAST 57TH STREET, 11234

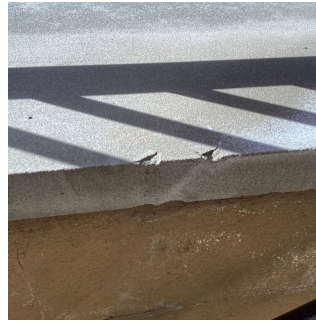
AW2

Question	Response
Architectural	
EXTERIOR	Inspected
AREAWAY	Inspected
Instance on AW1-AW4	Inspected
Instance Condition	3 - Fair
Instance Quantity	4
Instance Quantity Uom	EACH
Deficiency	AREAWAY WALLS: DETERIORATED COPING STONE
Roof Plan reference	K402
Deficiency Quantity	20
Quantity Uom	S.F.
Potential Action	REPAIR
Urgency of Action	PRIORITY 3
Purpose of Action	LEVEL 2

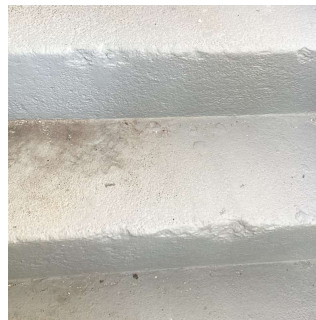
AW2

**AREAWAY STAIRS: DETERIORATED
TREADS/RISERS/NOSINGS**

70

REPAIR

PRIORITY 3

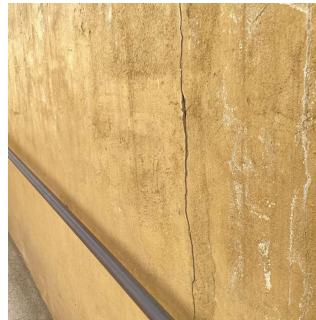
AW2
No violations recorded.

AREAWAY WALLS: CRACKS AND SPALLING

25
S.F.
REPLACE
PRIORITY 4
LEVEL 2

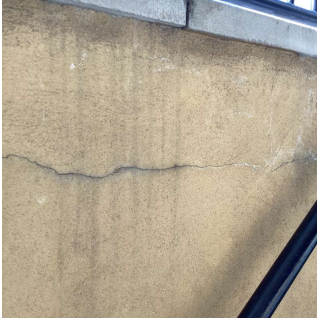
AREAWAY WALLS: CRACKS AND SPALLING

45
S.F.
REPAIR
PRIORITY 3
LEVEL 2

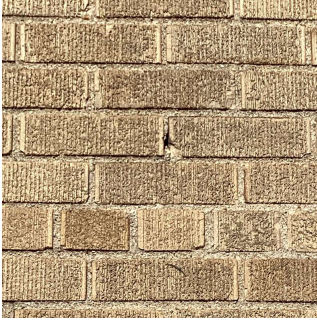
Violations	AW2 No violations recorded.
AWNINGS AND CANOPIES	
Condition	Inspected 2 - Between Good and Fair
Deficiency	No deficiencies recorded
CHIMNEY	
Material Type(s)	Inspected Masonry
Condition	3 - Fair
Deficiency	BRICK: DETERIORATED JOINTS
Roof Plan reference	<p>K402</p>

<p>East 57th Street</p>
Deficiency Quantity	10
Quantity Uom	S.F.
Potential Action	REPOINT
Urgency of Action	PRIORITY 4
Purpose of Action	LEVEL 2
Deficiency Photo1

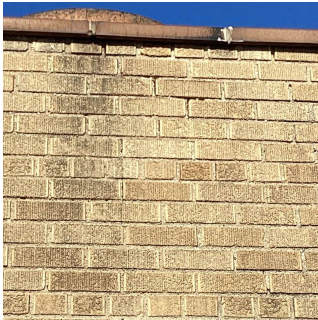
Violations	CH No violations recorded.
Deficiency	BRICK: DETERIORATED JOINTS

Deficiency Quantity	15
Quantity Uom	S.F.
Potential Action	REPOINT
Urgency of Action	PRIORITY 3
Purpose of Action	LEVEL 2
Deficiency Photo1

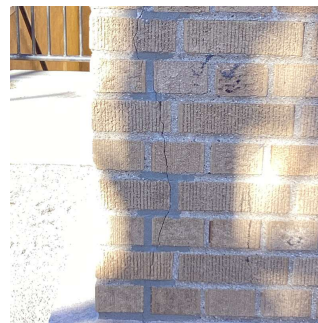
Facade B

BRICK: CRACKS/DISPLACED/SPALLED BRICK AT BUILDING CORNERS

80

REMOVE AND REBUILD

PRIORITY 4

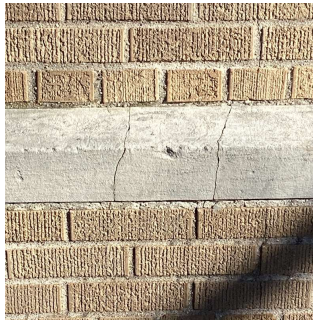
Facade C

STONE: CHIPPED/SPALLED/BROKEN PIECES - MINOR

150

REPAIR

PRIORITY 3

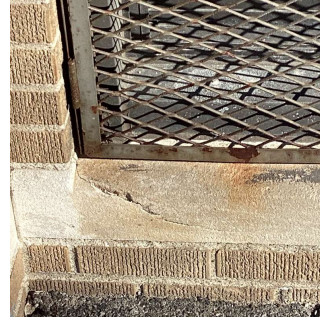
Facade C

BRICK: DETERIORATED MASONRY SILLS - MINOR

20

REPAIR

PRIORITY 3
LEVEL 2

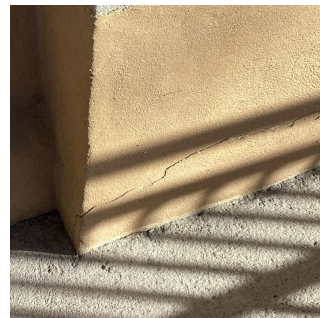
Facade C

STUCCO CEMENT SURFACE: CRACKS, SPALLING

20

REPLACE

PRIORITY 4

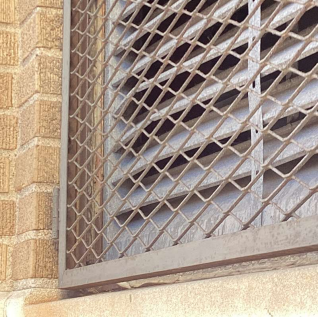
Question	Response
EXTERIOR	
EXTERIOR WALLS	Inspected
Violations	No violations recorded.
EXTERIOR SOFFITS	Does not Exist
LOADING DOCK	Does not Exist
LOUVER	Inspected
Condition	3 - Fair
Deficiency	BROKEN/ DENTED BLADES
Roof Plan reference	<p>K402</p>

Deficiency Quantity	60
Quantity Uom	S.F.
Potential Action	REPLACE
Urgency of Action	PRIORITY 4
Purpose of Action	LEVEL 2
Deficiency Photo1

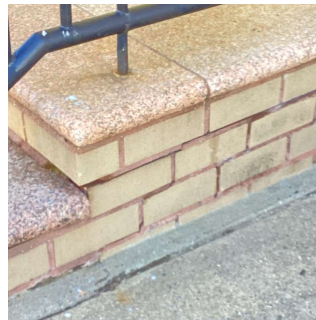
Facade D

BRICK: CRACKS/SPALLING - MINOR

20
 S.F.
 REPAIR
 PRIORITY 3
 LEVEL 2

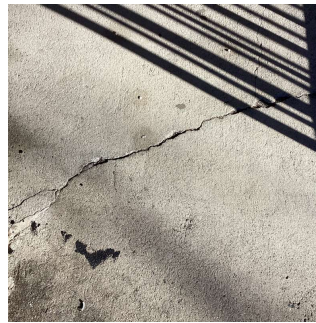
Facade C

Inspected
 4 - Between Fair and Poor
CONCRETE: CRACKS/SPALLING - MAJOR

20
 S.F.
 REPLACE
 PRIORITY 4
 LEVEL 2

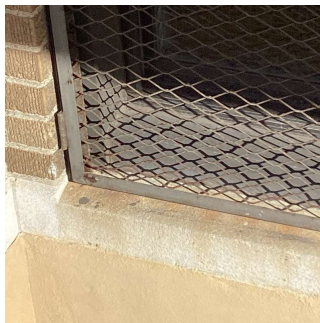
DETERIORATED/TORN-OUT/MISSING

150

REPLACE

PRIORITY 4

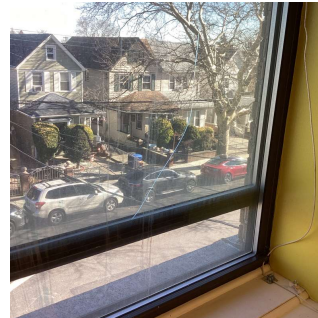
Facade A - Room 201

Violations	Facade C No violations recorded.
LINTELS	Inspected
Condition	2 - Between Good and Fair
Deficiency	No deficiencies recorded
WINDOWS	Inspected
Material Type(s)	Aluminum
Instance on Aluminum - Double Hung: All Facades	Inspected
Instance Condition	5 - Poor
Instance Quantity	600
Instance Quantity Uom	S.F.
Are these windows insulated	Yes
Installation Year	2000
Source of Installation	Custodial Staff
Deficiency	ALUMINUM - DOUBLE HUNG: BROKEN PANE
Roof Plan reference	K402

Deficiency Quantity	30
Quantity Uom	S.F.
Potential Action	MAINTENANCE
Urgency of Action	PRIORITY 3

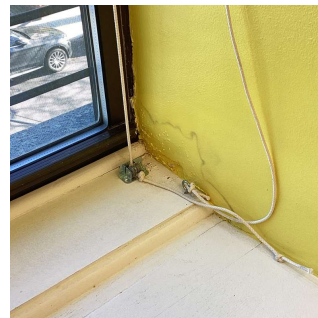
ALUMINUM - DOUBLE HUNG: AIR/WATER INFILTRATION

200

REPLACE TRIM, SILLS OR WEATHERSTRIPPING

PRIORITY 5

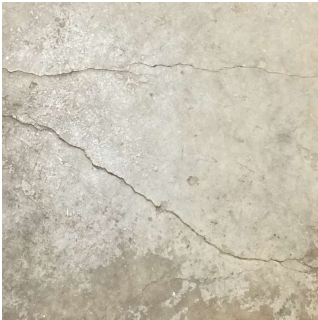
Question	Response
EXTERIOR	Inspected
WINDOWS	Inspected
WINDOWS	
Violations	Facade A - Room 201 (Facade A - Rooms 101, 105, 107, 109, 203, 205, 207 similar) No violations recorded.
INTERIOR	Inspected
POOLS	Does not Exist
STRUCTURAL	Inspected
COLUMNS/BEAMS/BEARING WALLS	Inspected
Condition	2 - Between Good and Fair
Deficiency	No deficiencies recorded
FLOOR STRUCTURE	Inspected
Condition	3 - Fair
Deficiency	CONCRETE SLAB ON GRADE: THRU CRACKS
Deficiency Location/Instance	Basement
Deficiency Quantity	60
Quantity Uom	S.F.
Potential Action	REPAIR
Urgency of Action	PRIORITY 3
Purpose of Action	LEVEL 5
Deficiency Photo1

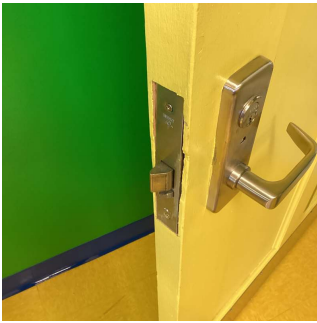
Question	Response
INTERIOR	Inspected
STRUCTURAL	
FOUNDATION WALLS	
Deficiency Photo1	 
Violations	Boiler Room No violations recorded.
ROOF STRUCTURE	Not Required
VAULTS-BUNKERS	Does not Exist
AUDITORIUM	Does not Exist
CAFETERIA	Does not Exist
CLASSROOMS/CORRIDORS/ADMIN SPACES	Inspected
Ceiling	Inspected
Condition	2 - Between Good and Fair
Deficiency	PLASTER: CRACKS/SPALLING - ACTIVE LEAK
Deficiency Location/Instance	Room 203
Deficiency Quantity	15
Quantity Uom	S.F.
Potential Action	REPLACE
Urgency of Action	PRIORITY 5
Purpose of Action	LEVEL 2
Deficiency Photo1	 
Violations	Room 203 No violations recorded.
Door(s)	Inspected
Condition	5 - Poor
Deficiency	WOOD: DETERIORATED DOOR
Deficiency Location/Instance	Rooms 106, 109, 202, 203, 207 and others
Deficiency Quantity	7
Quantity Uom	EACH
Potential Action	MAINTENANCE
Urgency of Action	PRIORITY 3
Purpose of Action	LEVEL 2

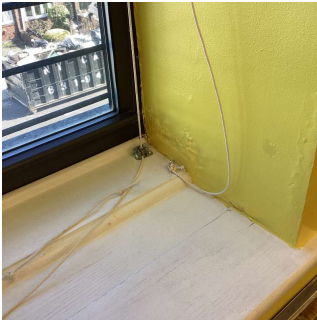
Violations	Room 207 No violations recorded.
Floor Finish	Inspected
Condition	2 - Between Good and Fair
Deficiency	No deficiencies recorded
Walls	Inspected
Condition	2 - Between Good and Fair
Deficiency	PLASTER: CRACKS/SPALLING - ACTIVE LEAK
Deficiency Location/Instance	Rooms 101, 105, 107, 109, 201, 205, 207
Deficiency Quantity	100
Quantity Uom	S.F.
Potential Action	REPLACE
Urgency of Action	PRIORITY 5
Purpose of Action	LEVEL 2
Deficiency Photo1

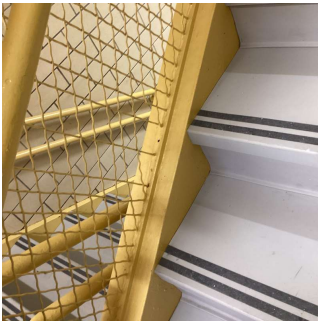
Violations	Room 207 No violations recorded.
Specialties	Does not Exist
GYMNASIUM	Does not Exist
INTERIOR DOOR HARDWARE	Inspected
Condition	2 - Between Good and Fair
Deficiency	No deficiencies recorded
INTERIOR GUARDS	Inspected
Condition	2 - Between Good and Fair
Deficiency	DETERIORATED/TORN-OUT/MISSING
Deficiency Location/Instance	Stair A/Basement
Deficiency Quantity	20
Quantity Uom	S.F.

Potential Action	REPLACE
Urgency of Action	PRIORITY 3

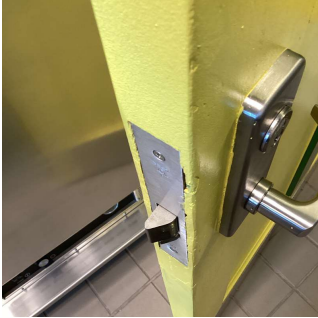
Question	Response
INTERIOR	
KITCHEN	
Door(s)	
Condition	3 - Fair
Deficiency	WOOD: DETERIORATED DOOR
Deficiency Location/Instance	Entrance
Deficiency Quantity	1
Quantity Uom	EACH
Potential Action	MAINTENANCE
Urgency of Action	PRIORITY 3
Purpose of Action	LEVEL 2
Deficiency Photo1

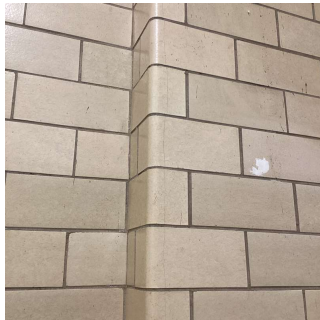
Question	Response
INTERIOR	
STAIRS/RAMPS: INTERIOR	
Ceiling	Inspected
Condition	2 - Between Good and Fair
Deficiency	No deficiencies recorded
Door(s)	Inspected
Condition	2 - Between Good and Fair
Deficiency	No deficiencies recorded
Partition	Does not Exist
Railings	Inspected
Condition	2 - Between Good and Fair
Deficiency	No deficiencies recorded
Stairs and Landings	Inspected
Condition	2 - Between Good and Fair
Deficiency	No deficiencies recorded
Walls	Inspected
Condition	2 - Between Good and Fair
Deficiency	GLAZED BLOCK: CRACKS/SPALLING
Deficiency Location/Instance	Stair A/1
Deficiency Quantity	10
Quantity Uom	S.F.
Potential Action	REPLACE
Urgency of Action	PRIORITY 3
Purpose of Action	LEVEL 2
Deficiency Photo1

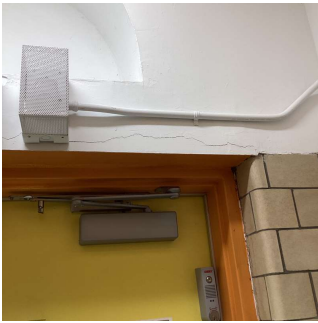
Violations	Stair A/1 No violations recorded.
Deficiency	PLASTER: CRACKS/SPALLING
Deficiency Location/Instance	Stair A/1
Deficiency Quantity	10
Quantity Uom	S.F.
Potential Action	REPLACE
Urgency of Action	PRIORITY 3

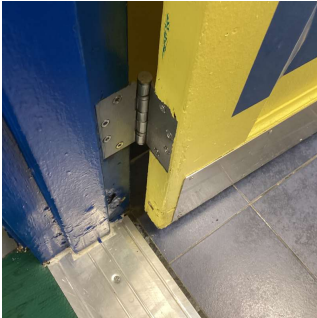
Question	Response
INTERIOR	
TOILET ROOMS - STUDENTS	
Door(s)	
Violations	Room 202A No violations recorded.
Deficiency	WOOD: DETERIORATED DOOR AND FRAME
Deficiency Location/Instance	Room B08
Deficiency Quantity	1
Quantity Uom	EACH
Potential Action	MAINTENANCE
Urgency of Action	PRIORITY 3
Purpose of Action	LEVEL 2
Deficiency Photo1

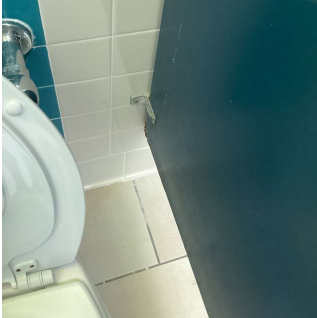
Violations	Room B08 No violations recorded.
Floor Finish	Inspected
Condition	1 - Good
Deficiency	No deficiencies recorded
Stalls	Inspected
Condition	5 - Poor
Deficiency	RUST - MAJOR
Deficiency Location/Instance	Room 202A
Deficiency Quantity	4
Quantity Uom	EACH
Potential Action	REPLACE
Urgency of Action	PRIORITY 3
Purpose of Action	LEVEL 2
Deficiency Photo1
