**NYC Department of Education
Building Condition Assessment Survey 2023 - 2024**

Architectural Inspection

Asset: 3K CENTER @ 337 74TH STREET - BROOKLYN, 337 74TH STREET, 11209

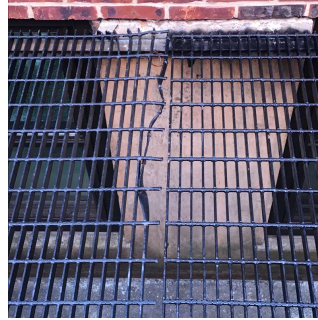
Facade C - AW1

AREAWAY SLAB: CRACKS AND SPALLING

Potential Action

REPAIR

Urgency of Action

PRIORITY 3

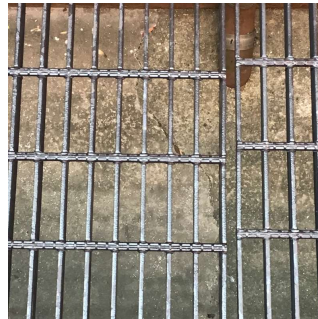
AREAWAY WALLS: CRACKS AND SPALLING

Deficiency Quantity	50
Quantity Uom	S.F.
Potential Action	REPAIR
Urgency of Action	PRIORITY 3
Purpose of Action	LEVEL 2
Deficiency Photo1	 
Violations	Facade C - AW1 No violations recorded.
AWNINGS AND CANOPIES	Does not Exist
CHIMNEY	Inspected
Material Type(s)	Masonry
Condition	2 - Between Good and Fair
Deficiency	No deficiencies recorded
COPING	Inspected
Condition	1 - Good
Deficiency	No deficiencies recorded
CORNICE	Does not Exist
DOORS	Inspected
DOORS AND FRAMES	Inspected
Condition	2 - Between Good and Fair
Deficiency	No deficiencies recorded
DOOR HARDWARE	Inspected
Condition	3 - Fair
Deficiency	No deficiencies recorded
LINTELS	Inspected
Condition	2 - Between Good and Fair
Deficiency	No deficiencies recorded
TRANSOM/SIDE LIGHT	Inspected
Condition	2 - Between Good and Fair
Deficiency	No deficiencies recorded

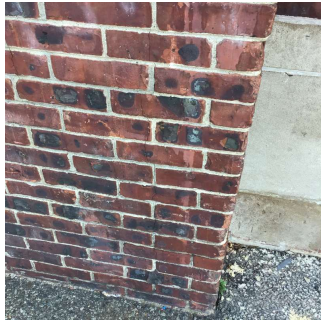
Question	Response
EXTERIOR	
EXTERIOR WALLS	Inspected
Material Type(s)	Masonry
Replacement Quantity	12,400
Replacement Uom	S.F.
Instance on All Facades	Inspected
Instance Condition	3 - Fair
Instance Quantity	12,400
Instance Quantity Uom	S.F.
Deficiency	BRICK: MINOR CRACKS AND SPALLING
Roof Plan reference	<p>K404</p>

Violations	Facade B No violations recorded.
Deficiency	STONE: CHIPPED/SPALLED/BROKEN PIECES - MINOR

Deficiency Quantity	100
Quantity Uom	S.F.
Potential Action	RESTITCH
Urgency of Action	PRIORITY 3
Purpose of Action	LEVEL 2
Deficiency Photo1

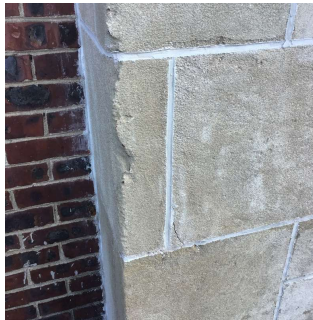
Facade B

BRICK: CRACKS/DISPLACED/SPALLED BRICK AT BUILDING CORNERS

Deficiency Quantity

20

Potential Action

REMOVE AND REBUILD

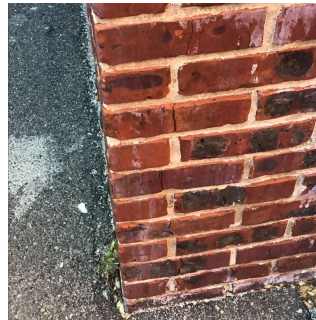
Facade C - Near AW1

BRICK: DETERIORATED MASONRY SILLS - MAJOR

Potential Action

REMOVE AND REPLACE

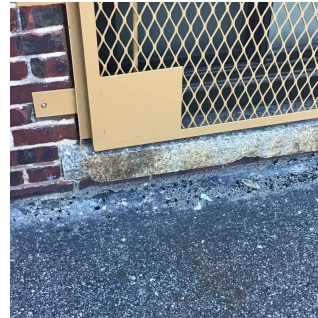
Facade C

BRICK: DETERIORATED MASONRY SILLS - MINOR

Potential Action

REPAIR

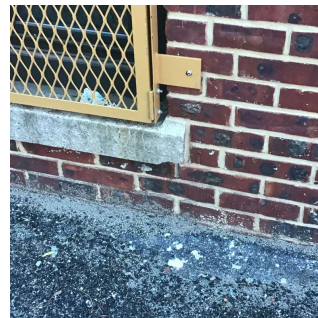
Facade C

BRICK: MAJOR / THRU CRACKS

Potential Action

REMOVE AND REBUILD

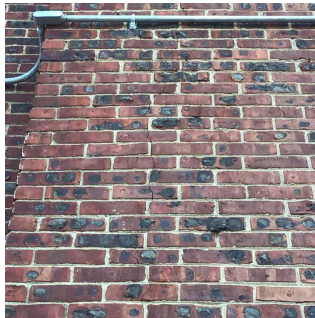
Facade B

BRICK: DETERIORATED JOINTS

Deficiency Quantity	1,000
Quantity Uom	S.F.
Potential Action	REPOINT
Urgency of Action	PRIORITY 3
Purpose of Action	LEVEL 2
Deficiency Photo1

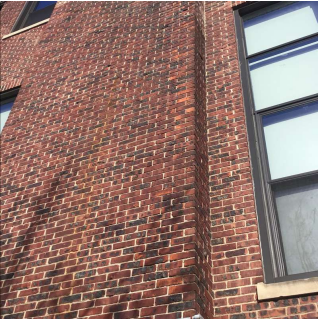
Violations	Facade A No violations recorded.
EXTERIOR SOFFITS	Does not Exist
LOADING DOCK	Does not Exist
LOUVER	Inspected
Condition	2 - Between Good and Fair
Deficiency	No deficiencies recorded
PARAPETS	Inspected
Material Type(s)	Masonry
Replacement Quantity	2,500
Replacement Uom	C.F.
Instance on All Facades	Inspected
Instance Condition	3 - Fair
Instance Quantity	2,500
Instance Quantity Uom	C.F.
Deficiency	BRICK: MINOR CRACKS, SPALLING

100
S.F.
REPAIR
PRIORITY 3
LEVEL 2

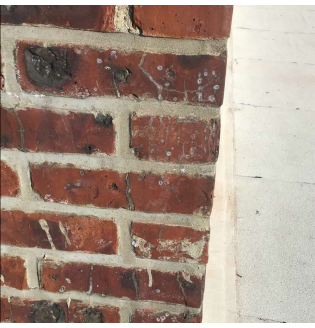
Violations	Roof 1 - BH No violations recorded.

Question	Response
EXTERIOR	
ROOF	
Roofing	
ROOFING	
Instance Quantity	16,400
Instance Quantity Uom	S.F.
Does the roof have major mechanical equipment sitting on Dunnage Steel less than 18" above the Roofing?	No
Does this roof instance have a Sustainable Roof System?	Yes
Sustainable Roof Type	White Roof
Sustainable Roof Location (Roof Number)	Roofs 1 - 3
Do solar panels exist on these roofs?	No
Is/Are the roof(s) suitable for Solar Panel installation?	Yes
Installation Year	2022
Source of Installation	Custodial Staff
Deficiency	No deficiencies recorded
ROOFING DRAINS	Does not Exist
Specialties	Inspected
BULKHEAD/PENTHOUSE	Inspected
Condition	3 - Fair
Deficiency	BULKHEAD/PENTHOUSE WALLS/EXTERIOR: CRACKS/SPALLING - MINOR
Roof Plan reference	K404

Deficiency Quantity	20
Quantity Uom	S.F.
Potential Action	REPAIR
Urgency of Action	PRIORITY 3
Purpose of Action	LEVEL 2
Deficiency Photo1

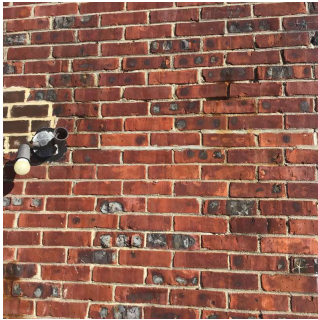
Deficiency	BULKHEAD/PENTHOUSE WALLS/EXTERIOR: DETERIORATED JOINTS

Deficiency Quantity	100
Quantity Uom	S.F.
Potential Action	REPOINT
Urgency of Action	PRIORITY 3
Purpose of Action	LEVEL 2
Deficiency Photo1

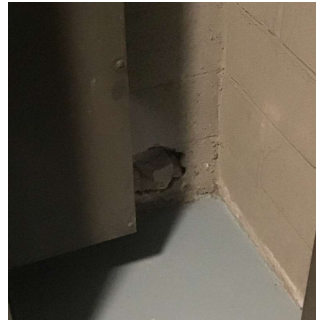
Room B112

CONCRETE: CRACKED/SPALLED/REINFORCEMENT EXPOSED

Deficiency Location/Instance

Basement - Elevator Machine Room, Electrical Room B110

Potential Action

REPAIR

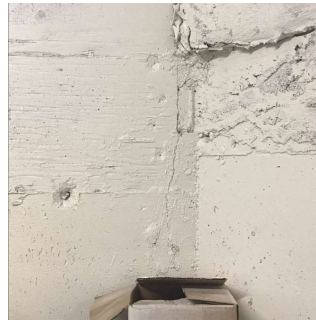
CONCRETE: WATER INFILTRATION IN ELECTRICAL PANEL ROOM

Basement - Electrical Room B110

Potential Action

INSTALL WATERPROOFING

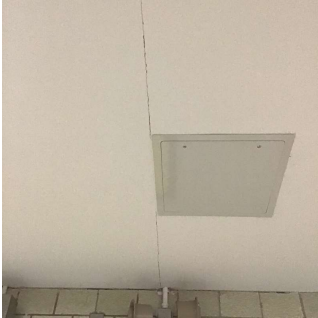
Question	Response
INTERIOR	
CLASSROOMS/CORRIDORS/ADMIN SPACES	Inspected
Ceiling	Inspected
Condition	2 - Between Good and Fair
Deficiency	GYPSUM BOARD: DAMAGED/DETERIORATED
Deficiency Location/Instance	Rooms 310,202,B104, Corridor near Rooms 312,103 and others
Deficiency Quantity	320
Quantity Uom	S.F.
Potential Action	REPLACE
Urgency of Action	PRIORITY 3
Purpose of Action	LEVEL 2
Deficiency Photo1

Corridor near Room 103
Violations	No violations recorded.
Door(s)	Inspected
Condition	1 - Good
Deficiency	No deficiencies recorded
Floor Finish	Inspected
Condition	2 - Between Good and Fair
Deficiency	TERRAZZO: CRACKS
Deficiency Location/Instance	Room 104, Corridor near Room 302, By Cafeteria, Next to Stair A/Basement
Deficiency Quantity	40
Quantity Uom	S.F.
Potential Action	REPLACE
Urgency of Action	PRIORITY 3
Purpose of Action	LEVEL 2
Deficiency Photo1

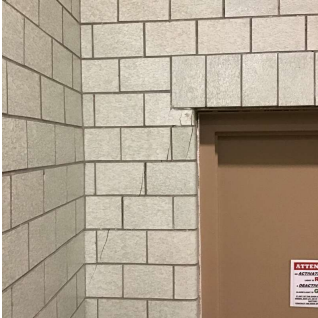
Question	Response
INTERIOR	
CLASSROOMS/CORRIDORS/ADMIN SPACES	
Walls	
Deficiency Location/Instance	Near East Exit - Vestibule, By Stairs A/3,Basement, D/1, Room 113 and others
Deficiency Quantity	60
Quantity Uom	S.F.
Potential Action	REPLACE
Urgency of Action	PRIORITY 3
Purpose of Action	LEVEL 2
Deficiency Photo1

Violations	Near East Exit - Vestibule No violations recorded.
Deficiency	GYPSUM BOARD: DETERIORATED
Deficiency Location/Instance	Room 104
Deficiency Quantity	20
Quantity Uom	S.F.
Potential Action	REPLACE
Urgency of Action	PRIORITY 3
Purpose of Action	LEVEL 2
Deficiency Photo1	 
Violations	Room 104 No violations recorded.
Specialties	Does not Exist
GYMNASIUM	Inspected
Instance on 1st Floor	Inspected
Ceiling	
Instance on 1st Floor	Inspected
Condition	2 - Between Good and Fair
Deficiency	GYPSUM BOARD: DAMAGED/DETERIORATED
Deficiency Location/Instance	Near Bleachers
Deficiency Quantity	10
Quantity Uom	S.F.
Potential Action	REPLACE

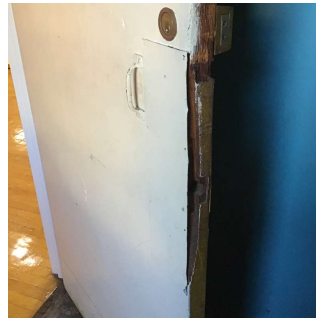
Room 111A

Deficiency	WOOD: DETERIORATED DOOR
Deficiency Location/Instance	Rooms 117,111A,110
Deficiency Quantity	4
Quantity Uom	EACH
Potential Action	MAINTENANCE
Urgency of Action	PRIORITY 3
Purpose of Action	LEVEL 2
Deficiency Photo1

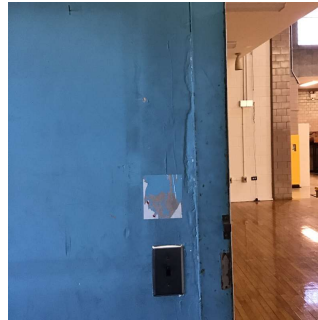
Room 111A

WALL PADDING: DETERIORATED

REPLACE

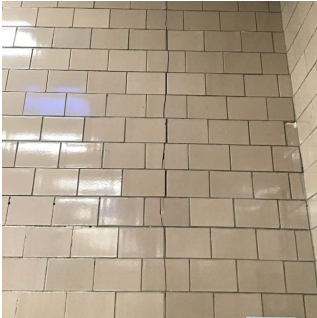
Question	Response
INTERIOR	
GYMNASIUM	
Walls	
Deficiency	GLAZED BLOCK: CRACKS/SPALLING
Deficiency Location/Instance	Near Rooms 114,113
Deficiency Quantity	30
Quantity Uom	S.F.
Potential Action	REPLACE
Urgency of Action	PRIORITY 3
Purpose of Action	LEVEL 2
Deficiency Photo1

Near Room 113
Violations	No violations recorded.
Deficiency	CERAMIC TILE: BROKEN/ MISSING
Deficiency Location/Instance	Near Stairs A and B, By Room 116, Center, Next to Glass Blocks
Deficiency Quantity	70
Quantity Uom	S.F.
Potential Action	REPLACE
Urgency of Action	PRIORITY 3
Purpose of Action	LEVEL 2
Deficiency Photo1

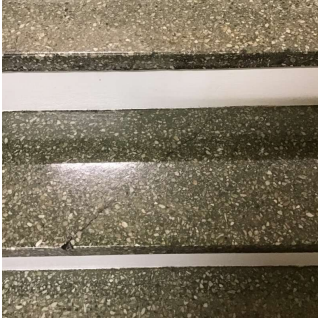
Question	Response
INTERIOR	
STAIRS/RAMPS: INTERIOR	
Stairs and Landings	
Condition	2 - Between Good and Fair
Deficiency	TERRAZZO: CRACKS
Deficiency Location/Instance	Stairs A/2, D/2,1,Basement, Corridor near East Exit - Vestibule and others
Deficiency Quantity	80
Quantity Uom	S.F.
Potential Action	REPLACE
Urgency of Action	PRIORITY 3
Purpose of Action	LEVEL 2
Deficiency Photo1

Violations	Stair D/2 No violations recorded.
Walls	Inspected
Condition	2 - Between Good and Fair
Deficiency	STONE: CRACKS/SPALLING
Deficiency Location/Instance	Room 205
Deficiency Quantity	10
Quantity Uom	S.F.
Potential Action	REPLACE
Urgency of Action	PRIORITY 3
Purpose of Action	LEVEL 2
Deficiency Photo1

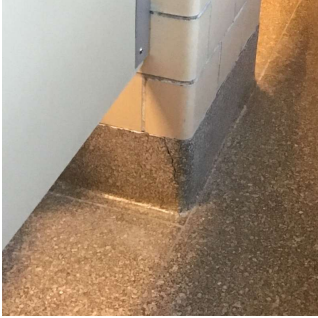
Violations	Room 205 No violations recorded.
Deficiency	GLAZED BLOCK: CRACKS/SPALLING
Deficiency Location/Instance	Stairs A/1, D/3,2,1, Exit A - Vestibule and others
Deficiency Quantity	70
Quantity Uom	S.F.
Potential Action	REPLACE
Urgency of Action	PRIORITY 3
