NYC Department of Education
Building Condition Assessment Survey 2023 - 2024

Architectural Inspection

Asset: MIDWOOD AF (MAIN) - BROOKLYN, 1124 EAST 17TH STREET, New York, 11210

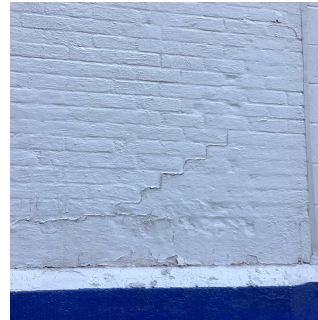
Facade B - Garage

BRICK: MAJOR / THRU CRACKS

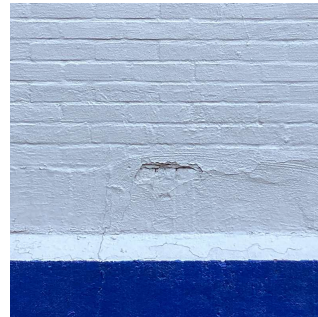
Facade B - Garage

CONCRETE MASONRY UNIT: MINOR CRACKS AND SPALLING

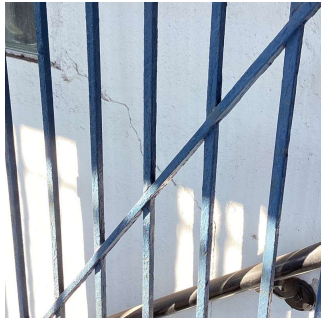
Violations	Facade A - Grandstand No violations recorded.
EXTERIOR SOFFITS	Does not Exist
LOUVER	Inspected
Condition	2 - Between Good and Fair
Deficiency	No deficiencies recorded
PARAPETS	Inspected
Material Type(s)	Concrete
Replacement Quantity	800
Replacement Uom	C.F.
Instance on Facade C - Grandstand	Inspected
Instance Condition	5 - Poor
Instance Quantity	800
Instance Quantity Uom	C.F.
Deficiency	CONCRETE: MAJOR DETERIORATION/CRACKS
Roof Plan reference

Deficiency Quantity	60
Quantity Uom	S.F.
Potential Action	REMOVE AND REBUILD
Urgency of Action	PRIORITY 4
Purpose of Action	LEVEL 2

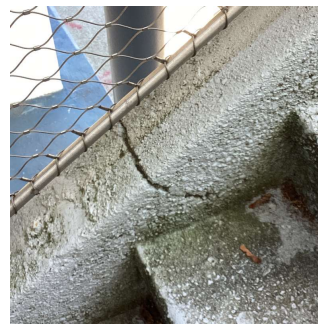
Facade D - Grandstand
No violations recorded.

Is/Are the roof(s) suitable for Solar Panel installation?	No
Installation Year	2018
Source of Installation	Custodial Staff
Deficiency	No deficiencies recorded
ROOFING DRAINS	Inspected
Condition	2 - Between Good and Fair
Deficiency	No deficiencies recorded
Specialties	Does not Exist
STAIRS/RAMPS: EXTERIOR	Inspected
BUILDING CHEEK/FLANK WALLS	Inspected
Condition	3 - Fair
Deficiency	CAST IN PLACE CONCRETE: CRACKS/SPALLING - MINOR

40
S.F.
REPAIR
PRIORITY 3
LEVEL 2

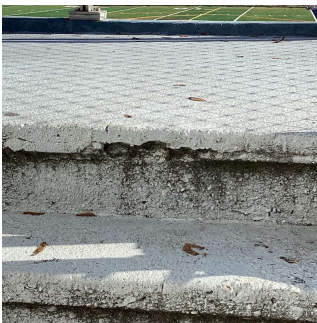
Violations	Facade B - Grandstand No violations recorded.
Deficiency	CONCRETE: CRACKS/SPALLING - MINOR
Roof Plan reference

Deficiency Quantity	10
Quantity Uom	S.F.
Potential Action	REPAIR
Urgency of Action	PRIORITY 3
Purpose of Action	LEVEL 2
Deficiency Photo1

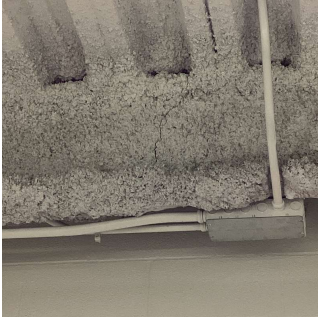
Office Storage
Violations	No violations recorded.
Deficiency	STEEL COLUMNS/BEAMS: DETERIORATED CONCRETE FIREPROOFING
Deficiency Location/Instance	1st Floor
Deficiency Quantity	10
Quantity Uom	S.F.
Potential Action	REPLACE
Urgency of Action	PRIORITY 4

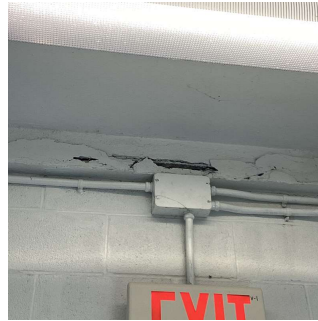
Stairwell B/1

STEEL COLUMNS/BEAMS: MAJOR RUSTING

REPLACE

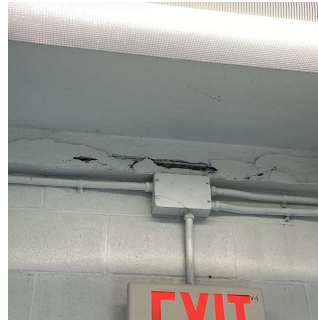
Stairwell B/1

**CONCRETE BEARING WALL:
CRACKED/SPALLED/REINFORCEMENT EXPOSED**

REPAIR

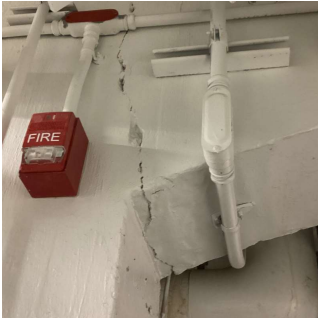
Violations	Boiler Room (2nd Floor Corridor similar) No violations recorded.
Deficiency	CONCRETE COLUMNS/BEAMS: CRACKED/SPALLED/REINFORCEMENT EXPOSED
Deficiency Location/Instance	Grandstand
Deficiency Quantity	35
Quantity Uom	S.F.
Potential Action	REPAIR
Urgency of Action	PRIORITY 3
Purpose of Action	LEVEL 5
Deficiency Photo1

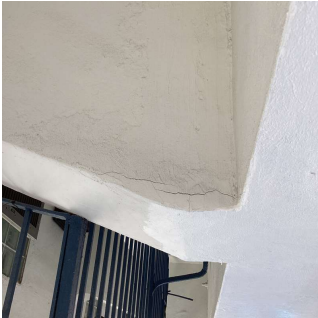
Violations	Grandstand No violations recorded.
Deficiency	CONCRETE COLUMNS/BEAMS: CRACKED/SPALLED/REINFORCEMENT EXPOSED
Deficiency Location/Instance	Grandstand
Deficiency Quantity	30
Quantity Uom	S.F.
Potential Action	REPLACE
Urgency of Action	PRIORITY 4

Purpose of Action	LEVEL 5

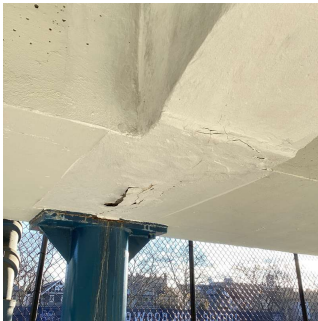
Violations	Grandstand 35672562L
Deficiency	CONCRETE COLUMNS/BEAMS: CRACKED/SPALLED/REINFORCEMENT EXPOSED
Deficiency Location/Instance	Grandstand
Deficiency Quantity	40
Quantity Uom	S.F.
Potential Action	REPLACE
Urgency of Action	PRIORITY 5
Purpose of Action	LEVEL 6
Deficiency Photo1

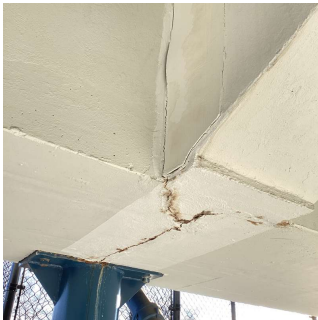
Violations	Grandstand No violations recorded.
FLOOR STRUCTURE	
Condition	Inspected 3 - Fair
Deficiency	CONCRETE: CRACKS/SPALLED/REINFORCEMENT EXPOSED
Deficiency Location/Instance	2nd Floor
Deficiency Quantity	25
Quantity Uom	S.F.
Potential Action	REPAIR
Urgency of Action	PRIORITY 3
Purpose of Action	LEVEL 5
Deficiency Photo1

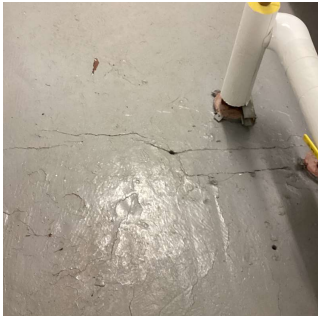
Question	Response
INTERIOR	
STRUCTURAL	
FLOOR STRUCTURE	
Violations	Room 202 No violations recorded.
Deficiency	CONCRETE SLAB ON GRADE: THRU CRACKS
Deficiency Location/Instance	Basement
Deficiency Quantity	50
Quantity Uom	S.F.
Potential Action	REPAIR
Urgency of Action	PRIORITY 3
Purpose of Action	LEVEL 5
Deficiency Photo1	 
Violations	Boiler Room - Grandstand (Garage similar) No violations recorded.
Deficiency	CONCRETE SLAB ON GRADE: THRU CRACKS
Deficiency Location/Instance	Basement
Deficiency Quantity	30
Quantity Uom	S.F.
Potential Action	REPLACE
Urgency of Action	PRIORITY 4
Purpose of Action	LEVEL 5
Deficiency Photo1

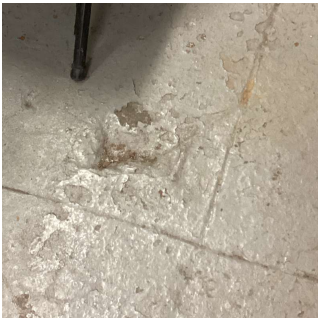
Violations	Boiler Room No violations recorded.
FOUNDATION WALLS	
Material Type(s)	Inspected Concrete
Condition	3 - Fair
Deficiency	CONCRETE: CRACKED/SPALLED/REINFORCEMENT EXPOSED
Deficiency Location/Instance	Garage
Deficiency Quantity	50
Quantity Uom	S.F.
Potential Action	REPAIR

Question	Response
INTERIOR	
STRUCTURAL	
FOUNDATION WALLS	
Urgency of Action	PRIORITY 3
Purpose of Action	LEVEL 5
Deficiency Photo1

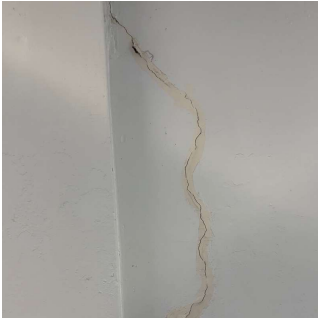
Corridor between Stairwells
No violations recorded.

Deficiency	PLASTER: CRACKS/SPALLING - ACTIVE LEAK
Deficiency Location/Instance	Corridor between Stairwells
Deficiency Quantity	15
Quantity Uom	S.F.
Potential Action	REPLACE
Urgency of Action	PRIORITY 5
Purpose of Action	LEVEL 2
Deficiency Photo1

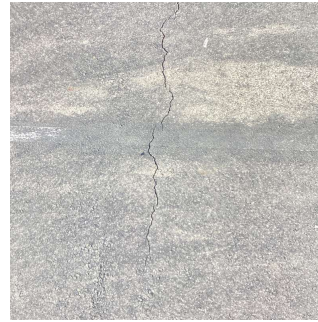
Handball Courts

ASPHALT: DAMAGED/DETERIORATED

REPLACE

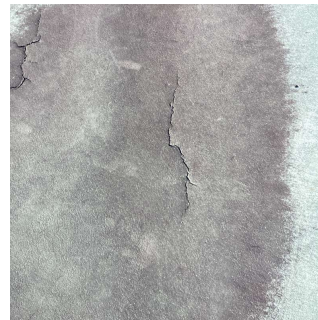
Tennis Courts

ASPHALT: DAMAGED/DETERIORATED

REPLACE

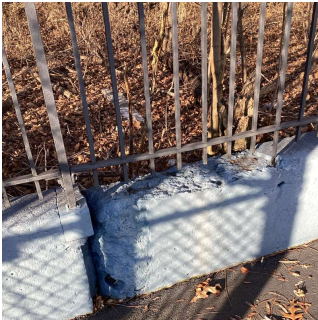
Violations	Avenue L Entrance No violations recorded.
Deficiency	WROUGHT IRON: DAMAGED/DETERIORATED
Deficiency Location/Instance	Avenue L, K Entrances, near Stair A
Deficiency Quantity	240
Quantity Uom	S.F.
Potential Action	REPLACE
Urgency of Action	PRIORITY 3
Purpose of Action	LEVEL 2
Deficiency Photo1

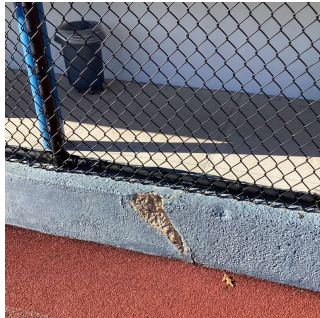
Violations	Walkway along Grand Stand 35672562L
Deficiency	CAST IN PLACE CONCRETE: CRACKS/SPALLING - MAJOR
Deficiency Location/Instance	Avenue L, K Entrances, Along Grand Stand Walkway
Deficiency Quantity	250
Quantity Uom	S.F.
Potential Action	REPLACE
Urgency of Action	PRIORITY 3
Purpose of Action	LEVEL 2
