NYC Department of Education
Building Condition Assessment Survey 2023 - 2024

Architectural Inspection

K407

Asset: MIDWOOD AF NO. 2 - BROOKLYN, 2839 BEDFORD AVENUE, New York, 11210

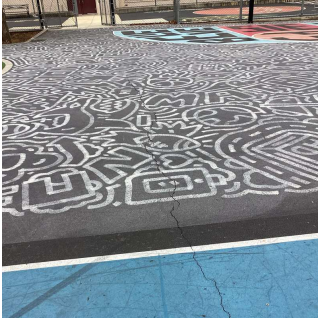
Near Basketball Hoops
Violations	No violations recorded.
Concrete	
	Does not Exist
Pavers	
	Inspected
Condition	2 - Between Good and Fair
Deficiency	DAMAGED/MISSING
Deficiency Location/Instance	Center

Question	Response
SITE	
FENCES	
Violations	No violations recorded.
Deficiency	CHAIN LINK: MISSING SECTIONS
Deficiency Location/Instance	Right Side of Track
Deficiency Quantity	50
Quantity Uom	S.F.
Potential Action	REPLACE
Urgency of Action	PRIORITY 3
Purpose of Action	LEVEL 2
Deficiency Photo1	No photo recorded
Violations	No violations recorded.
IRRIGATION SYSTEM	
	Does not Exist
PAVING	
	Inspected
Student Non-Use	Does not Exist
Student Use	Inspected
Gravel Exists?	No
Asphalt	
Condition	3 - Fair
Deficiency	CRACKS - MAJOR
Deficiency Location/Instance	Near Basketball Hoops, Track, near playground
Deficiency Quantity	70
Quantity Uom	S.F.
Potential Action	REPLACE
Urgency of Action	PRIORITY 3
Purpose of Action	LEVEL 2
Deficiency Photo1

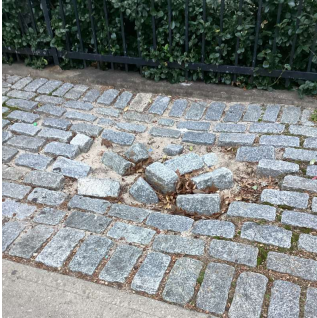
Yes	Tripping Hazard	Broken cobblestones, resulting in potential tripping hazard	SITE PAVING DOT Sidewalk Pavers	Bedford Avenue	Steven Fassano	Custodian

Question	Response
SITE	
PAVING	
DOT Sidewalk	
Pavers	
Deficiency Photo1
