NYC Department of Education
Building Condition Assessment Survey 2023 - 2024

Architectural Inspection

Asset: **LINCOLN AF - BROOKLYN, 2800 OCEAN PARKWAY, New York, 11235**

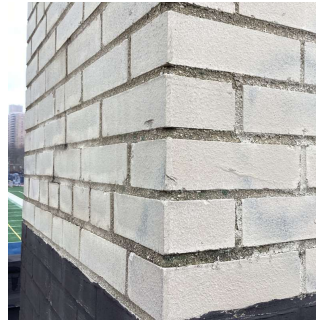
Chimney

BRICK: MINOR CRACKS AND SPALLING

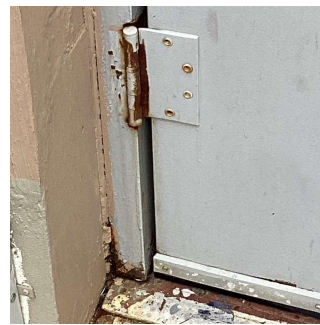
Question	Response
EXTERIOR	
CORNICE	
Deficiency Photo1	 
Violations	Facade A No violations recorded.
DOORS	Inspected
DOORS AND FRAMES	Inspected
Condition	5 - Poor
Deficiency	METAL: DETERIORATED DOOR AND FRAME - MAJOR DETERIORATION
Roof Plan reference	
Deficiency Quantity	2
Quantity Uom	EACH
Potential Action	REPLACE
Urgency of Action	PRIORITY 4
Purpose of Action	LEVEL 2
Deficiency Photo1	 
Violations	Facade A No violations recorded.
Deficiency	METAL: DETERIORATED DOOR AND FRAME - MINOR DETERIORATION

2
EACH
MAINTENANCE
PRIORITY 3
LEVEL 2

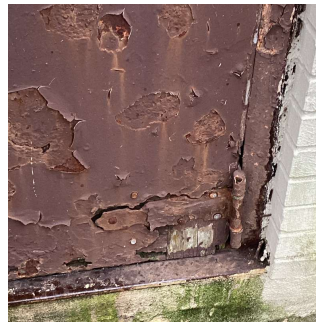
Facade E

METAL CLAD: DETERIORATED DOOR AND FRAME - MAJOR DETERIORATION

6
EACH
REPLACE
PRIORITY 4
LEVEL 2

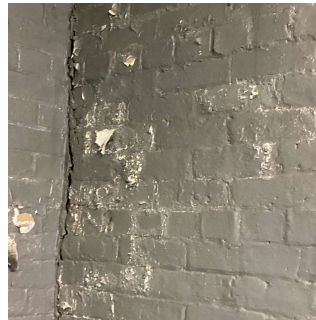
Concession Building

BRICK: WATER INFILTRATION IN NON-INSTRUCTIONAL SPACE

REPAIR

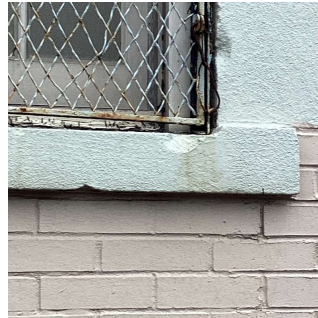
Facade B

BRICK: DETERIORATED MASONRY SILLS - MAJOR

REMOVE AND REPLACE

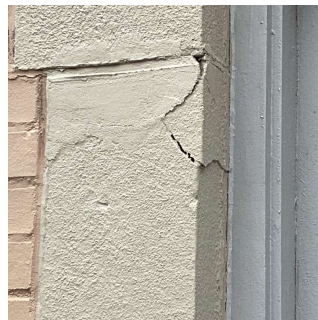
Facade A

STONE: CHIPPED/SPALLED/BROKEN PIECES - MAJOR

REPLACE

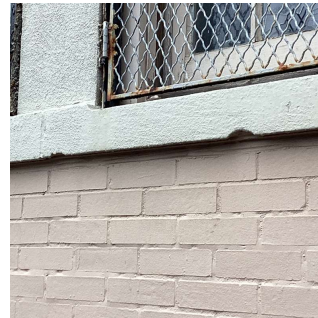
Facade A

BRICK: DETERIORATED MASONRY SILLS - MINOR

REPAIR

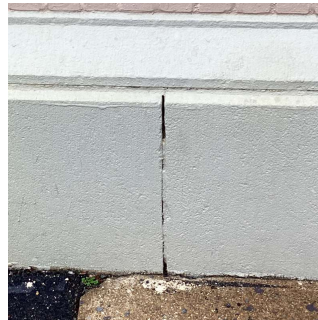
Facade A

STONE: DETERIORATED JOINTS

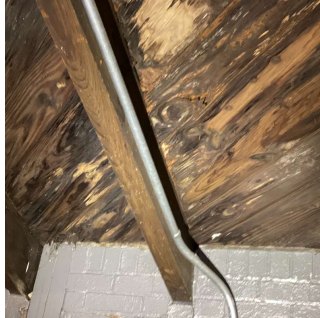
Roof 3 - Concession Building
Violations	No violations recorded.
Instance on Built-Up: Roofs 1, 2 - Field House	Inspected
Instance Condition	5 - Poor
Instance Photo

Source of Installation	Custodial Staff
Deficiency	SINGLE PLY, FULLY ADHERED ROOF: ROOFING: MAJOR ACTIVE ROOF LEAKS IN NON-INSTRUCTIONAL SPACE
Roof Plan reference	 
Deficiency Quantity	100
Quantity Uom	S.F.
Potential Action	REPLACE ROOFING WITHOUT MAJOR EQUIPMENT REMOVAL
Urgency of Action	PRIORITY 5

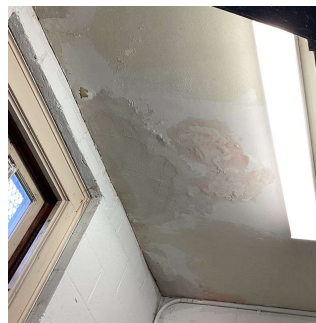
BUILT-UP: ROOFING: MAJOR ACTIVE ROOF LEAKS IN INSTRUCTIONAL SPACE

Roof 2 - 1st Floor Varsity Locker Room (Roof 2 - 1st Floor Varsity Toilet Room, Roof 1 - 1st Floor Junior Varsity Locker Room and Toilet Room similar)

REPLACE ROOFING WITHOUT MAJOR EQUIPMENT REMOVAL

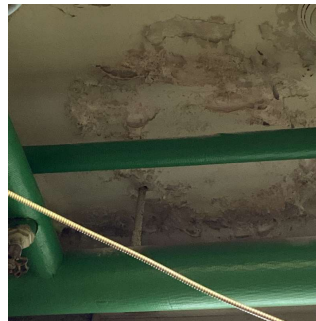
BUILT-UP: ROOFING: MAJOR ACTIVE ROOF LEAKS IN NON-INSTRUCTIONAL SPACE

Roof 1 - Boiler Room
No violations recorded.

200
S.F.
REPLACE ROOFING WITHOUT MAJOR EQUIPMENT
REMOVAL
PRIORITY 5
LEVEL 2

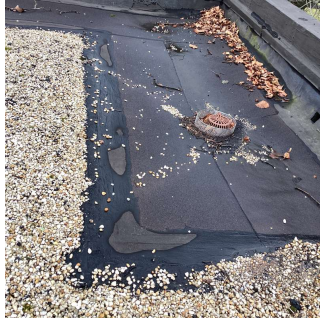
BUILT-UP: ROOFING: LOSS OF GRAVEL

180
S.F.
INSTALL NEW GRAVEL
PRIORITY 3
LEVEL 2

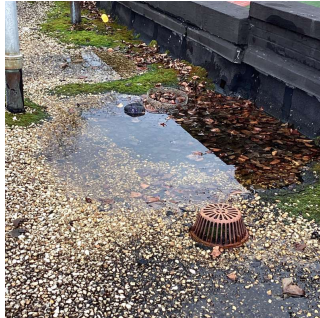
Violations	Roof 2 No violations recorded.
ROOFING DRAINS	Inspected
Condition	5 - Poor
Deficiency	CLOGGED
Roof Plan reference

Deficiency Quantity	2
Quantity Uom	EACH
Potential Action	MAINTENANCE
Urgency of Action	PRIORITY 5
Purpose of Action	LEVEL 2
Deficiency Photo1

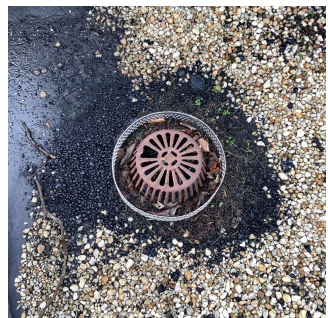
Violations	Roof 1 No violations recorded.
Deficiency	DETERIORATED

Deficiency Quantity	3
Quantity Uom	EACH
Potential Action	REPLACE
Urgency of Action	PRIORITY 4
Purpose of Action	LEVEL 2
Deficiency Photo1

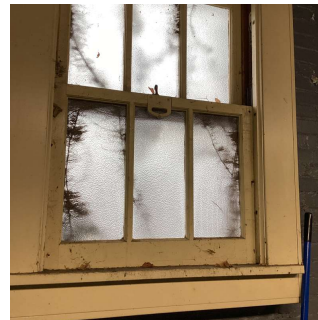
Facade H

Question	Response
EXTERIOR	
WINDOWS	
EXTERIOR GUARDS	
Elevation	 
Deficiency Quantity	60
Quantity Uom	S.F.
Potential Action	REPLACE
Urgency of Action	PRIORITY 4
Purpose of Action	LEVEL 2
Deficiency Photo1	 
Violations	Facade A No violations recorded.
LINTELS	Inspected
Condition	2 - Between Good and Fair
Deficiency	No deficiencies recorded
WINDOWS	Inspected
Material Type(s)	Solid Wood
Instance on Wood: Facades A-D, H	Inspected
Instance Condition	5 - Poor
Instance Quantity	410
Instance Quantity Uom	S.F.
Are these windows insulated	No
Installation Year	1996
Source of Installation	Custodial Staff
Deficiency	WOOD: INOPERABLE BALANCE

REPLACE BALANCES

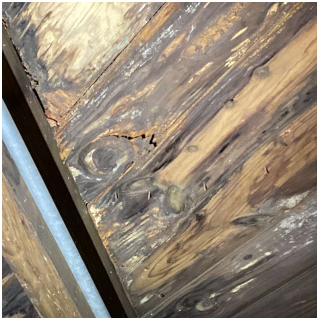
Question	Response
EXTERIOR	
WINDOWS	
WINDOWS	
Potential Action	MAINTENANCE
Urgency of Action	PRIORITY 3
Purpose of Action	LEVEL 2
Deficiency Photo1	 
Violations	Facade A No violations recorded.
INTERIOR	Inspected
STRUCTURAL	Inspected
COLUMNS/BEAMS/BEARING WALLS	Inspected
Condition	2 - Between Good and Fair
Deficiency	No deficiencies recorded
FLOOR STRUCTURE	Inspected
Condition	3 - Fair
Deficiency	CONCRETE SLAB ON GRADE: THRU CRACKS
Deficiency Location/Instance	1st Floor
Deficiency Quantity	90
Quantity Uom	S.F.
Potential Action	REPAIR
Urgency of Action	PRIORITY 3
Purpose of Action	LEVEL 5
Deficiency Photo1	 
Violations	Boiler Room (Concession Building similar) No violations recorded.
FOUNDATION WALLS	Inspected
Material Type(s)	Concrete
Condition	2 - Between Good and Fair
Deficiency	No deficiencies recorded
ROOF STRUCTURE	Inspected
Condition	3 - Fair
Deficiency	WOOD SLAT: MISSING/CRACKED/SPALLED
Deficiency Location/Instance	Concession Building

Question	Response
INTERIOR	
STRUCTURAL	
ROOF STRUCTURE	
Deficiency Quantity	50
Quantity Uom	S.F.
Potential Action	REPLACE
Urgency of Action	PRIORITY 4
Purpose of Action	LEVEL 5
Deficiency Photo1

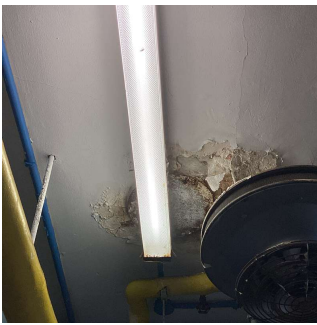
Question	Response
INTERIOR	
SHOWER ROOM	
Ceiling	
Deficiency Photo1

Violations	Center No violations recorded.
Door(s)	
Instance on 1st Floor - Junior Varsity	Does not Exist
Floor Finish	
Instance on 1st Floor - Junior Varsity	Inspected
Condition	2 - Between Good and Fair
Deficiency	No deficiencies recorded
Walls	
Instance on 1st Floor - Junior Varsity	Inspected
Condition	2 - Between Good and Fair
Deficiency	No deficiencies recorded
STAIRS/RAMPS: INTERIOR	Does not Exist
TOILET ROOMS - STAFF	Inspected
Ceiling	Inspected
Condition	1 - Good
Deficiency	No deficiencies recorded
Door(s)	Not Required
Floor Finish	Inspected
Condition	1 - Good
Deficiency	No deficiencies recorded
Stalls	Inspected
Condition	1 - Good
Deficiency	No deficiencies recorded
Walls	Inspected
Condition	1 - Good
Deficiency	No deficiencies recorded
TOILET ROOMS - STUDENTS	Inspected
Ceiling	Inspected
Condition	5 - Poor
Deficiency	PLASTER: CRACKS/SPALLING - ACTIVE LEAK

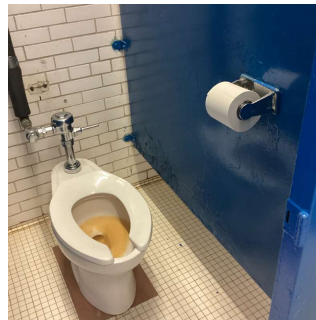
Junior Varsity Locker Room

RUST - MAJOR

REPLACE

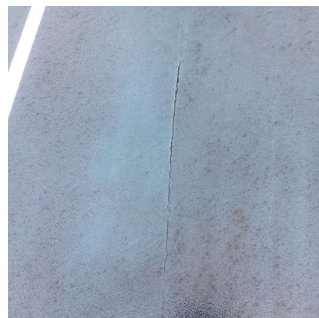
Question	Response
ATHLETIC FIELDS	
PLAYING SURFACE	
Deficiency	ASPHALT: DAMAGED/DETERIORATED
Deficiency Location/Instance	Tennis Courts
Roof Plan reference

Violations	Tennis Courts No violations recorded.
FIXED EQUIPMENT	
Inspected	
Basketball Backboard	Does not Exist
Basketball Hoops	Does not Exist
Basketball Posts	Does not Exist
Football Goal Posts	Inspected
Condition	2 - Between Good and Fair
Deficiency	No deficiencies recorded
Tennis Net Posts	Inspected
Condition	2 - Between Good and Fair
Deficiency	No deficiencies recorded
SEATING	
Inspected	
Benches	Inspected
Concrete	Does not Exist
Metal/Wood/Plastic	Inspected
Condition	2 - Between Good and Fair
Deficiency	No deficiencies recorded
Bleachers	Inspected
Concrete	Does not Exist
Metal/Wood/Plastic	Inspected
Condition	3 - Fair

Deficiency Quantity	30
Quantity Uom	S.F.
Potential Action	REPAIR
Urgency of Action	PRIORITY 3
Purpose of Action	LEVEL 2
Deficiency Photo1

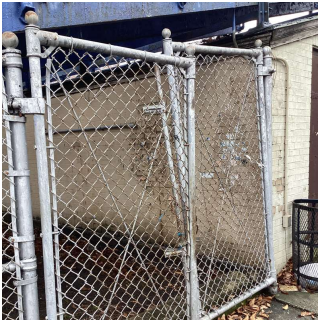
Question	Response
SITE	
FENCES	
Violations	No violations recorded.
Deficiency	CHAIN LINK: DAMAGED/DETERIORATED
Deficiency Location/Instance	Near Bleachers, Entrance, Shore Parkway, West Avenue
Deficiency Quantity	500
Quantity Uom	S.F.
Potential Action	REPLACE
Urgency of Action	PRIORITY 3
Purpose of Action	LEVEL 2
Deficiency Photo1

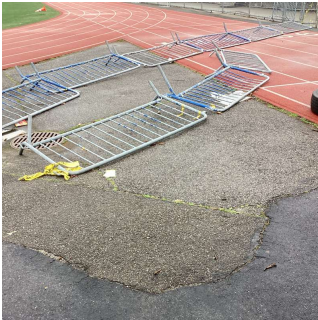
Question	Response
SITE	
PAVING	
Student Use	
Asphalt	Inspected
Condition	4 - Between Fair and Poor
Deficiency	CRACKS - MAJOR
Deficiency Location/Instance	Along Running Track
Deficiency Quantity	750
Quantity Uom	S.F.
Potential Action	REPLACE
Urgency of Action	PRIORITY 3
Purpose of Action	LEVEL 2
Deficiency Photo1

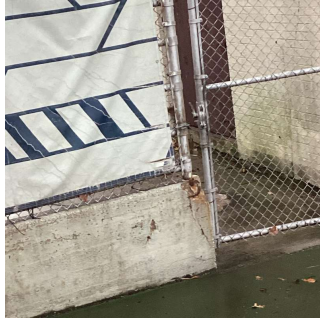
Violations	Near Field House No violations recorded.
SEATING	Does not Exist
SITE WALLS (NOT RETAINING WALLS)	Inspected
Condition	2 - Between Good and Fair
Deficiency	CAST IN PLACE CONCRETE: CRACKS/SPALLING - MAJOR
Deficiency Location/Instance	Near Tennis Court

Question	Response
SITE	
SITE WALLS (NOT RETAINING WALLS)	
Potential Action	REPLACE
Urgency of Action	PRIORITY 3
Purpose of Action	LEVEL 2
Deficiency Photo1

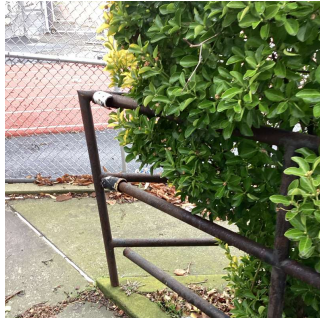
Near Bleachers
Violations	No violations recorded.
Deficiency	MISSING
Deficiency Location/Instance	Near Field House
Deficiency Quantity	15
Quantity Uom	L.F.
Potential Action	REPLACE
Urgency of Action	PRIORITY 5
Purpose of Action	LEVEL 6

Near Tennis Court
Violations	No violations recorded.
STAIRS/RAMPS: EXTERIOR	
	Inspected
Railings	Inspected
Condition	5 - Poor
Deficiency	DAMAGED
Deficiency Location/Instance	Near Bleachers
Deficiency Quantity	10
Quantity Uom	L.F.
Potential Action	REPLACE
Urgency of Action	PRIORITY 3
Purpose of Action	LEVEL 2
Deficiency Photo1
