**NYC Department of Education
Building Condition Assessment Survey 2023 - 2024**

Architectural Inspection

K412

Asset: 3K CENTER @ 5202 3RD AVENUE - BROOKLYN, 5202 3RD AVENUE, 11220

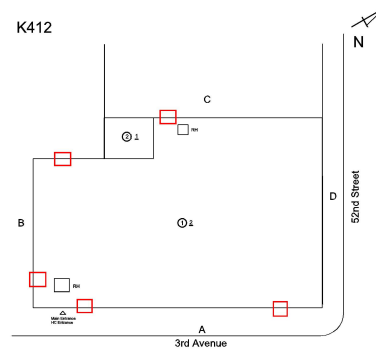
Roof Plan reference

CAST STONE: CRACKED/BROKEN PIECES

REPLACE-IN-KIND

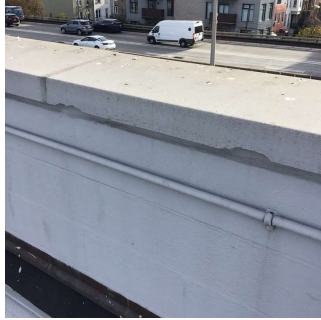
Deficiency Quantity

25

Violations	Roof 1 - Facade A No violations recorded.
CORNICE	Does not Exist
DOORS	Inspected
DOORS AND FRAMES	Inspected
Condition	1 - Good
Deficiency	No deficiencies recorded
DOOR HARDWARE	Inspected
Condition	1 - Good
Deficiency	No deficiencies recorded
LINTELS	Inspected
Condition	1 - Good
Deficiency	No deficiencies recorded
TRANSOM/SIDE LIGHT	Inspected
Condition	1 - Good
Deficiency	No deficiencies recorded
EXTERIOR WALLS	Inspected
Material Type(s)	Masonry
Replacement Quantity	5,000
Replacement Uom	S.F.
Instance on All Facades	Inspected
Instance Condition	3 - Fair
Instance Quantity	5,000
Instance Quantity Uom	S.F.
Deficiency	CONCRETE MASONRY UNIT: MAJOR / THRU CRACKS
Roof Plan reference

PRIORITY 4

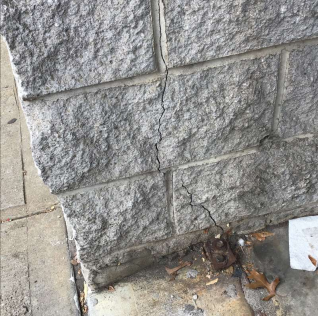
Deficiency Quantity	20
Quantity Uom	S.F.
Potential Action	REMOVE AND REBUILD
Urgency of Action	PRIORITY 4
Purpose of Action	LEVEL 2
Deficiency Photo1

Violations	Facade A No violations recorded.
EXTERIOR SOFFITS	Inspected
Condition	2 - Between Good and Fair
Deficiency	No deficiencies recorded
LOADING DOCK	Does not Exist
LOUVER	Inspected
Condition	2 - Between Good and Fair
Deficiency	No deficiencies recorded
PARAPETS	Inspected
Material Type(s)	Masonry
Replacement Quantity	4,200
Replacement Uom	C.F.
Instance on Roof 1	Inspected
Instance Condition	2 - Between Good and Fair
Instance Quantity	4,200
Instance Quantity Uom	C.F.
Deficiency	No deficiencies recorded
PLAZA DECK	Does not Exist
ROOF	Inspected
Roofing	Inspected
Replacement Quantity	15,000
Replacement Uom	S.F.
ROOF HATCH/SMOKE HATCH	Inspected

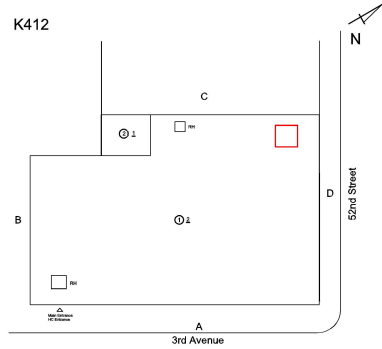
Roof 1
Instance Quantity	15,000
Instance Quantity Uom	S.F.
Does the roof have major mechanical equipment sitting on Dunnage Steel less than 18" above the Roofing?	No
Does this roof instance have a Sustainable Roof System?	Yes
Sustainable Roof Type	White Roof
Sustainable Roof Location (Roof Number)	Roof 1
Do solar panels exist on these roofs?	No
Is/Are the roof(s) suitable for Solar Panel installation?	No
Installation Year	2022
Source of Installation	Custodial Staff
Deficiency	MODIFIED BITUMEN: ROOFING: DELAMINATION
Roof Plan reference

Deficiency Quantity	30
Quantity Uom	S.F.

Question	Response
EXTERIOR	
ROOF	
Roofing	
ROOFING	
Deficiency Photo1	 
Violations	Roof 1 - near North corner No violations recorded.
Deficiency	MODIFIED BITUMEN: FLASHING: DETERIORATED JOINTS
Roof Plan reference	 
Deficiency Quantity	15
Quantity Uom	L.F.
Potential Action	MAINTENANCE
Urgency of Action	PRIORITY 3
Purpose of Action	LEVEL 2
Deficiency Photo1	 
Violations	Roof 1 No violations recorded.
ROOFING DRAINS	Inspected
Condition	1 - Good
Deficiency	No deficiencies recorded
Specialties	Does not Exist
STAIRS/RAMPS: EXTERIOR	Does not Exist
WINDOWS	Inspected
Replacement Quantity	500
Replacement Uom	S.F.

Potential Action	REPLACE ROOFING WITHOUT MAJOR EQUIPMENT REMOVAL
Urgency of Action	PRIORITY 4
Purpose of Action	LEVEL 2

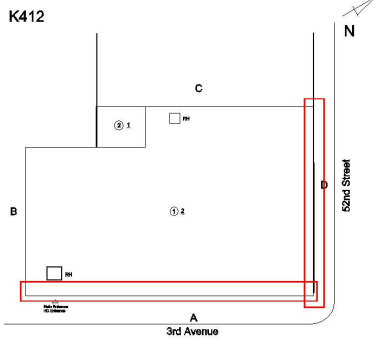
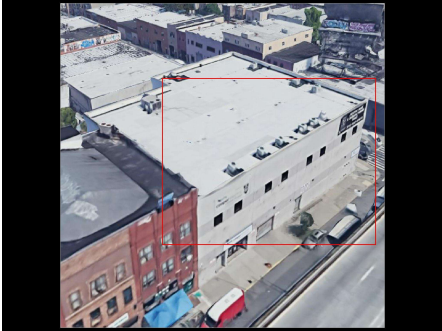
Elevation

Question	Response
EXTERIOR	
WINDOWS	
EXTERIOR GUARDS	Inspected
Condition	1 - Good
Deficiency	No deficiencies recorded
LINTELS	Inspected
Condition	1 - Good
Deficiency	No deficiencies recorded
WINDOWS	Inspected
Material Type(s)	Aluminum
Instance on Aluminum - Other: Facades A, D	Inspected
Instance Condition	3 - Fair
Instance Quantity	500
Instance Quantity Uom	S.F.
Are these windows insulated	Yes
Installation Year	2022
Source of Installation	Custodial Staff
Deficiency	ALUMINUM - OTHER: AIR/WATER INFILTRATION, DETERIORATED JOINTS WITH DAMAGED CAULKING
Roof Plan reference

Deficiency Quantity	50
Quantity Uom	L.F.
Potential Action	MAINTENANCE
Urgency of Action	PRIORITY 3
Purpose of Action	LEVEL 2
Deficiency Photo1	No photo recorded
Violations	No violations recorded.
INTERIOR	Inspected
POOLS	Does not Exist
STRUCTURAL	Inspected
COLUMNS/BEAMS/BEARING WALLS	Inspected
Condition	2 - Between Good and Fair
