NYC Department of Education
Building Condition Assessment Survey 2023 - 2024

Architectural Inspection

Asset: SAMUEL J. TILDEN HS - K, 5800 TILDEN AVENUE, New York, 11203

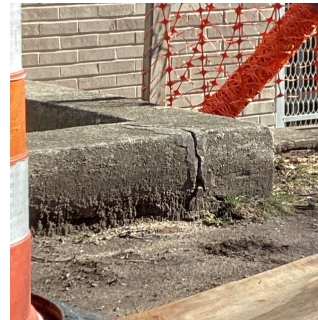
AW2

Question	Response
Architectural	
EXTERIOR	Inspected
AREAWAY	Inspected
Instance on AW1 - AW3	Inspected
Instance Condition	3 - Fair
Instance Quantity	3
Instance Quantity Uom	EACH
Deficiency	AREAWAY WALLS: CRACKS AND SPALLING

REPLACE

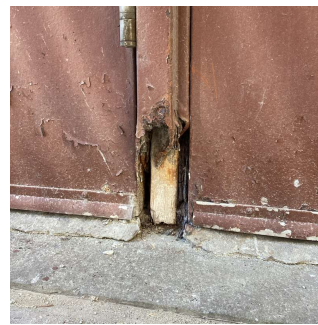
Facade M - Exit 9

METAL: DETERIORATED DOOR AND FRAME - MAJOR DETERIORATION

10
EACH
REPLACE
PRIORITY 4
LEVEL 2

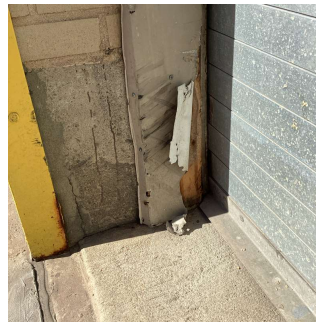
Facade L

ROLL-UP DOOR: DETERIORATED DOOR AND FRAME - MAJOR DETERIORATION

600
S.F.
REPLACE
PRIORITY 4
LEVEL 2

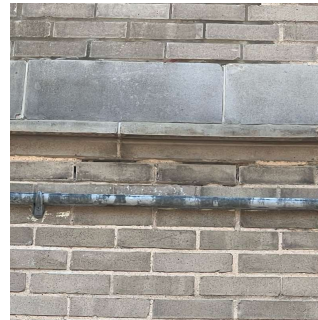
Facade F

BRICK: DETERIORATED JOINTS

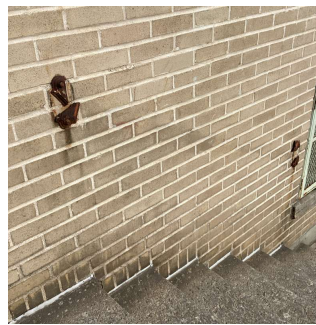
CUPOLA/ SPIRES/ TOWERS	Does not Exist
DORMER	Does not Exist
DUNNAGE STEEL	Does not Exist
SKYLIGHT/ROOF VENT	Inspected
Material Type(s)	Plastic
Condition	2 - Between Good and Fair
Deficiency	No deficiencies recorded
ROOF/GRAVITY TANK	Does not Exist
STAIRS/RAMPS: EXTERIOR	Inspected
BUILDING CHEEK/FLANK WALLS	Inspected
Condition	2 - Between Good and Fair
Deficiency	No deficiencies recorded
RAILINGS	Inspected
Condition	5 - Poor
Deficiency	MISSING RAILING

Facade G
No violations recorded.

10
L.F.
REPLACE
PRIORITY 5
LEVEL 6

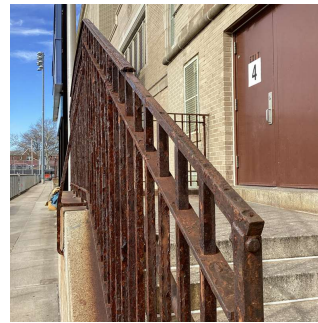
Facade G

DAMAGED

20
L.F.
REPLACE
PRIORITY 4
LEVEL 2

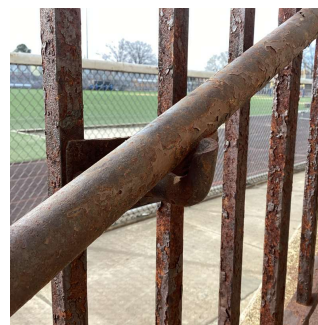
Facade G

BROKEN BRACKET

REPLACE

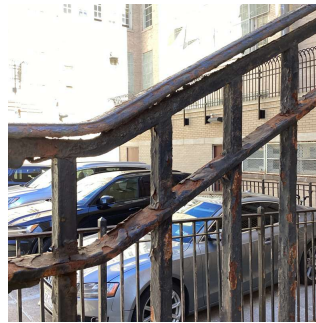
RUST - MAJOR

Facade J
No violations recorded.

20
L.F.
REPLACE
PRIORITY 4
LEVEL 2

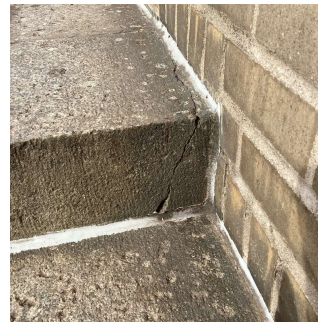
Facade G

STONE: CRACKS/SPALLING - MINOR

10
S.F.
REPAIR
PRIORITY 3
LEVEL 2

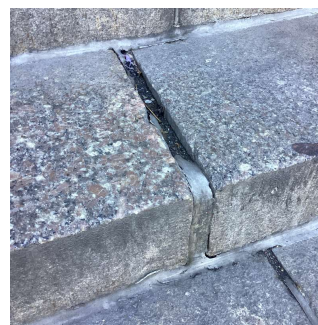
Facade A

STONE: DETERIORATED JOINTS

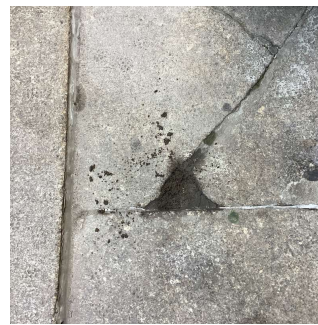
STONE: CRACKS/SPALLING - MAJOR

Facade A
No violations recorded.

20
S.F.
REPLACE
PRIORITY 4
LEVEL 2

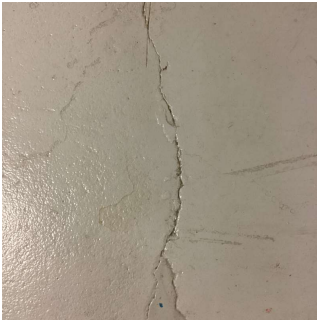
Violations	Boiler Room No violations recorded.
Deficiency	CONCRETE SLAB ON GRADE: THRU CRACKS
Deficiency Location/Instance	Boiler Room
Deficiency Quantity	40
Quantity Uom	S.F.
Potential Action	REPLACE
Urgency of Action	PRIORITY 4
Purpose of Action	LEVEL 5
Deficiency Photo1

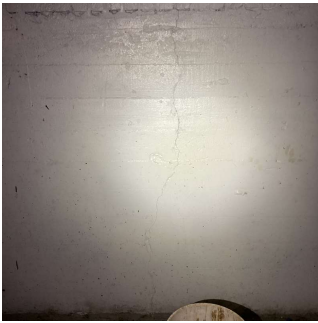
Violations	Boiler Room No violations recorded.
FOUNDATION WALLS	
Material Type(s)	Inspected Concrete, Masonry
Condition	3 - Fair
Deficiency	CONCRETE: CRACKED/SPALLED/REINFORCEMENT EXPOSED
Deficiency Location/Instance	Basement - Gas Meter Room, Storage
Deficiency Quantity	40
Quantity Uom	S.F.
Potential Action	REPAIR
Urgency of Action	PRIORITY 3
Purpose of Action	LEVEL 5

Violations	Basement - Gas Meter Room No violations recorded.
ROOF STRUCTURE	
Condition	Inspected 3 - Fair
Deficiency	CONCRETE: CRACKED/SPALLED/REINFORCEMENT EXPOSED
Deficiency Location/Instance	Roof 1 - Library Mechanical Room
Deficiency Quantity	10
Quantity Uom	S.F.
Potential Action	REPAIR
Urgency of Action	PRIORITY 4
Purpose of Action	LEVEL 5
Deficiency Photo1

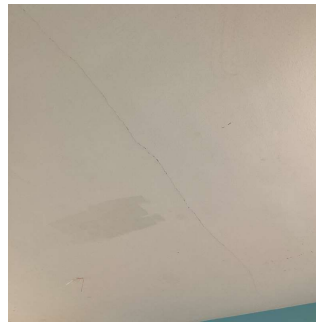
Room B30
Violations	No violations recorded.
Deficiency	PLASTER: CRACKS/SPALLING
Deficiency Location/Instance	Corridor near Room 318A
Deficiency Quantity	20
Quantity Uom	S.F.
Potential Action	REPLACE
Urgency of Action	PRIORITY 3
Purpose of Action	LEVEL 2

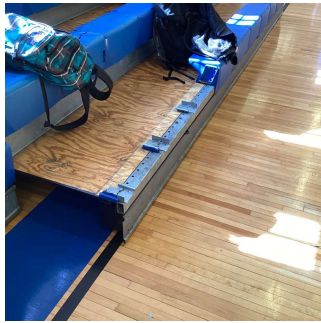
Yes	Protruding Elements	Exposed metal is a potential safety hazard.	INTERIOR GYMNASIUM Seating	Middle Bleachers	Saleh Al-Awgari	Fireman

Violations	Middle Bleachers No violations recorded.
Deficiency	DAMAGED BLEACHERS
Deficiency Location/Instance	Left and Right Side, Center
Deficiency Quantity	80
Quantity Uom	S.F.
Potential Action	REPLACE
Urgency of Action	PRIORITY 3
Purpose of Action	LEVEL 2
Deficiency Photo1

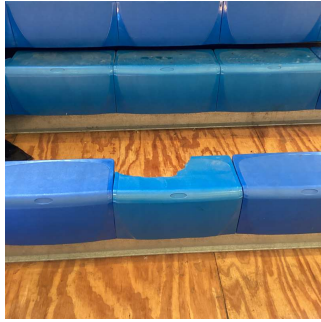
Violations	Left Side No violations recorded.
Sliding-folding Partition	
Instance on 1st Floor - Gymnasium 2	Does not Exist
Instance on 1st Floor - Gymnasium 3	Does not Exist
Instance on 1st Floor - Gymnasium 1	Does not Exist
Stage

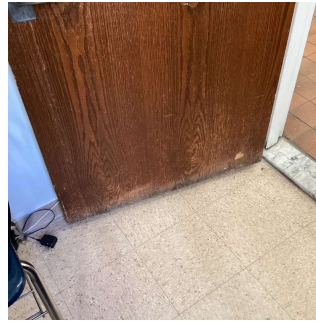
Violations	Storage Room No violations recorded.
Deficiency	WOOD: DETERIORATED DOOR
Deficiency Location/Instance	Office
Deficiency Quantity	1
Quantity Uom	EACH
Potential Action	MAINTENANCE
Urgency of Action	PRIORITY 3
Purpose of Action	LEVEL 2

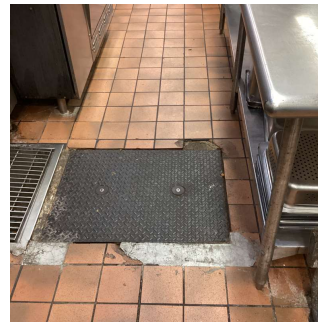
Yes	Tripping Hazard	Severely damaged quarry tile floor is a potential tripping hazard.	INTERIOR KITCHEN Floor Finish	Near ovens	Saleh Al-Awgari	Fireman
-----	-----------------	--	-----------------------------------	------------	-----------------	---------

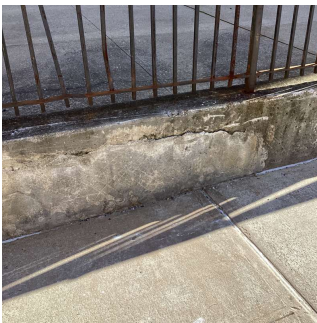
Violations	Near Exit 6 No violations recorded.
Deficiency	MASONRY UNIT: DETERIORATED CONTROL/EXPANSION JOINT
Deficiency Location/Instance	Near Exit 6
Deficiency Quantity	20
Quantity Uom	L.F.
Potential Action	REPLACE
Urgency of Action	PRIORITY 3
Purpose of Action	LEVEL 2
Deficiency Photo1
