**NYC Department of Education**  
**Building Condition Assessment Survey 2023 - 2024**

Architectural Inspection

**K422**

**Asset:**        **SPRING CREEK EDUCATIONAL CAMPUS - BROOKLYN, 1065 ELTON STREET, New York, 11208**

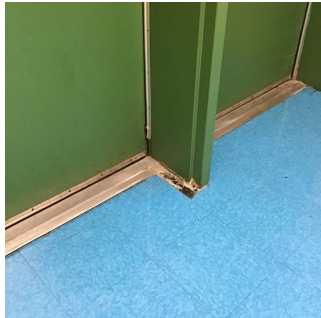
METAL: DETERIORATED DOOR AND FRAME - MINOR DETERIORATION

2  
 EACH  
 MAINTENANCE  
 PRIORITY 3

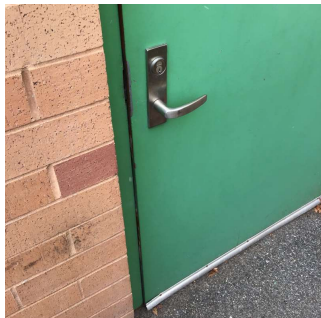
Violations	Facade D No violations recorded.
Deficiency	METAL: DETERIORATED DOOR - MINOR DETERIORATION
Roof Plan reference	K422 LINWOOD STREET FLATLANDS AVENUE ELTON STREET

Deficiency Quantity	1
Quantity Uom	EACH
Potential Action	MAINTENANCE
Urgency of Action	PRIORITY 3
Purpose of Action	LEVEL 2
Deficiency Photo1

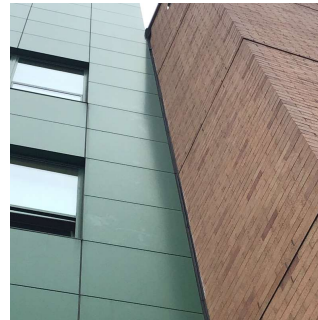
Facade C

Question	Response
<b>EXTERIOR</b>	
<b>DOORS</b>	Inspected
<b>TRANSOM/SIDE LIGHT</b>	
Deficiency	No deficiencies recorded
<b>EXTERIOR WALLS</b>	Inspected
Material Type(s)	Concrete, Masonry, Steel
Replacement Quantity	41,000
Replacement Uom	S.F.
Instance on All Facades	Inspected
Instance Condition	3 - Fair
Instance Quantity	41,000
Instance Quantity Uom	S.F.
Deficiency	METAL PANEL: WATER INFILTRATION IN INSTRUCTIONAL SPACE
Roof Plan reference	<p>K422</p>  
Elevation	 
Deficiency Quantity	50
Quantity Uom	S.F.
Potential Action	REPAIR
Urgency of Action	PRIORITY 5
Purpose of Action	LEVEL 2
Deficiency Photo1	 
Violations	No violations recorded.
Deficiency	BRICK: DETERIORATED CONTROL/EXPANSION JOINTS

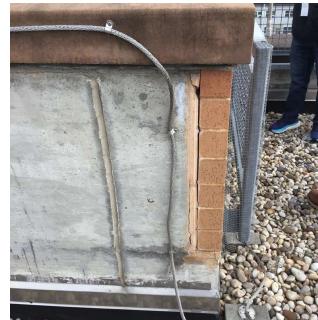
Roof 1

Question	Response
<b>EXTERIOR</b>	
<b>EXTERIOR WALLS</b>	
Elevation	 
Deficiency Quantity	20
Quantity Uom	S.F.
Potential Action	REPAIR
Urgency of Action	PRIORITY 3
Purpose of Action	LEVEL 2
Deficiency Photo1	 
Violations	Facade C No violations recorded.
<b>EXTERIOR SOFFITS</b>	Inspected
Condition	2 - Between Good and Fair
Deficiency	No deficiencies recorded
<b>LOADING DOCK</b>	Does not Exist
<b>LOUVER</b>	Inspected
Condition	2 - Between Good and Fair
Deficiency	No deficiencies recorded
<b>PARAPETS</b>	Inspected
Material Type(s)	Concrete, Masonry, Metal
Replacement Quantity	12,000
Replacement Uom	C.F.
Instance on All Facades	Inspected
Instance Condition	3 - Fair
Instance Quantity	12,000
Instance Quantity Uom	C.F.
Deficiency	BRICK: MAJOR DETERIORATION/CRACKS

10  
S.F.  
REMOVE AND REBUILD  
PRIORITY 4  
LEVEL 2

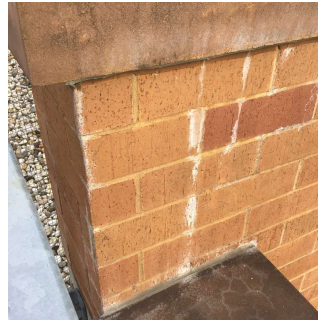
Roof 1

**BRICK: EFFLORESCENCE**

40  
S.F.  
MAINTENANCE  
PRIORITY 1  
LEVEL 1

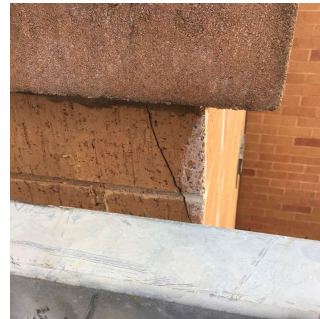
Roof 1

BRICK: MINOR CRACKS, SPALLING

REPAIR

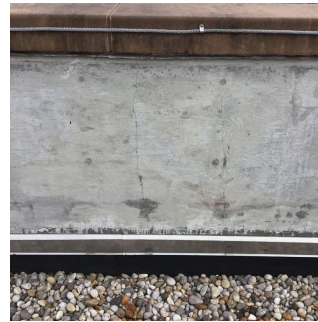
Roof 1  
 No violations recorded.

CONCRETE: MINOR CRACKS, SPALLING

30  
 S.F.  
 REPAIR  
 PRIORITY 3  
 LEVEL 2

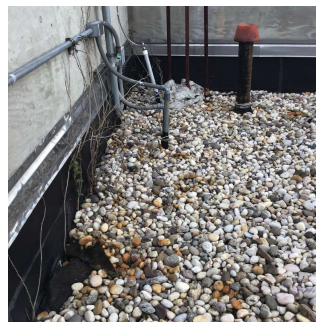
Roof 1 PH  
No violations recorded.

Deficiency Quantity	10
Quantity Uom	L.F.
Potential Action	MAINTENANCE
Urgency of Action	PRIORITY 3
Purpose of Action	LEVEL 2
Deficiency Photo1	 
	Roof 1 PH
Violations	No violations recorded.
Deficiency	IRMA: FLASHING: BASE FLASHING DETERIORATED

30  
S.F.  
REPAIR  
PRIORITY 3  
LEVEL 2

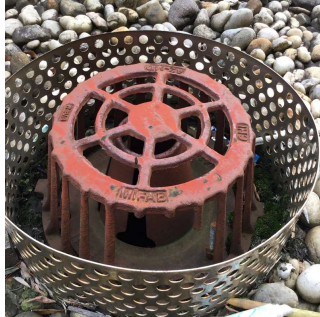
DETERIORATED

2  
EACH  
REPLACE  
PRIORITY 4  
LEVEL 2

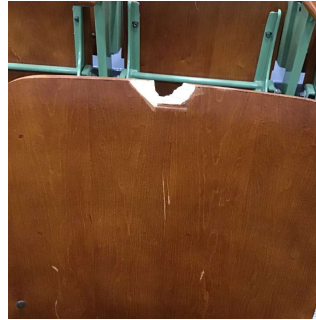
<b>Door(s)</b>	
Instance on 1st Floor (599 seats)	Inspected
Condition	2 - Between Good and Fair
Deficiency	No deficiencies recorded
<b>Fixed H/C Lift</b>	
Instance on 1st Floor (599 seats)	Does not Exist
<b>Fixed Seating</b>	
Instance on 1st Floor (599 seats)	Inspected
Condition	3 - Fair
Deficiency	DAMAGED/BROKEN/INOPERABLE
Deficiency Location/Instance	Seat K/10
Deficiency Quantity	1

Quantity Uom	EACH
Potential Action	REPLACE
Urgency of Action	PRIORITY 5
Purpose of Action	LEVEL 6
Deficiency Photo1

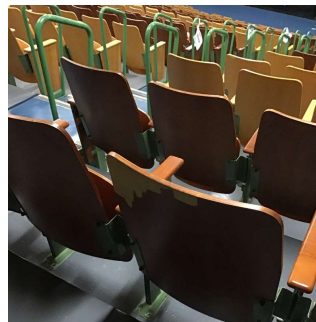
Seat R/28

Deficiency	DAMAGED/BROKEN/INOPERABLE
Deficiency Location/Instance	Seats E/23, R/28, S/30,28,26, and others
Deficiency Quantity	24
Quantity Uom	EACH
Potential Action	REPLACE
Urgency of Action	PRIORITY 3
Purpose of Action	LEVEL 2
Deficiency Photo1

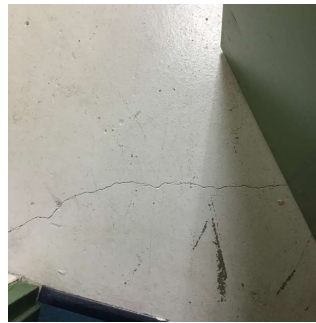
Exit 134G

Instance on 1st Floor (599 seats)	Inspected
Condition	2 - Between Good and Fair
Deficiency	CONCRETE: CRACKS
Deficiency Location/Instance	Near stage, exit 134G, seat T/23
Deficiency Quantity	30
Quantity Uom	S.F.
Potential Action	REPLACE
Urgency of Action	PRIORITY 3
Purpose of Action	LEVEL 2

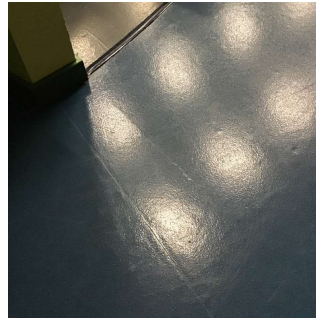
Near stage

EPOXY FLOORING: CRACKS/SPALLING

REPLACE

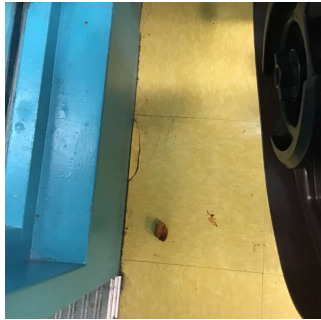
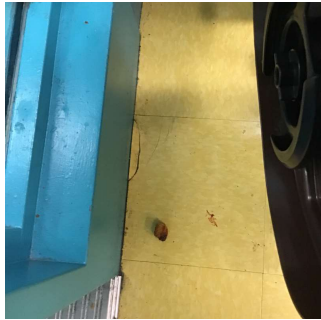
Near Entrance

Instance on 1st Floor - Students south (Room 117)	Inspected
Condition	2 - Between Good and Fair
Deficiency	VINYL TILES: BROKEN/DETERIORATED/MISSING TILES
Deficiency Location/Instance	Near Entrance, center, windows
Deficiency Quantity	30
Quantity Uom	S.F.
Potential Action	REPLACE
Urgency of Action	PRIORITY 3
Purpose of Action	LEVEL 2
Deficiency Photo1

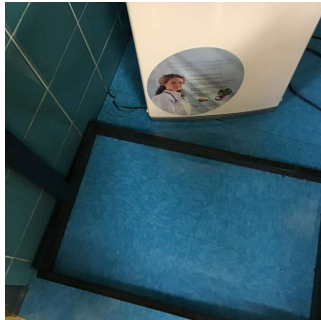
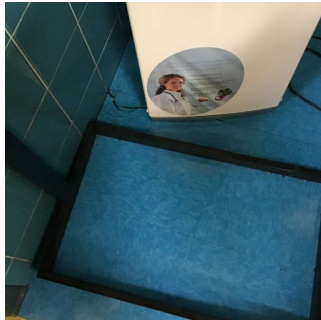
Near Servery

Instance on 1st Floor - Students north (Room 125 F)	Inspected
Condition	2 - Between Good and Fair
Deficiency	VINYL TILES: BROKEN/DETERIORATED/MISSING TILES
Deficiency Location/Instance	Near Entrance, windows, exit
Deficiency Quantity	20
Quantity Uom	S.F.
Potential Action	REPLACE
Urgency of Action	PRIORITY 3
Purpose of Action	LEVEL 2
Deficiency Photo1

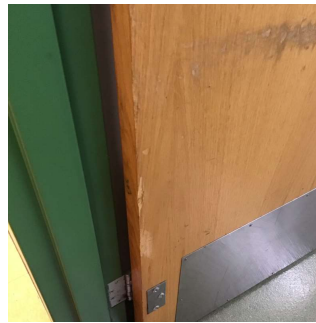
Room 423

Question	Response
<b>INTERIOR</b>	
<b>CAFETERIA</b>	
<b>Walls</b>	
Urgency of Action	PRIORITY 3
Purpose of Action	LEVEL 2
Deficiency Photo1	 
Violations	Near Servery No violations recorded.
<b>Window Curtains/Shades/Blinds</b>	
Instance on 1st Floor - Staff (750 SF)	Does not Exist
Instance on 1st Floor - Students north (Room 125 F)	Does not Exist
Instance on 1st Floor - Students south (Room 117)	Does not Exist
<b>CLASSROOMS/CORRIDORS/ADMIN SPACES</b>	
<b>Ceiling</b>	Inspected
Condition	2 - Between Good and Fair
Deficiency	ACOUSTIC TILES: DAMAGED/MISSING
Deficiency Location/Instance	Corridor near Room 423,403,325,323,103, and others
Deficiency Quantity	50
Quantity Uom	S.F.
Potential Action	REPLACE
Urgency of Action	PRIORITY 3
Purpose of Action	LEVEL 2
Deficiency Photo1	 
Violations	Corridor near Room 103 No violations recorded.
<b>Door(s)</b>	
Condition	5 - Poor
Deficiency	WOOD: DETERIORATED DOOR
Deficiency Location/Instance	Rooms 421,403,343,321,246, and others

Deficiency Quantity	9
Quantity Uom	EACH
Potential Action	MAINTENANCE
Urgency of Action	PRIORITY 3
Purpose of Action	LEVEL 2

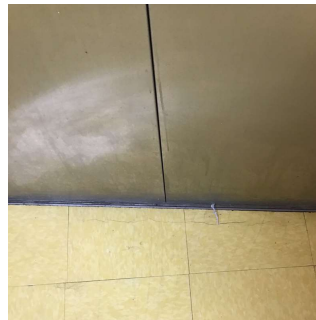
Corridor near Elevator/4

VINYL TILES: DETERIORATED SUBSTRATE

REPLACE

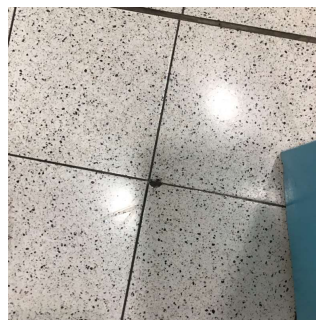
CERAMIC TILE: BROKEN/MISSING TILES

REPLACE

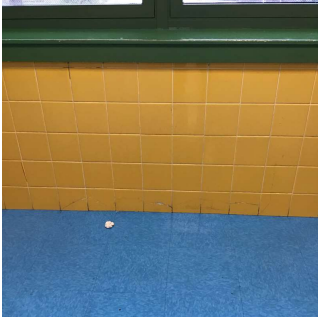
Violations	Corridor near Room 103 No violations recorded.
Deficiency	CERAMIC TILE: BROKEN/ MISSING
Deficiency Location/Instance	Corridor near Room 243,220,103,B/4,A/1, and others
Deficiency Quantity	80
Quantity Uom	S.F.
Potential Action	REPLACE
Urgency of Action	PRIORITY 3
Purpose of Action	LEVEL 2
Deficiency Photo1

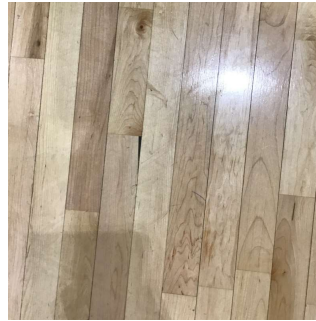
Near Windows

Near Entrance
Violations	No violations recorded.
<b>Door(s)</b>	
Instance on 1st Floor	Inspected
Condition	2 - Between Good and Fair
Deficiency	No deficiencies recorded
<b>Fixed Equipment</b>	
Instance on 1st Floor	Inspected
Condition	2 - Between Good and Fair
Deficiency	No deficiencies recorded
<b>Floor Finish</b>	
Instance on 1st Floor	Inspected
Condition	2 - Between Good and Fair
Deficiency	WOOD: DAMAGED/DETERIORATED
Deficiency Location/Instance	Near Windows, center
Deficiency Quantity	10
Quantity Uom	S.F.
Potential Action	REPLACE

Urgency of Action	PRIORITY 3
Purpose of Action	LEVEL 2

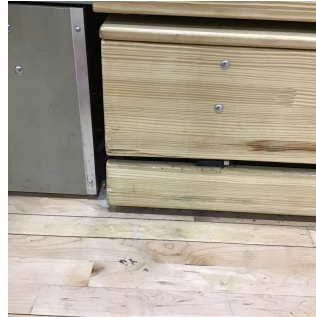
Near Windows

DAMAGED BLEACHERS

REPLACE

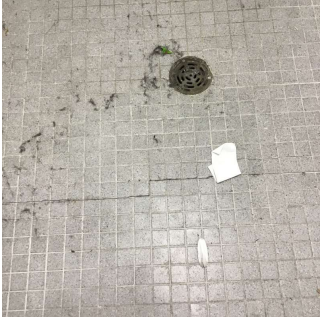
Instance on 1st Floor - Visitors	Inspected
Condition	2 - Between Good and Fair
Deficiency	No deficiencies recorded
<b>Floor Finish</b>	
Instance on 1st Floor - Visitors	Inspected
Condition	3 - Fair
Deficiency	CERAMIC TILE: DETERIORATED SUBSTRATE
Deficiency Location/Instance	Center
Deficiency Quantity	10
Quantity Uom	S.F.

Question	Response
<b>INTERIOR</b>	
<b>SHOWER ROOM</b>	
<b>Floor Finish</b>	
Potential Action	REPLACE
Urgency of Action	PRIORITY 3
Purpose of Action	LEVEL 2
Deficiency Photo1

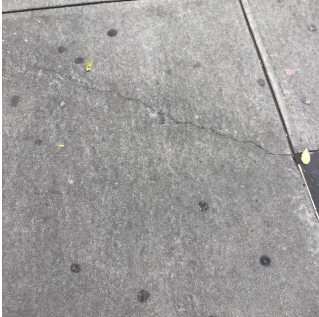
Question	Response
<b>SITE</b>	
<b>PAVING</b>	
<b>Site Sidewalks &amp; Walkways</b>	
<b>Asphalt</b>	Does not Exist
<b>Concrete</b>	Inspected
Condition	3 - Fair
Deficiency	DAMAGED/DETERIORATED/MISSING SECTIONS
Deficiency Location/Instance	Near exit 9, along Elton street, Flatlands avenue
Deficiency Quantity	325
Quantity Uom	S.F.
Potential Action	REPLACE
Urgency of Action	PRIORITY 3
Purpose of Action	LEVEL 2
Deficiency Photo1

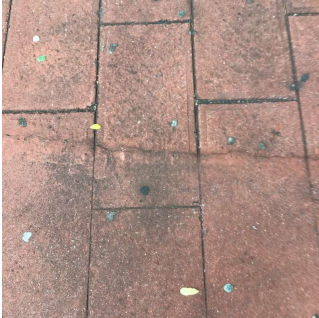
Near exit 9
Violations	No violations recorded.
<b>Pavers</b>	Inspected
Condition	3 - Fair
Deficiency	DAMAGED/MISSING
Deficiency Location/Instance	Near exit 6, exit 9, along Elton street
Deficiency Quantity	60
Quantity Uom	S.F.
Potential Action	REPLACE
Urgency of Action	PRIORITY 3
Purpose of Action	LEVEL 2
Deficiency Photo1

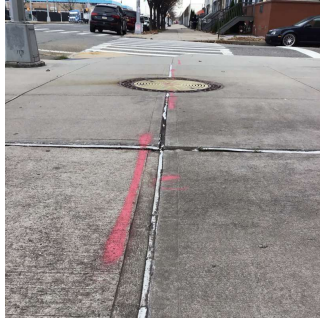
Near exit 9
Violations	No violations recorded.
<b>DOT Sidewalk</b>	Inspected
<b>Asphalt</b>	Does not Exist
<b>Concrete</b>	Inspected
Condition	4 - Between Fair and Poor
Deficiency	HEAVING

Question	Response
<b>SITE</b>	
<b>PAVING</b>	
<b>DOT Sidewalk</b>	
<b>Concrete</b>	
Deficiency Quantity	175
Quantity Uom	S.F.
Potential Action	REPLACE
Urgency of Action	PRIORITY 3
Purpose of Action	LEVEL 2
Deficiency Photo1

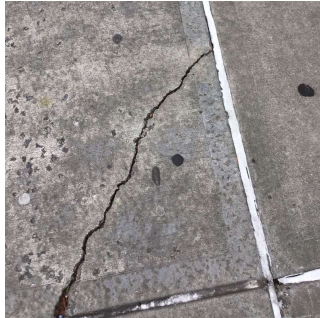
Along Flatland Avenue
Violations	No violations recorded.
Deficiency	DAMAGED/DETERIORATED/MISSING SECTIONS
Deficiency Location/Instance	Along Flatland Avenue, Elton Street, Linwood Street
Deficiency Quantity	450
Quantity Uom	S.F.
Potential Action	REPLACE
Urgency of Action	PRIORITY 3
Purpose of Action	LEVEL 2
Deficiency Photo1

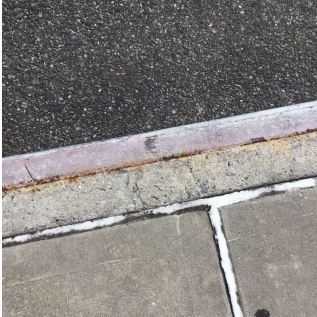
Along Flatland Avenue
Violations	No violations recorded.
Deficiency	DAMAGED CURBS
Deficiency Location/Instance	Along Flatland Avenue, Elton Street, Linwood Street
Deficiency Quantity	45
Quantity Uom	L.F.
Potential Action	REPLACE
Urgency of Action	PRIORITY 3
Purpose of Action	LEVEL 2

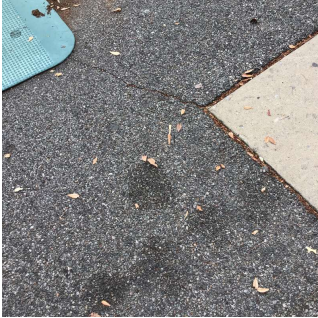
Violations	Along Flatland Avenue No violations recorded.
<b>Pavers</b>	Does not Exist
<b>PLAYGROUNDS</b>	Inspected
Instance on East side of Schoolyard	Inspected
<b>Benches</b>	
Instance on East side of Schoolyard	Inspected
Condition	2 - Between Good and Fair
Deficiency	No deficiencies recorded
<b>Fence</b>	
Instance on East side of Schoolyard	Inspected
Condition	2 - Between Good and Fair
Deficiency	CONCRETE CURB: DAMAGED/DETERIORATED
Deficiency Location/Instance	Schoolyard
Deficiency Quantity	10
Quantity Uom	S.F.
Potential Action	REPLACE
Urgency of Action	PRIORITY 3
Purpose of Action	LEVEL 2
Deficiency Photo1	 
Violations	Schoolyard No violations recorded.
<b>Pavement</b>	
Instance on East side of Schoolyard	Inspected
Condition	2 - Between Good and Fair
Deficiency	ASPHALT: CRACKS - MAJOR
Deficiency Location/Instance	Schoolyard

Question	Response
<b>SITE</b>	
<b>PLAYGROUNDS</b>	
<b>Pavement</b>	
Potential Action	REPLACE
Urgency of Action	PRIORITY 3
Purpose of Action	LEVEL 2
Deficiency Photo1
