NYC Department of Education
Building Condition Assessment Survey 2023 - 2024

Architectural Inspection

K426

Asset: MADISON AF - BROOKLYN, 3787 BEDFORD AVENUE, New York, 11229

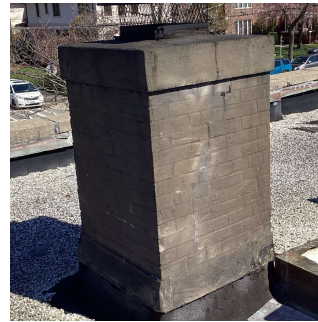
Roof 1
No violations recorded.

BRICK: MINOR CRACKS AND SPALLING

10
S.F.
RESTITCH
PRIORITY 3
LEVEL 2

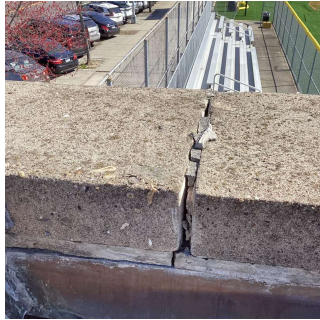
CAST STONE: DETERIORATED TRANSVERSE JOINTS

50
L.F.
MAINTENANCE
PRIORITY 3
LEVEL 2

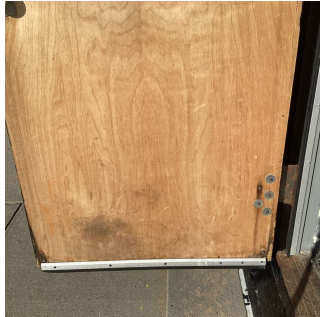
Violations	Roof 1 No violations recorded.
CORNICE	Inspected
Condition	2 - Between Good and Fair
Deficiency	No deficiencies recorded
DOORS	Inspected
DOORS AND FRAMES	Inspected
Condition	5 - Poor
Deficiency	METAL CLAD: DETERIORATED DOOR - MAJOR DETERIORATION
Roof Plan reference

Deficiency Quantity	4
Quantity Uom	EACH
Potential Action	REPLACE
Urgency of Action	PRIORITY 4
Purpose of Action	LEVEL 2
Deficiency Photo1

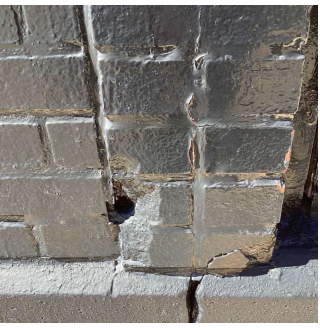
Question	Response
EXTERIOR	
DOORS	Inspected
LINTELS	Inspected
Condition	2 - Between Good and Fair
Deficiency	No deficiencies recorded
TRANSOM/SIDE LIGHT	Does not Exist
EXTERIOR WALLS	Inspected
Material Type(s)	Masonry
Replacement Quantity	4,000
Replacement Uom	S.F.
Instance on Fieldhouse	Inspected
Instance Condition	3 - Fair
Instance Quantity	2,500
Instance Quantity Uom	S.F.
Deficiency	BRICK: MAJOR / THRU CRACKS
Roof Plan reference

Deficiency Quantity	20
Quantity Uom	S.F.
Potential Action	REMOVE AND REBUILD
Urgency of Action	PRIORITY 4
Purpose of Action	LEVEL 2
Deficiency Photo1

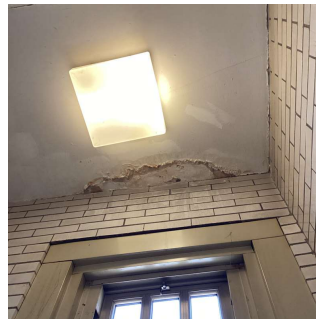
Roof 1 - 1st Floor - in West Office Room
No violations recorded.

Question	Response
EXTERIOR	
ROOF	
Roofing	
ROOFING	
Instance Photo	 
	Roof 1
Instance Quantity	2,400
Instance Quantity Uom	S.F.
Does the roof have major mechanical equipment sitting on Dunnage Steel less than 18" above the Roofing?	No
Does this roof instance have a Sustainable Roof System?	No
Do solar panels exist on these roofs?	No
Is/Are the roof(s) suitable for Solar Panel installation?	No
Installation Year	2002
Source of Installation	Custodial Staff
Deficiency	BUILT-UP: FLASHING: CAP FLASHING DAMAGED
Roof Plan reference	 
Deficiency Quantity	30
Quantity Uom	L.F.
Potential Action	REPLACE
Urgency of Action	PRIORITY 4
Purpose of Action	LEVEL 2
Deficiency Photo1	 
	Roof 1
Violations	No violations recorded.
Deficiency	BUILT-UP: ROOFING: MAJOR ACTIVE ROOF LEAKS IN INSTRUCTIONAL SPACE

100
S.F.
REPLACE ROOFING WITHOUT MAJOR EQUIPMENT
REMOVAL
PRIORITY 5
LEVEL 2

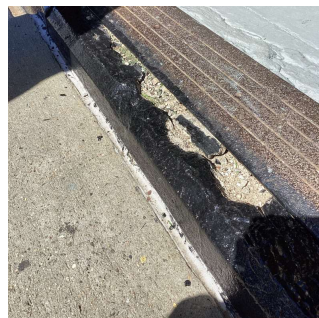
Question	Response
EXTERIOR	
ROOF	Inspected
Roofing	Inspected
ROOFING DRAINS	
Condition	2 - Between Good and Fair
Deficiency	No deficiencies recorded
Specialties	Does not Exist
STAIRS/RAMPS: EXTERIOR	Inspected
BUILDING CHEEK/FLANK WALLS	Does not Exist
RAILINGS	Does not Exist
STAIRS/RAMPS	Inspected
Condition	5 - Poor
Deficiency	STONE: CRACKS/SPALLING - MAJOR
Roof Plan reference

Deficiency Quantity	25
Quantity Uom	S.F.
Potential Action	REPLACE
Urgency of Action	PRIORITY 4
Purpose of Action	LEVEL 2
Deficiency Photo1

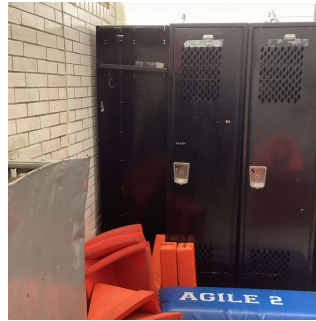
Near Main Entrance
Violations	No violations recorded.
Locker Room Lockers	
Instance on 1st Floor - West (30 Lockers)	Inspected
Condition	3 - Fair
Deficiency	DAMAGED UNITS
Deficiency Location/Instance	Near Windows
Deficiency Quantity	1
Quantity Uom	EACH
Potential Action	REPLACE
Urgency of Action	PRIORITY 3
Purpose of Action	LEVEL 2
Deficiency Photo1	 
	Near Windows
Violations	No violations recorded.
Instance on 1st Floor - East (48 Lockers)	Inspected
Condition	3 - Fair
Deficiency	DAMAGED UNITS
Deficiency Location/Instance	In Shower Room
Deficiency Quantity	3
Quantity Uom	EACH
Potential Action	REPLACE
Urgency of Action	PRIORITY 3
Purpose of Action	LEVEL 2

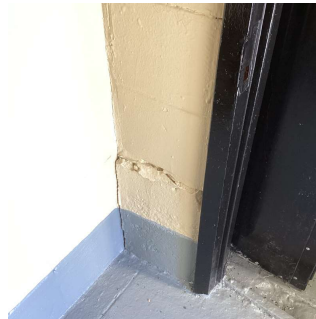
Instance on 1st Floor - East (48 Lockers)	Inspected
Condition	2 - Between Good and Fair
Deficiency	GLAZED BLOCK: CRACKS/SPALLING
Deficiency Location/Instance	Near Main Entrance
Deficiency Quantity	10
Quantity Uom	S.F.
Potential Action	REPLACE
Urgency of Action	PRIORITY 3
Purpose of Action	LEVEL 2
Deficiency Photo1

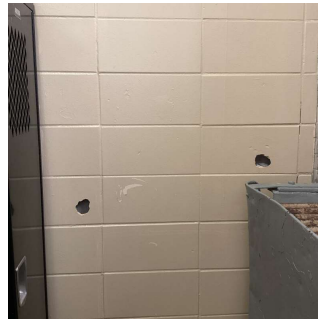
Near Entrance

Deficiency GLAZED BLOCK: CRACKS/SPALLING

Potential Action REPLACE

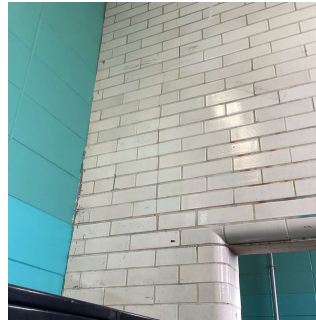
Near Entrance

BRICK: CRACKS/SPALLING

REPLACE

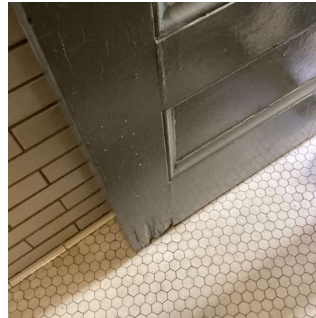
In West Office Room

WOOD: DETERIORATED DOOR

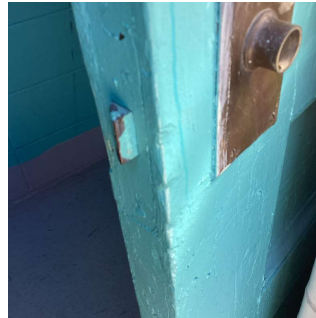
Girls Toilet Room

WOOD: DETERIORATED DOOR

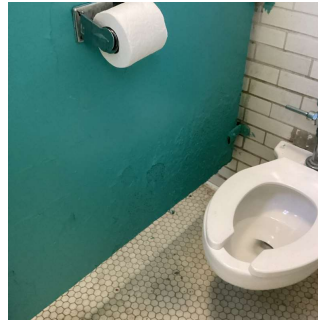
In West Locker Room

RUST - MAJOR

REPLACE

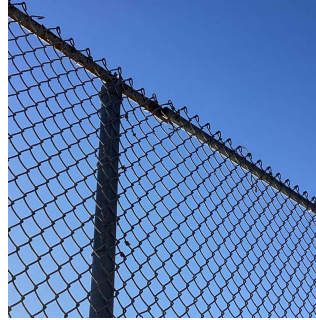
Deficiency	No deficiencies recorded
Culverts - Soil Covering	Does not Exist
DRINKING FOUNTAINS	Inspected
Condition	1 - Good
Deficiency	No deficiencies recorded
FENCES	Inspected
Condition	3 - Fair
Deficiency	CHAIN LINK: DAMAGED POST/RAIL
Deficiency Location/Instance	Bedford Avenue
Deficiency Quantity	10
Quantity Uom	L.F.
Potential Action	REPLACE
Urgency of Action	PRIORITY 3
Purpose of Action	LEVEL 2

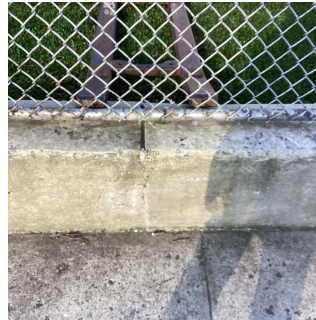
Quentin Road

CONCRETE CURB: DAMAGED/DETERIORATED

REPLACE

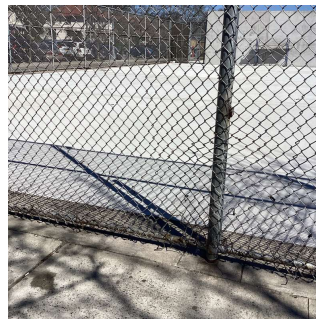
Bedford Avenue

CHAIN LINK: DAMAGED/DETERIORATED

REPLACE
