NYC Department of Education
Building Condition Assessment Survey 2023 - 2024

Architectural Inspection

Asset: BROOKLYN TECH AF - BROOKLYN, 490 CLERMONT AVENUE, New York, 11238

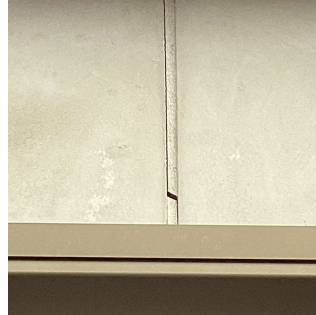
Facade B

Question	Response
EXTERIOR	
DOORS	
DOORS AND FRAMES	
Deficiency Photo1	 
Violations	Facade H No violations recorded.
DOOR HARDWARE	Inspected
Condition	2 - Between Good and Fair
Deficiency	No deficiencies recorded
LINTELS	Inspected
Condition	2 - Between Good and Fair
Deficiency	No deficiencies recorded
TRANSOM/SIDE LIGHT	Does not Exist
EXTERIOR WALLS	Inspected
Material Type(s)	Masonry, Concrete
Replacement Quantity	3,200
Replacement Uom	S.F.
Instance on Facades A - D (Field House)	Inspected
Instance Condition	2 - Between Good and Fair
Instance Quantity	2,500
Instance Quantity Uom	S.F.
Deficiency	CAST IN PLACE / PRE-CAST CONCRETE: DETERIORATED JOINTS
Roof Plan reference	<p>K431</p>  
Elevation	 
Deficiency Quantity	10
Quantity Uom	L.F.

REPOINT
PRIORITY 3
LEVEL 2

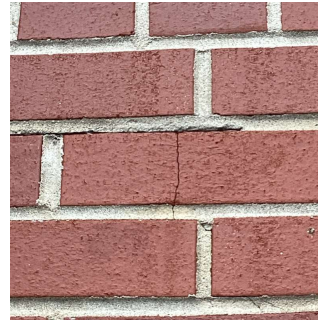
Facade H

Deficiency

BRICK: MAJOR / THRU CRACKS

Deficiency Quantity

10

Quantity Uom

S.F.

Potential Action

REMOVE AND REBUILD

Urgency of Action

PRIORITY 4

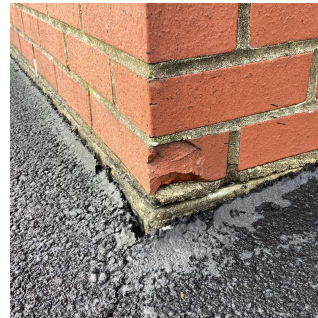
Facade H

Deficiency

BRICK: DETERIORATED JOINTS

Question	Response
EXTERIOR	
EXTERIOR WALLS	
Roof Plan reference	
Elevation	
Deficiency Quantity	20
Quantity Uom	S.F.
Potential Action	REPOINT
Urgency of Action	PRIORITY 3
Purpose of Action	LEVEL 2
Deficiency Photo1	
Violations	Facade G No violations recorded.
EXTERIOR SOFFITS	Inspected
Condition	1 - Good
Deficiency	No deficiencies recorded
LOUVER	Inspected
Condition	1 - Good
Deficiency	No deficiencies recorded
PARAPETS	Does not Exist
PLAZA DECK	Does not Exist
ROOF	Inspected
Roofing	Inspected
Replacement Quantity	3,000
Replacement Uom	S.F.
ROOF HATCH/SMOKE HATCH	Does not Exist
LEADERS, GUTTERS, DOWNSPOUTS, SCUPPERS	Inspected

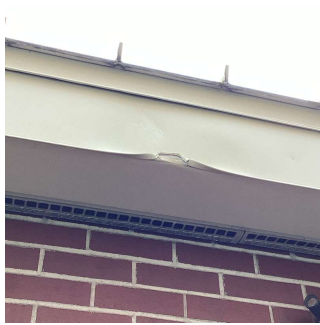
Roof 2 - Facade G
Violations	No violations recorded.

Roof 2
Instance Quantity	560
Instance Quantity Uom	S.F.
Does the roof have major mechanical equipment sitting on Dunnage Steel less than 18" above the Roofing?	No
Does this roof instance have a Sustainable Roof System?	Yes
Sustainable Roof Type	White Roof
Sustainable Roof Location (Roof Number)	Roof 2
Do solar panels exist on these roofs?	No
Is/Are the roof(s) suitable for Solar Panel installation?	No
Installation Year	2001
Source of Installation	Custodial Staff
Deficiency	METAL: FLASHING: DETERIORATED METAL FLASHING
Roof Plan reference	K431

Deficiency Quantity	10
Quantity Uom	L.F.
Potential Action	REMOVE AND REPLACE
Urgency of Action	PRIORITY 4
Purpose of Action	LEVEL 2

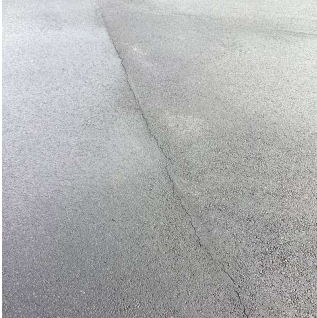
Question	Response
SITE	
FENCES	
Deficiency Photo1	 
Violations	Near Entrance No violations recorded.
Deficiency	CHAIN LINK: DAMAGED POST/RAIL
Deficiency Location/Instance	Left Side of Field
Deficiency Quantity	20
Quantity Uom	L.F.
Potential Action	REPLACE
Urgency of Action	PRIORITY 3
Purpose of Action	LEVEL 2
Deficiency Photo1	 
Violations	Left Side of Field No violations recorded.
IRRIGATION SYSTEM	Does not Exist
PAVING	Inspected
Student Non-Use	Inspected
Gravel Exists?	No
Asphalt	Inspected
Condition	1 - Good
Deficiency	No deficiencies recorded
Concrete	Inspected
Condition	1 - Good
Deficiency	No deficiencies recorded
Pavers	Does not Exist
Student Use	Inspected
Gravel Exists?	No
Asphalt	Inspected
Condition	3 - Fair
Deficiency	CRACKS - MAJOR
Deficiency Location/Instance	Fulton Street
Deficiency Quantity	250
Quantity Uom	S.F.

Fulton Street
Violations	No violations recorded.
Concrete	Does not Exist
Pavers	Does not Exist
Site Sidewalks & Walkways	Inspected
Asphalt	Does not Exist
Concrete	Inspected
Condition	3 - Fair
Deficiency	CRACKS - MAJOR
Deficiency Location/Instance	Clermont Avenue
Deficiency Quantity	350
Quantity Uom	S.F.
Potential Action	REPLACE
Urgency of Action	PRIORITY 3
Purpose of Action	LEVEL 2
Deficiency Photo1	 
	Clermont Avenue
Violations	No violations recorded.
Pavers	Inspected
Condition	1 - Good
Deficiency	No deficiencies recorded
DOT Sidewalk	Inspected
Asphalt	Does not Exist
Concrete	Inspected
Condition	4 - Between Fair and Poor

Question	Response
SITE	
PAVING	
Student Use	
Asphalt	
Potential Action	REPLACE
Urgency of Action	PRIORITY 3
Purpose of Action	LEVEL 2
Deficiency Photo1

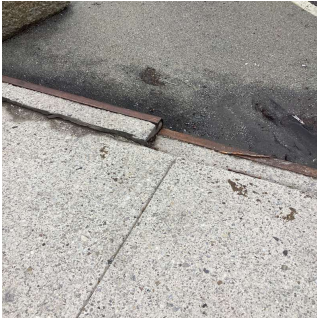
Question	Response
SITE	
PAVING	
DOT Sidewalk	
Concrete	
Deficiency	DAMAGED CURBS
Deficiency Location/Instance	Clermont Avenue
Deficiency Quantity	30
Quantity Uom	L.F.
Potential Action	REPLACE
Urgency of Action	PRIORITY 3
Purpose of Action	LEVEL 2
Deficiency Photo1

Violations	Clermont Avenue No violations recorded.
Deficiency	HEAVING
Deficiency Location/Instance	Fulton Street
Deficiency Quantity	50
Quantity Uom	S.F.
Potential Action	REPLACE
Urgency of Action	PRIORITY 3
Purpose of Action	LEVEL 2
Deficiency Photo1

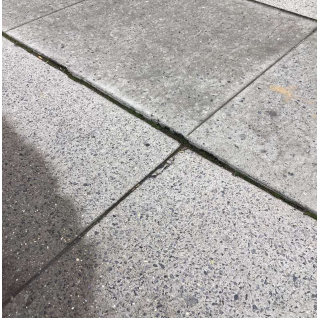
Violations	Fulton Street No violations recorded.
Deficiency	DAMAGED/DETERIORATED/MISSING SECTIONS
Deficiency Location/Instance	Clermont Avenue, Fulton Street
Deficiency Quantity	875
Quantity Uom	S.F.
Potential Action	REPLACE
Urgency of Action	PRIORITY 3
Purpose of Action	LEVEL 2

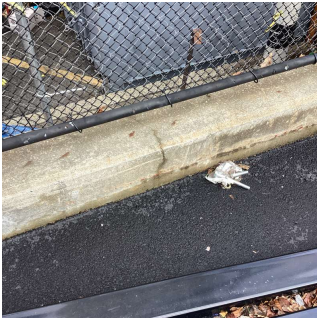
Violations	Clermont Avenue No violations recorded.
Pavers	Does not Exist
PLAYGROUNDS	Does not Exist
RETAINING WALLS	Inspected
Are there any Retaining Walls 6' OR higher facing public street/sidewalk?	No
Condition	3 - Fair
Deficiency	CAST IN PLACE CONCRETE: CRACKS/SPALLING - MAJOR
Deficiency Location/Instance	Left Side of Field
Deficiency Quantity	40
Quantity Uom	S.F.
Potential Action	REPLACE
Urgency of Action	PRIORITY 3
Purpose of Action	LEVEL 2
Deficiency Photo1

Violations	Left Side of Field No violations recorded.
SEATING	Inspected
Benches	Inspected
Concrete	Does not Exist
Metal/Wood/Plastic	Inspected
Condition	1 - Good
Deficiency	No deficiencies recorded
SITE WALLS (NOT RETAINING WALLS)	Inspected
Condition	1 - Good
Deficiency	No deficiencies recorded
STAIRS/RAMPS: EXTERIOR	Inspected
Railings	Inspected
