**NYC Department of Education**  
**Building Condition Assessment Survey 2023 - 2024**

Architectural Inspection

**K437**

**Asset:**           **PARKSIDE COMMUNITY COMPLEX - BROOKLYN, 713 CATON AVENUE, New York, 11218**

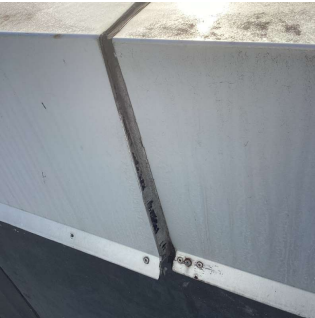
Question	Response
<b>EXTERIOR</b>	
<b>COPING</b>	Inspected
Condition	3 - Fair
Deficiency	METAL: DETERIORATED TRANSVERSE JOINTS
Roof Plan reference

Deficiency Quantity	70
Quantity Uom	L.F.
Potential Action	MAINTENANCE
Urgency of Action	PRIORITY 3
Purpose of Action	LEVEL 2
Deficiency Photo1

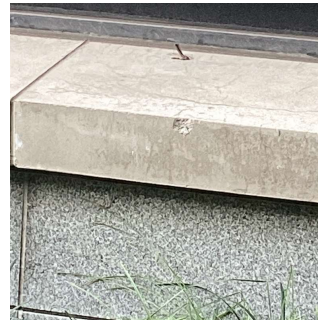
Facade D

**BRICK: DETERIORATED MASONRY SILLS - MINOR**

50  
L.F.  
REPAIR  
PRIORITY 3  
LEVEL 2

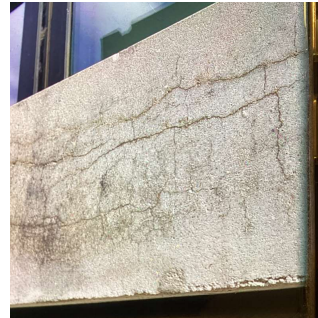
Facade F

**BRICK: DETERIORATED MASONRY SILLS - MAJOR**

10  
L.F.  
REMOVE AND REPLACE

PRIORITY 4  
LEVEL 2

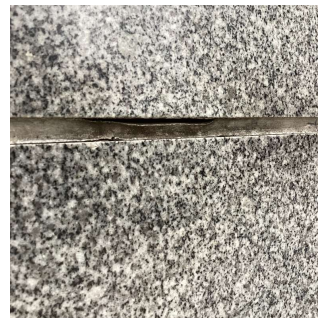
Facade J

**STONE: DETERIORATED JOINTS**

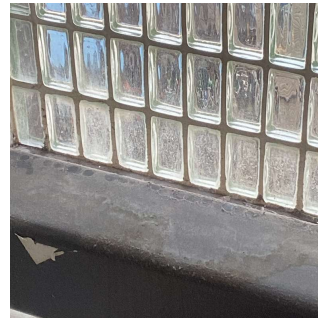
Facade G - Stair A/ 1-3

**BRICK: WATER INFILTRATION IN INSTRUCTIONAL SPACE**

REPAIR

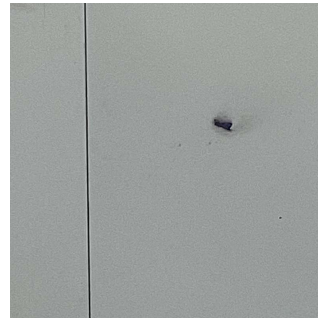
Facade A  
No violations recorded.

METAL: DETERIORATION/DAMAGED/MISSING PIECES

10  
S.F.  
REPLACE  
PRIORITY 4  
LEVEL 2

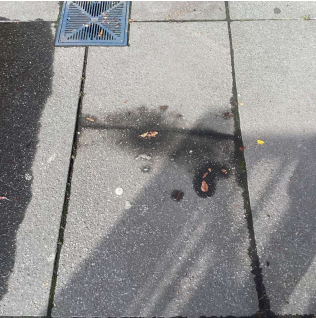
Question	Response
<b>EXTERIOR</b>	
<b>PLAZA DECK</b>	Inspected
Instance on Pavers: Roof 7	Inspected
Instance Condition	4 - Between Fair and Poor
Instance Quantity	3,400
Instance Quantity Uom	S.F.
Installation Year	2015
Source of Installation	Custodial Staff
Deficiency	PAVERS: PAVERS IN POOR CONDITION
Roof Plan reference

Deficiency Quantity	10
Quantity Uom	S.F.
Potential Action	REPLACE
Urgency of Action	PRIORITY 4
Purpose of Action	LEVEL 2
Deficiency Photo1

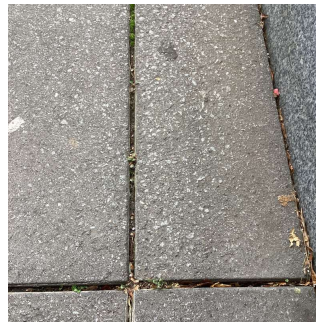
Roof 7

Violations	No violations recorded.
Deficiency	PAVERS: DETERIORATED JOINTS
Roof Plan reference

Deficiency Quantity	80
Quantity Uom	L.F.
Potential Action	REPOINT
Urgency of Action	PRIORITY 3

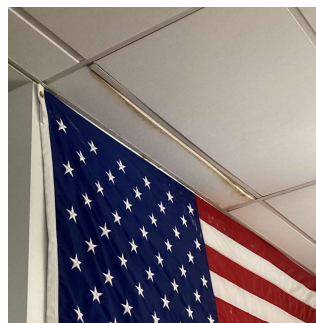
Roof 7 - Cafeteria near main entrance

**PAVERS: MAJOR ACTIVE PLAZA DECK LEAKS IN INSTRUCTIONAL SPACE**

100  
S.F.  
REPLACE  
PRIORITY 5  
LEVEL 2

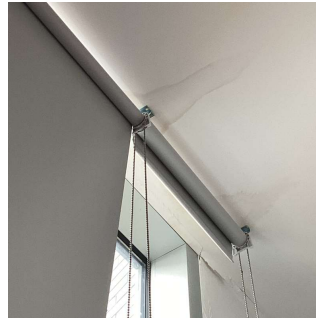
Roof 1 - Rooms 502, 505  
Roof 3 - 420B (Shown), 434

Roof 1
Instance Quantity	21,500
Instance Quantity Uom	S.F.
Does the roof have major mechanical equipment sitting on Dunnage Steel less than 18" above the Roofing?	No
Does this roof instance have a Sustainable Roof System?	No
Do solar panels exist on these roofs?	No
Is/Are the roof(s) suitable for Solar Panel installation?	Yes
Installation Year	2015
Source of Installation	Custodial Staff
Deficiency	IRMA: ROOFING: MAJOR ACTIVE ROOF LEAKS IN INSTRUCTIONAL SPACE
Roof Plan reference

Deficiency Quantity	400
Quantity Uom	S.F.
Potential Action	REPLACE ROOFING WITHOUT MAJOR EQUIPMENT REMOVAL
Urgency of Action	PRIORITY 5
Purpose of Action	LEVEL 2

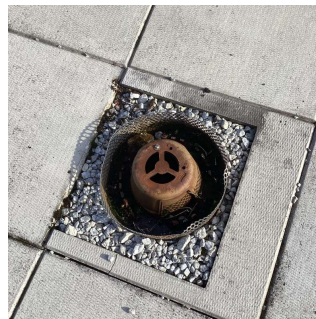
Roof 2

DETERIORATED

REPLACE

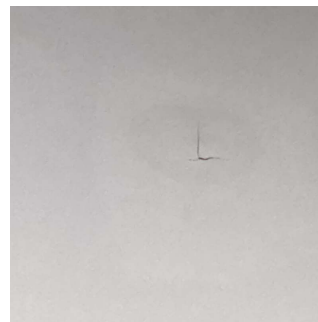
PH  
 No violations recorded.

BULKHEAD/PENTHOUSE WALLS/INTERIOR: PLASTER  
CRACKS/SPALLING

10  
 S.F.  
 REPLACE  
 PRIORITY 3  
 LEVEL 2

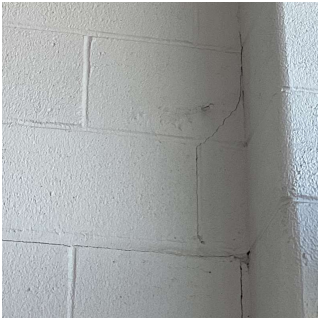
Deficiency **BULKHEAD/PENTHOUSE WALLS/INTERIOR: CMU CRACKS/SPALLING**

30  
 S.F.  
 REPLACE  
 PRIORITY 3  
 LEVEL 2

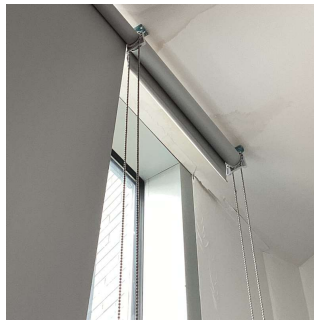
Facade C - Room 420B

Are these windows insulated	Yes
Installation Year	2015
Source of Installation	Custodial Staff
Deficiency	ALUMINUM - OTHER: AIR/WATER INFILTRATION

100  
L.F.  
REPLACE TRIM, SILLS OR WEATHERSTRIPPING  
PRIORITY 5  
LEVEL 2

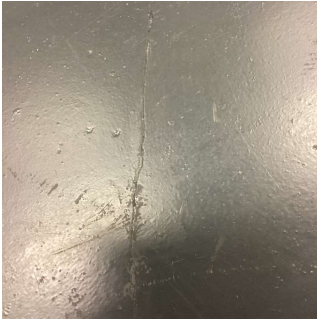
Violations	5th Floor - Boiler Room No violations recorded.
Deficiency	CONCRETE SLAB ON GRADE: THRU CRACKS
Deficiency Location/Instance	Basement - Electrical Room, C28, C23
Deficiency Quantity	30
Quantity Uom	S.F.
Potential Action	REPLACE
Urgency of Action	PRIORITY 4
Purpose of Action	LEVEL 5
Deficiency Photo1

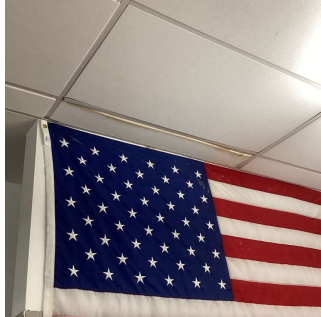
Deficiency	ACOUSTIC TILES: DAMAGED/MISSING - ACTIVE LEAK
Deficiency Location/Instance	Near Main Entrance
Deficiency Quantity	10
Quantity Uom	S.F.
Potential Action	REPLACE
Urgency of Action	PRIORITY 5
Purpose of Action	LEVEL 2
Deficiency Photo1

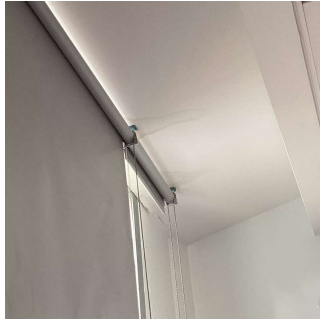
Question	Response
<b>INTERIOR</b>	
<b>CAFETERIA</b>	
<b>Walls</b>	
Instance on Basement	Inspected
Condition	2 - Between Good and Fair
Deficiency	GYPSUM BOARD: DETERIORATED
Deficiency Location/Instance	Near Main Entrance, By Servery
Deficiency Quantity	20
Quantity Uom	S.F.
Potential Action	REPLACE
Urgency of Action	PRIORITY 3
Purpose of Action	LEVEL 2
Deficiency Photo1	 
Violations	Near Main Entrance No violations recorded.
<b>Window Curtains/Shades/Blinds</b>	
Instance on Basement	Does not Exist
<b>CLASSROOMS/CORRIDORS/ADMIN SPACES</b>	
<b>Ceiling</b>	
Condition	Inspected
Condition	2 - Between Good and Fair
Deficiency	GYPSUM BOARD: DAMAGED/DETERIORATED - ACTIVE LEAK
Deficiency Location/Instance	Room 420B
Deficiency Quantity	10
Quantity Uom	S.F.
Potential Action	REPLACE
Urgency of Action	PRIORITY 5
Purpose of Action	LEVEL 2
Deficiency Photo1

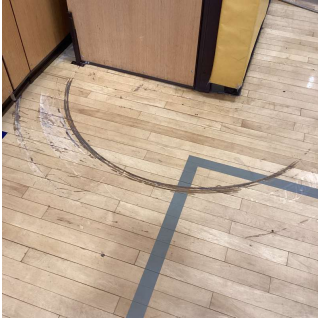
Question	Response
<b>INTERIOR</b>	
<b>GYMNASIUM</b>	
<b>Floor Finish</b>	
Instance on Basement	Inspected
Condition	2 - Between Good and Fair
Deficiency	WOOD: DAMAGED/DETERIORATED
Deficiency Location/Instance	Left Side
Deficiency Quantity	20
Quantity Uom	S.F.
Potential Action	REPLACE
Urgency of Action	PRIORITY 3
Purpose of Action	LEVEL 2
Deficiency Photo1

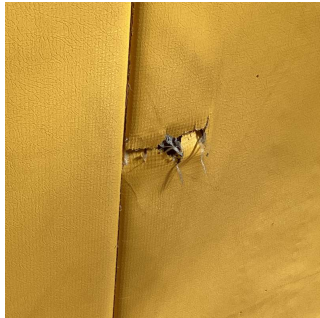
<b>Walls</b>	
Instance on Basement	Inspected
Condition	2 - Between Good and Fair
Deficiency	WALL PADDING: DETERIORATED
Deficiency Location/Instance	Right and Left Side
Deficiency Quantity	120
Quantity Uom	S.F.
Potential Action	REPLACE
Urgency of Action	PRIORITY 3

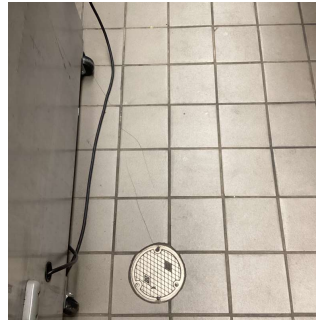
Violations	Left side No violations recorded.
<b>Window Curtains/Shades/Blinds</b>	
Instance on Basement	Does not Exist
<b>INTERIOR DOOR HARDWARE</b>	Inspected
Condition	2 - Between Good and Fair
Deficiency	No deficiencies recorded
<b>INTERIOR GUARDS</b>	Inspected
Condition	2 - Between Good and Fair
Deficiency	No deficiencies recorded
<b>KITCHEN</b>	Inspected
Instance on Basement	Inspected
<b>Ceiling</b>	
Instance on Basement	Inspected
Condition	2 - Between Good and Fair
Deficiency	No deficiencies recorded
<b>Door(s)</b>	
Instance on Basement	Inspected
Condition	2 - Between Good and Fair
Deficiency	No deficiencies recorded
<b>Floor Finish</b>	
Instance on Basement	Inspected
Condition	2 - Between Good and Fair
Deficiency	QUARRY TILE: BROKEN/MISSING TILES
Deficiency Location/Instance	Servery
Deficiency Quantity	10

Quantity Uom	S.F.
Potential Action	REPLACE
Urgency of Action	PRIORITY 3
Purpose of Action	LEVEL 2

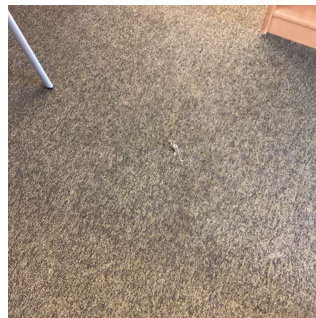
Near Stair B/3

CARPET: WORN/DETERIORATED

REPLACE

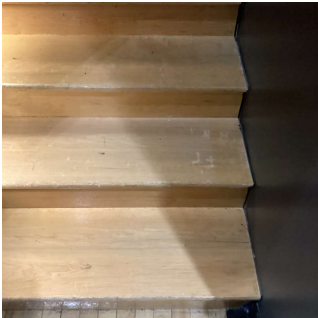
Instance on 2nd Floor	Inspected
Condition	3 - Fair
Deficiency	DAMAGED STEPS
Deficiency Location/Instance	Right and Left Side
Deficiency Quantity	30
Quantity Uom	S.F.
Potential Action	REPLACE
Urgency of Action	PRIORITY 3
Purpose of Action	LEVEL 2
Deficiency Photo1

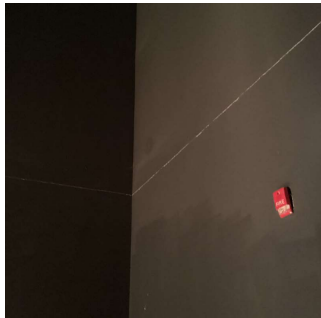
Instance on 2nd Floor	Inspected
Condition	2 - Between Good and Fair
Deficiency	GYPSUM BOARD: DETERIORATED
Deficiency Location/Instance	Right Side
Deficiency Quantity	30
Quantity Uom	S.F.
Potential Action	REPLACE
Urgency of Action	PRIORITY 3
Purpose of Action	LEVEL 2
Deficiency Photo1

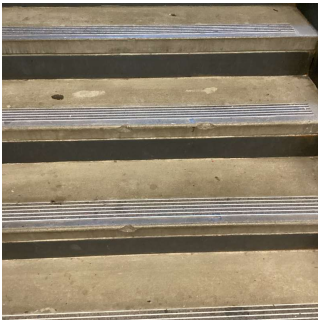
Question	Response
<b>INTERIOR</b>	
<b>STAIRS/RAMPS: INTERIOR</b>	
<b>Partition</b>	Does not Exist
<b>Railings</b>	Inspected
Condition	2 - Between Good and Fair
Deficiency	No deficiencies recorded
<b>Stairs and Landings</b>	Inspected
Condition	2 - Between Good and Fair
Deficiency	CONCRETE: CRACKS/SPALLING - MAJOR
Deficiency Location/Instance	Stair A/Basement
Deficiency Quantity	10
Quantity Uom	S.F.
Potential Action	REPLACE
Urgency of Action	PRIORITY 3
Purpose of Action	LEVEL 2
Deficiency Photo1

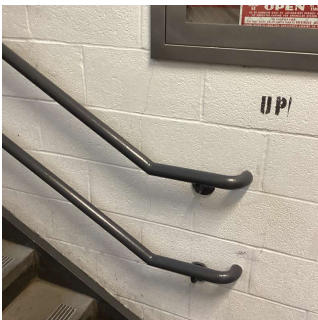
Violations	Stair A/Basement No violations recorded.
<b>Walls</b>	Inspected
Condition	2 - Between Good and Fair
Deficiency	MASONRY: CRACKS/SPALLING
Deficiency Location/Instance	Stairs A/Basement, 1, 2
Deficiency Quantity	30
Quantity Uom	S.F.
Potential Action	REPLACE
Urgency of Action	PRIORITY 3
Purpose of Action	LEVEL 2
Deficiency Photo1

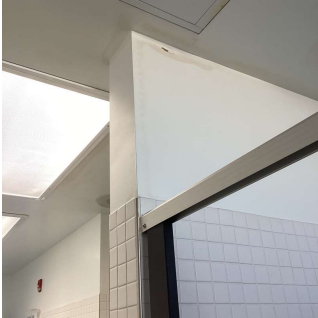
Question	Response
<b>INTERIOR</b>	
<b>TOILET ROOMS - STUDENTS</b>	
<b>Door(s)</b>	Inspected
Condition	2 - Between Good and Fair
Deficiency	No deficiencies recorded
<b>Floor Finish</b>	Inspected
Condition	2 - Between Good and Fair
Deficiency	No deficiencies recorded
<b>Stalls</b>	Inspected
Condition	2 - Between Good and Fair
Deficiency	No deficiencies recorded
<b>Walls</b>	Inspected
Condition	2 - Between Good and Fair
Deficiency	GYPSUM BOARD: DETERIORATED
Deficiency Location/Instance	Room 527
Deficiency Quantity	10
Quantity Uom	S.F.
Potential Action	REPLACE
Urgency of Action	PRIORITY 3
Purpose of Action	LEVEL 2
Deficiency Photo1

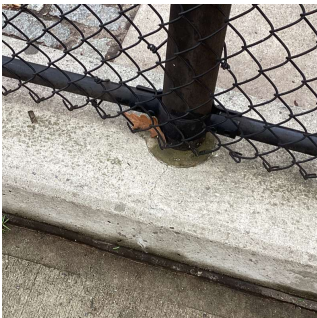
Question	Response
<b>SITE</b>	
<b>FENCES</b>	
Condition	3 - Fair
Deficiency	CHAIN LINK: DAMAGED/DETERIORATED
Deficiency Location/Instance	Caton Avenue
Deficiency Quantity	50
Quantity Uom	S.F.
Potential Action	REPLACE
Urgency of Action	PRIORITY 3
Purpose of Action	LEVEL 2
Deficiency Photo1	 
Violations	Caton Avenue No violations recorded.
Deficiency	CONCRETE CURB: DAMAGED/DETERIORATED
Deficiency Location/Instance	E 8th Street
Deficiency Quantity	20
Quantity Uom	S.F.
Potential Action	REPLACE
Urgency of Action	PRIORITY 3
Purpose of Action	LEVEL 2
Deficiency Photo1

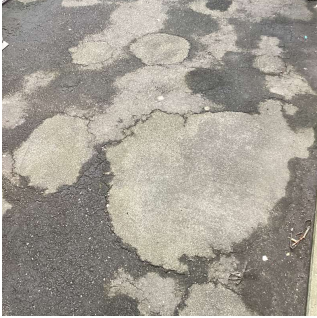
Violations	E 8th Street No violations recorded.
<b>IRRIGATION SYSTEM</b>	Does not Exist
<b>PAVING</b>	Inspected
<b>Student Non-Use</b>	Inspected
Gravel Exists?	No
<b>Asphalt</b>	Inspected
Condition	2 - Between Good and Fair
Deficiency	CRACKS - MAJOR
Deficiency Location/Instance	Near Schoolyard, By Room 130
Deficiency Quantity	30
Quantity Uom	S.F.
Potential Action	REPLACE

Question	Response
<b>SITE</b>	
<b>PAVING</b>	
<b>Student Non-Use</b>	
<b>Asphalt</b>	
Urgency of Action	PRIORITY 3
Purpose of Action	LEVEL 2
Deficiency Photo1

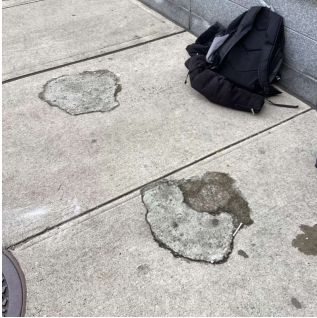
Violations	Near Schoolyard No violations recorded.
<b>Concrete</b>	Inspected
Condition	2 - Between Good and Fair
Deficiency	No deficiencies recorded
<b>Pavers</b>	Does not Exist
<b>Student Use</b>	Inspected
Gravel Exists?	No
<b>Asphalt</b>	Inspected
Condition	2 - Between Good and Fair
Deficiency	No deficiencies recorded
<b>Concrete</b>	Inspected
Condition	3 - Fair
Deficiency	DAMAGED/DETERIORATED/MISSING SECTIONS
Deficiency Location/Instance	Schoolyard
Deficiency Quantity	350
Quantity Uom	S.F.
Potential Action	REPLACE
Urgency of Action	PRIORITY 3
Purpose of Action	LEVEL 2
Deficiency Photo1

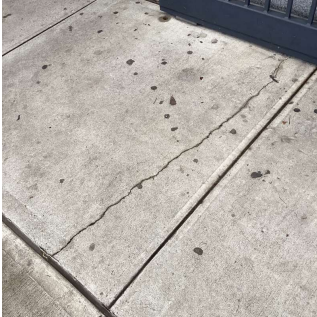
Question	Response
<b>SITE</b>	
<b>PAVING</b>	
<b>Site Sidewalks &amp; Walkways</b>	
<b>Asphalt</b>	Does not Exist
<b>Concrete</b>	Inspected
Condition	3 - Fair
Deficiency	CRACKS - MAJOR
Deficiency Location/Instance	Caton Avenue, E 8th Avenue
Deficiency Quantity	50
Quantity Uom	S.F.
Potential Action	REPLACE
Urgency of Action	PRIORITY 3
Purpose of Action	LEVEL 2
Deficiency Photo1

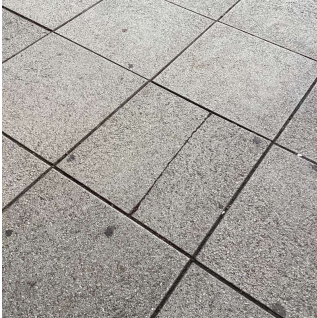
Caton Avenue
Violations	No violations recorded.
<b>Pavers</b>	Inspected
Condition	3 - Fair
Deficiency	DAMAGED/MISSING
Deficiency Location/Instance	Main Entrance
Deficiency Quantity	50
Quantity Uom	S.F.
Potential Action	REPLACE
Urgency of Action	PRIORITY 3
Purpose of Action	LEVEL 2
Deficiency Photo1
