NYC Department of Education
Building Condition Assessment Survey 2023 - 2024

Architectural Inspection

K441

Asset: 3K CENTER @ 274 ATLANTIC AVENUE - BROOKLYN, 274 ATLANTIC AVENUE, 11201

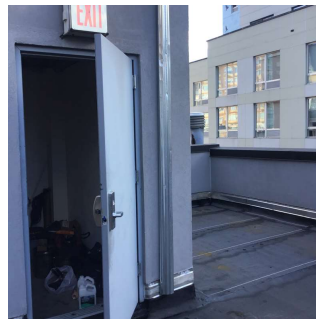
Penthouse
No violations recorded.

Question	Response
EXTERIOR	
PARAPETS	Inspected
Instance Quantity	1,000
Instance Quantity Uom	C.F.
Deficiency	No deficiencies recorded
PLAZA DECK	Does not Exist
ROOF	Inspected
Roofing	Inspected
Replacement Quantity	10,000
Replacement Uom	S.F.
ROOF HATCH/SMOKE HATCH	Does not Exist
LEADERS, GUTTERS, DOWNSPOUTS, SCUPPERS	Inspected
Condition	3 - Fair
Deficiency	DAMAGED/MISSING
Roof Plan reference

K441
10
L.F.
REPLACE
PRIORITY 4
LEVEL 2

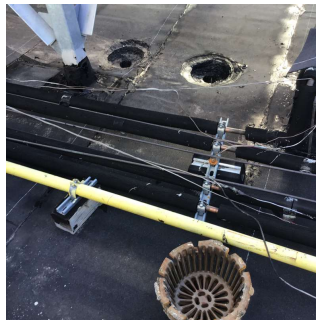
Roof 1
 No violations recorded.

Condition	5 - Poor
Deficiency	DETERIORATED

4
 EACH
 REPLACE
 PRIORITY 4
 LEVEL 2

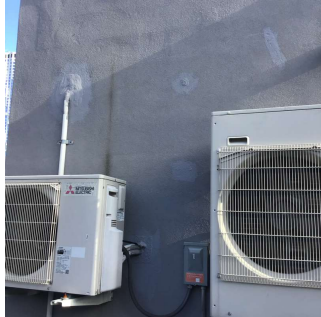
BULKHEAD/PENTHOUSE WALLS/EXTERIOR:
 CRACKS/SPALLING - MINOR

50
 S.F.
 REPAIR
 PRIORITY 3
 LEVEL 2

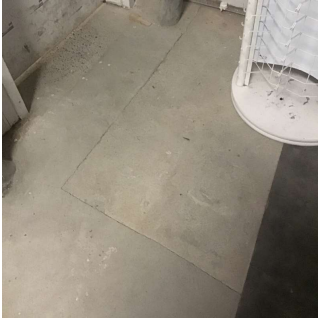
Question	Response
INTERIOR	
STRUCTURAL	
FLOOR STRUCTURE	
Condition	3 - Fair
Deficiency	CONCRETE: CRACKS/SPALLED/REINFORCEMENT EXPOSED
Deficiency Location/Instance	Electrical Panel Room
Deficiency Quantity	30
Quantity Uom	S.F.
Potential Action	REPAIR
Urgency of Action	PRIORITY 3
Purpose of Action	LEVEL 5
Deficiency Photo1

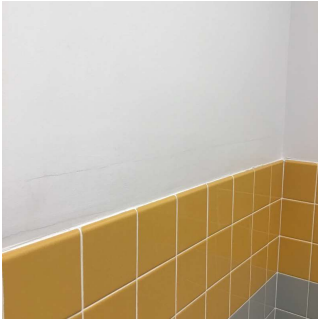
Violations	Room 104A No violations recorded.
LIFE SAFETY	Inspected
F.D. HOLDING AREA	Does not Exist
STEEL STAIRS	Does not Exist
SITE	Does not Exist
ARTWORK	Does not Exist

Question	Response
INTERIOR	
TOILET ROOMS - STAFF	Inspected
Walls	Inspected
Condition	1 - Good
Deficiency	No deficiencies recorded
TOILET ROOMS - STUDENTS	Inspected
Ceiling	Inspected
Condition	1 - Good
Deficiency	No deficiencies recorded
Door(s)	Inspected
Condition	1 - Good
Deficiency	No deficiencies recorded
Floor Finish	Inspected
Condition	1 - Good
Deficiency	No deficiencies recorded
Stalls	Does not Exist
Walls	Inspected
Condition	2 - Between Good and Fair
Deficiency	GYP SUM BOARD: DETERIORATED
Deficiency Location/Instance	Room 104A
Deficiency Quantity	10
Quantity Uom	S.F.
Potential Action	REPLACE
Urgency of Action	PRIORITY 3
Purpose of Action	LEVEL 2
Deficiency Photo1
