**NYC Department of Education  
Building Condition Assessment Survey 2023 - 2024**

Architectural Inspection

**K446**

**Asset:** NEW UTRECHT AF - BROOKLYN, 1601 80 STREET, New York, 11214

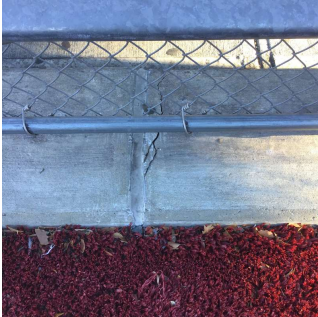
Question	Response
<b>ATHLETIC FIELDS</b>	
<b>SEATING</b>	
<b>Bleachers</b>	
Concrete	Does not Exist
Metal/Wood/Plastic	Inspected
Condition	1 - Good
Deficiency	No deficiencies recorded
<b>SITE</b>	Inspected
<b>CONTAINERIZATION</b>	Does not Exist
Drainage System for Asphalt	Does not Exist
Drainage System for Concrete	Does not Exist
Drainage System for Soil	Does not Exist
<b>DRINKING FOUNTAINS</b>	Does not Exist
<b>FENCES</b>	Inspected
Condition	2 - Between Good and Fair
Deficiency	CONCRETE CURB: DAMAGED/DETERIORATED
Deficiency Location/Instance	79th Street
Deficiency Quantity	10
Quantity Uom	S.F.
Potential Action	REPLACE
Urgency of Action	PRIORITY 3
Purpose of Action	LEVEL 2
Deficiency Photo1

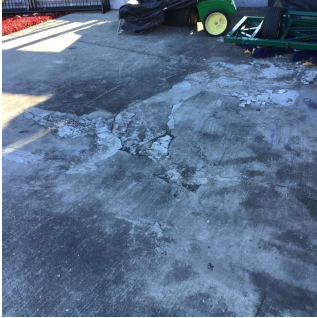
<b>Pavers</b>	Does not Exist
<b>Student Use</b>	Does not Exist
<b>Site Sidewalks &amp; Walkways</b>	Inspected
Asphalt	Does not Exist
Concrete	Inspected
Condition	3 - Fair
Deficiency	DAMAGED/DETERIORATED/MISSING SECTIONS
Deficiency Location/Instance	Near Bleachers

Question	Response
<b>SITE</b>	
<b>PAVING</b>	
<b>Site Sidewalks &amp; Walkways</b>	
<b>Concrete</b>	
Deficiency Quantity	200
Quantity Uom	S.F.
Potential Action	REPLACE
Urgency of Action	PRIORITY 3
Purpose of Action	LEVEL 2
Deficiency Photo1

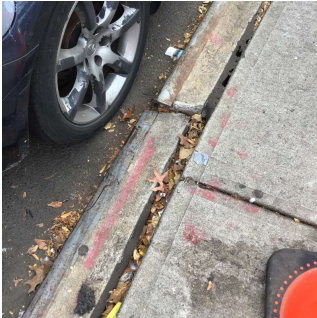
79th Street
Violations	No violations recorded.
Deficiency	HEAVING
Deficiency Location/Instance	80th Street, 79th Street
Deficiency Quantity	150
Quantity Uom	S.F.
Potential Action	REPLACE
Urgency of Action	PRIORITY 3
Purpose of Action	LEVEL 2

Near Bleachers
Violations	No violations recorded.
<b>Pavers</b>	Does not Exist
<b>DOT Sidewalk</b>	Inspected
<b>Asphalt</b>	Does not Exist
<b>Concrete</b>	Inspected
Condition	4 - Between Fair and Poor
Deficiency	DAMAGED CURBS
Deficiency Location/Instance	80th Street
Deficiency Quantity	20
Quantity Uom	L.F.
Potential Action	REPLACE
Urgency of Action	PRIORITY 5
Purpose of Action	LEVEL 6
Deficiency Photo1

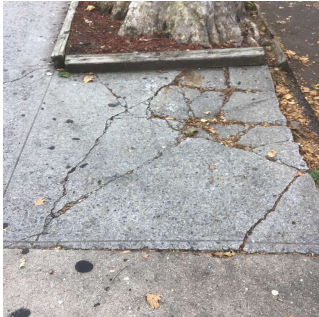
80th Street
Violations	No violations recorded.
Deficiency	DAMAGED CURBS
Deficiency Location/Instance	80th Street, 79th Street
Deficiency Quantity	200
Quantity Uom	L.F.
Potential Action	REPLACE
Urgency of Action	PRIORITY 3
Purpose of Action	LEVEL 2
Deficiency Photo1

80th Street
Violations	No violations recorded.
Deficiency	DAMAGED/DETERIORATED/MISSING SECTIONS
Deficiency Location/Instance	80th Street, 17th Avenue, New Utrecht Avenue, 79th Street
Deficiency Quantity	1,850
Quantity Uom	S.F.
Potential Action	REPLACE
Urgency of Action	PRIORITY 3
Purpose of Action	LEVEL 2
Deficiency Photo1

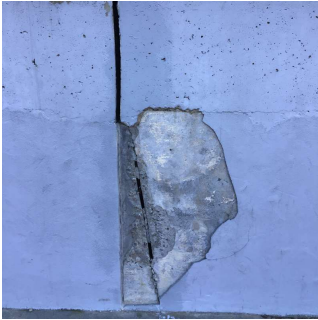
Question	Response
<b>SITE</b>	
<b>PAVING</b>	Inspected
<b>DOT Sidewalk</b>	
<b>Concrete</b>	Inspected
Violations	No violations recorded.
<b>Pavers</b>	Does not Exist
<b>PLAYGROUNDS</b>	Does not Exist
<b>RETAINING WALLS</b>	Inspected
Are there any Retaining Walls 6' OR higher facing public street/sidewalk?	No
Condition	3 - Fair
Deficiency	CAST IN PLACE CONCRETE: CRACKS/SPALLING - MAJOR
Deficiency Location/Instance	80th Street, 17th Avenue, 79th Street
Deficiency Quantity	180
Quantity Uom	S.F.
Potential Action	REPLACE
Urgency of Action	PRIORITY 3
Purpose of Action	LEVEL 2
Deficiency Photo1
