NYC Department of Education
Building Condition Assessment Survey 2023 - 2024

Architectural Inspection

Asset: GRAND STREET CAMPUS (OLD E.D.HS)-K, 850 GRAND STREET, New York, 11225

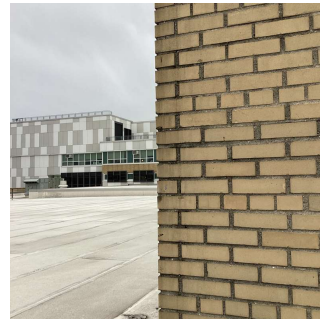
Chimney

BRICK: MAJOR / THRU CRACKS

20
S.F.
REMOVE AND REBUILD
PRIORITY 4
LEVEL 2

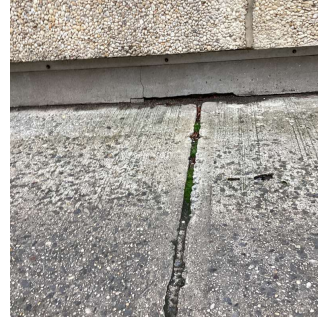
Facade C

CAST IN PLACE / PRE-CAST CONCRETE: MINOR
CRACKS/SPALLING

REPAIR
PRIORITY 3
LEVEL 2

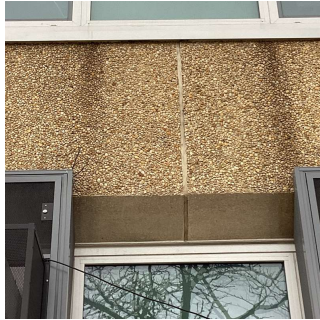
CAST IN PLACE / PRE-CAST CONCRETE: DETERIORATED CONTROL/EXPANSION JOINTS

240
L.F.
MAINTENANCE
PRIORITY 3
LEVEL 2

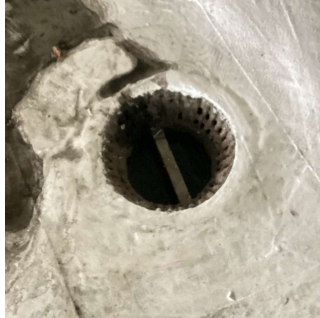
Deficiency	No deficiencies recorded
ROOFING DRAINS	Inspected
Condition	3 - Fair
Deficiency	DETERIORATED
Roof Plan reference

Deficiency Quantity	1
Quantity Uom	EACH
Potential Action	REPLACE
Urgency of Action	PRIORITY 4

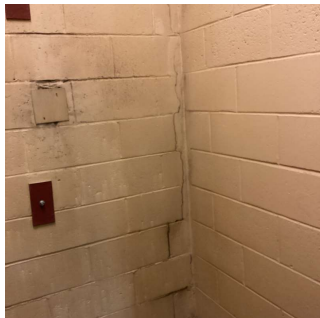
Violations	Roof 8 No violations recorded.
Specialties	Inspected
BULKHEAD/PENTHOUSE	Inspected
Condition	3 - Fair
Deficiency	BULKHEAD/PENTHOUSE WALLS/INTERIOR: CMU CRACKS/SPALLING
Roof Plan reference

Deficiency Quantity	80
Quantity Uom	S.F.
Potential Action	REPLACE
Urgency of Action	PRIORITY 3
Purpose of Action	LEVEL 2
Deficiency Photo1

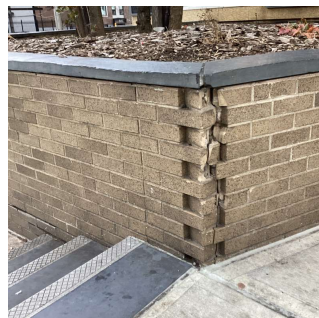
Deficiency	BRICK: DETERIORATED COPING STONE
------------	---

Question	Response
EXTERIOR	
STAIRS/RAMPS: EXTERIOR	Inspected
BUILDING CHEEK/FLANK WALLS	
Quantity Uom	S.F.
Potential Action	REPLACE
Urgency of Action	PRIORITY 4
Purpose of Action	LEVEL 2
Deficiency Photo1

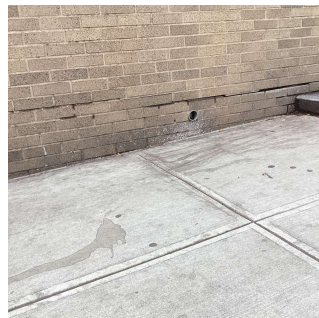
Violations	Main Entrance No violations recorded.
Deficiency	BRICK: DETERIORATED JOINTS
Roof Plan reference

Deficiency Quantity	100
Quantity Uom	S.F.
Potential Action	REPOINT
Urgency of Action	PRIORITY 3
Purpose of Action	LEVEL 2
Deficiency Photo1

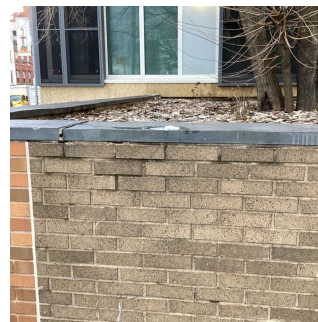
Violations	Main Entrance No violations recorded.
Deficiency	BRICK: DETERIORATED JOINTS AT COPING STONES

80
L.F.
MAINTENANCE
PRIORITY 3
LEVEL 2

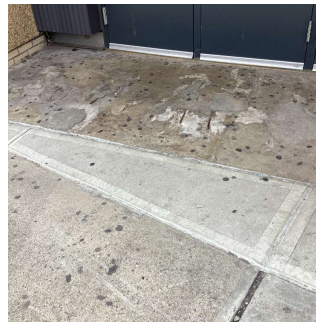
Exit 7 - Facade R

CONCRETE: CRACKS/SPALLING - MAJOR

80
S.F.
REPLACE
PRIORITY 4
LEVEL 2

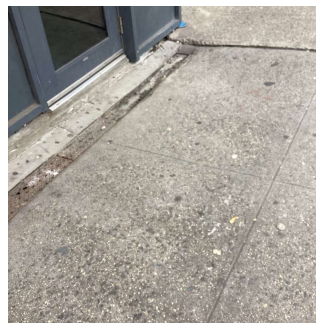
Exit 1 (A)

CONCRETE: DETERIORATED SUBSTRATE

REPLACE SUBSTRATE AND RESET

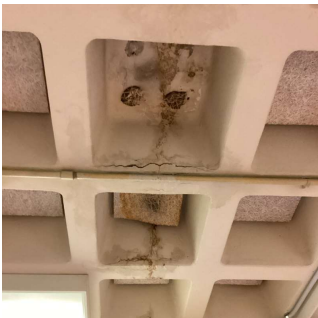
Question	Response
EXTERIOR	
WINDOWS	
WINDOWS	Inspected
Material Type(s)	Aluminum
Instance on Aluminum - Other: All Facades	Inspected
Instance Condition	1 - Good
Instance Quantity	34,500
Instance Quantity Uom	S.F.
Are these windows insulated	Yes
Installation Year	2021
Source of Installation	Custodial Staff
Deficiency	No deficiencies recorded
Instance on Aluminum - Other: Facade J	Inspected
Instance Condition	1 - Good
Instance Quantity	500
Instance Quantity Uom	S.F.
Are these windows insulated	Yes
Installation Year	2021
Source of Installation	Custodial Staff
Deficiency	No deficiencies recorded
INTERIOR	Inspected
POOLS	Does not Exist
STRUCTURAL	Inspected
COLUMNS/BEAMS/BEARING WALLS	Inspected
Condition	2 - Between Good and Fair
Deficiency	No deficiencies recorded
FLOOR STRUCTURE	Inspected
Condition	4 - Between Fair and Poor
Deficiency	CONCRETE: CRACKS/SPALLED/REINFORCEMENT EXPOSED
Deficiency Location/Instance	1st Floor Cafeteria A, Cafeteria B

Deficiency Quantity	100
Quantity Uom	S.F.
Potential Action	REPAIR
Urgency of Action	PRIORITY 5
Purpose of Action	LEVEL 6
Deficiency Photo1

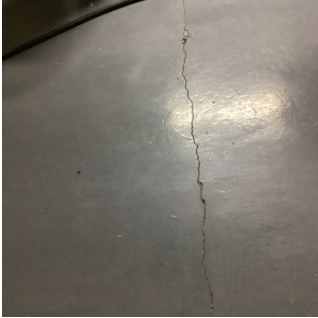
Violations	Cafeteria A No violations recorded.
Deficiency	CONCRETE SLAB ON GRADE: THRU CRACKS
Deficiency Location/Instance	Room LM89D, Basement Corridor to Boiler Room, Girls Locker Room, Tunnel below Facade E, F, G
Deficiency Quantity	200

Question	Response
INTERIOR	
STRUCTURAL	
FLOOR STRUCTURE	
Quantity Uom	S.F.
Potential Action	REPAIR
Urgency of Action	PRIORITY 3
Purpose of Action	LEVEL 5
Deficiency Photo1
