NYC Department of Education
Building Condition Assessment Survey 2023 - 2024

Architectural Inspection

Asset: GRAND ST CAMPUS AF(OLD E.D. HS)-K, 850 GRAND STREET, New York, 11225

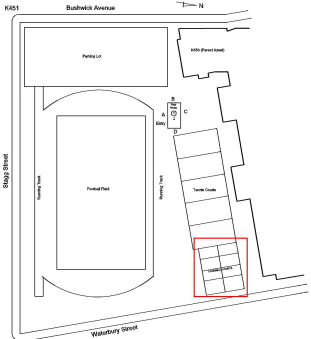
Question	Response
INTERIOR	Inspected
STRUCTURAL	Inspected
COLUMNS/BEAMS/BEARING WALLS	Inaccessible
FLOOR STRUCTURE	Inaccessible
FOUNDATION WALLS	Does not Exist
ROOF STRUCTURE	Inspected
Condition	2 - Between Good and Fair
Deficiency	No deficiencies recorded
VAULTS-BUNKERS	Does not Exist
CLASSROOMS/CORRIDORS/ADMIN SPACES	Does not Exist
INTERIOR DOOR HARDWARE	Does not Exist
LOCKER ROOM	Does not Exist
SHOWER ROOM	Does not Exist
STAIRS/RAMPS: INTERIOR	Does not Exist
TOILET ROOMS - STAFF	Does not Exist
TOILET ROOMS - STUDENTS	Does not Exist
ATHLETIC FIELDS	Inspected
PLAYING SURFACE	Inspected
Synthetic Turf Field exists?	Yes
Year of Installation	2004
Replacement Quantity	163,000
Replacement Uom	S.F.
Instance on Handball Courts	Inspected
Instance Condition	5 - Poor
Instance Quantity	8,000
Instance Quantity Uom	S.F.
Deficiency	ASPHALT: DAMAGED/DETERIORATED
Deficiency Location/Instance	All Handball Courts
Roof Plan reference

Deficiency Quantity	5,000
Quantity Uom	S.F.
Potential Action	REPLACE
Urgency of Action	PRIORITY 4
Purpose of Action	LEVEL 2

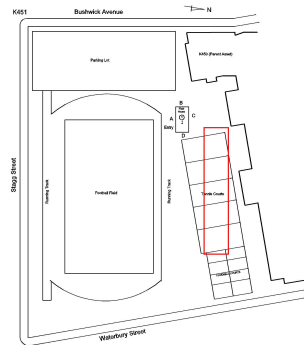
5 - Poor

ASPHALT: DAMAGED/DETERIORATED

All Courts

REPLACE

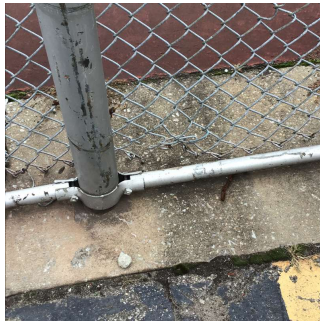
Question	Response
ATHLETIC FIELDS	
PLAYING SURFACE	Inspected
Instance Quantity Uom	S.F.
FIXED EQUIPMENT	Inspected
Basketball Backboard	Does not Exist
Basketball Hoops	Does not Exist
Basketball Posts	Does not Exist
Football Goal Posts	Under Construction
Tennis Net Posts	Does not Exist
SEATING	Inspected
Benches	Inspected
Concrete	Does not Exist
Metal/Wood/Plastic	Under Construction
Bleachers	Inspected
Concrete	Does not Exist
Metal/Wood/Plastic	Under Construction
SITE	Inspected
CONTAINERIZATION	Does not Exist
Drainage System for Asphalt	Inspected
Catch Basins/Manhole - Surrounded by asphalt	Inspected
Condition	2 - Between Good and Fair
Deficiency	No deficiencies recorded
Culverts - Asphalt Covering	Does not Exist
Drainage System for Concrete	Does not Exist
Drainage System for Soil	Does not Exist
DRINKING FOUNTAINS	Under Construction
FENCES	Inspected
Condition	4 - Between Fair and Poor
Deficiency	CHAIN LINK: DAMAGED/DETERIORATED

Deficiency Location/Instance	Near handball court, handball court, along Waterbury Street
Deficiency Quantity	200
Quantity Uom	S.F.
Potential Action	REPLACE
Urgency of Action	PRIORITY 3
Purpose of Action	LEVEL 2
Deficiency Photo1

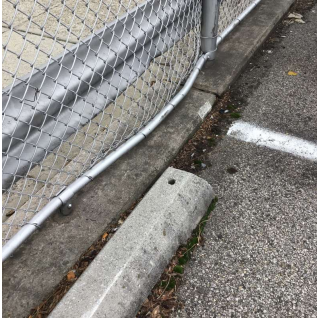
Tennis Court
Violations	No violations recorded.
Deficiency	CHAIN LINK: DAMAGED POST/RAIL
Deficiency Location/Instance	Parking Lot, handball court

Question	Response
SITE	
FENCES	
Deficiency Quantity	140
Quantity Uom	L.F.
Potential Action	REPLACE
Urgency of Action	PRIORITY 3
Purpose of Action	LEVEL 2
Deficiency Photo1

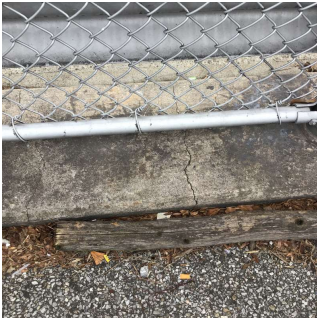
Parking Lot
Violations	No violations recorded.
Deficiency	CONCRETE CURB: DAMAGED/DETERIORATED
Deficiency Location/Instance	Parking Lot, tennis court, handball court
Deficiency Quantity	175
Quantity Uom	S.F.
Potential Action	REPLACE
Urgency of Action	PRIORITY 3
Purpose of Action	LEVEL 2
Deficiency Photo1

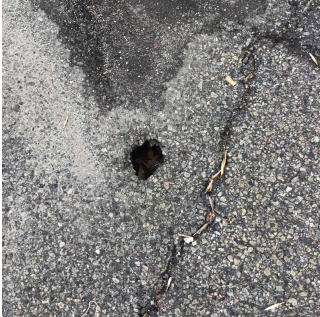
Question	Response
SITE	
FENCES	
Deficiency Photo1	 
Violations	Parking Lot No violations recorded.
IRRIGATION SYSTEM	Does not Exist
PAVING	Inspected
Student Non-Use	Inspected
Gravel Exists?	No
Asphalt	Inspected
Condition	4 - Between Fair and Poor
Deficiency	POTHOLES
Deficiency Location/Instance	Parking Lot
Deficiency Quantity	20
Quantity Uom	S.F.
Potential Action	REPAIR
Urgency of Action	PRIORITY 5
Purpose of Action	LEVEL 6
Deficiency Photo1	 
Violations	Parking Lot No violations recorded.
Deficiency	POTHOLES
Deficiency Location/Instance	Parking Lot
Deficiency Quantity	10
Quantity Uom	S.F.
Potential Action	REPAIR
Urgency of Action	PRIORITY 3
Purpose of Action	LEVEL 2

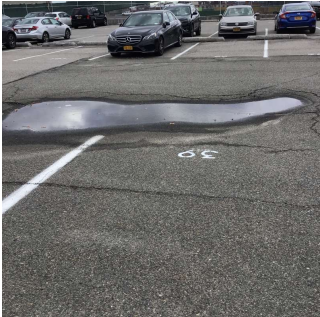
Violations	Parking Lot No violations recorded.
Deficiency	LOCALIZED SINK AREA
Deficiency Location/Instance	Parking Lot
Deficiency Quantity	300
Quantity Uom	S.F.
Potential Action	REPAIR
Urgency of Action	PRIORITY 3
Purpose of Action	LEVEL 2
Deficiency Photo1

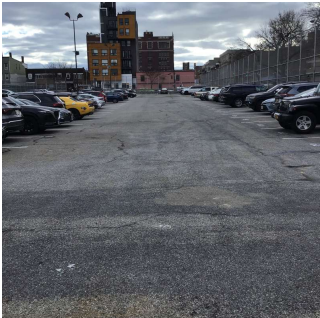
Violations	Parking Lot No violations recorded.
Deficiency	CRACKS - MAJOR
Deficiency Location/Instance	Parking Lot
Deficiency Quantity	3,500
Quantity Uom	S.F.
Potential Action	REPLACE
Urgency of Action	PRIORITY 3
Purpose of Action	LEVEL 2
Deficiency Photo1

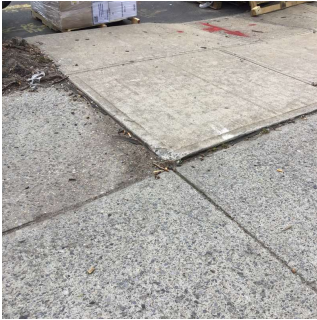
Question	Response
SITE	
PAVING	
Student Non-Use	Inspected
Asphalt	Inspected
Violations	No violations recorded.
Concrete	Does not Exist
Pavers	Does not Exist
Student Use	Inspected
Gravel Exists?	No
Asphalt	Under Construction
Concrete	Under Construction
Pavers	Does not Exist
Site Sidewalks & Walkways	Inspected
Asphalt	Under Construction
Concrete	Under Construction
Pavers	Does not Exist
DOT Sidewalk	Inspected
Asphalt	Does not Exist
Concrete	Inspected
Condition	4 - Between Fair and Poor
Deficiency	HEAVING
Deficiency Location/Instance	Along Bushwick Avenue, Stagg Street, Waterbury Street
Deficiency Quantity	300
Quantity Uom	S.F.
Potential Action	REPLACE
Urgency of Action	PRIORITY 3
Purpose of Action	LEVEL 2
Deficiency Photo1

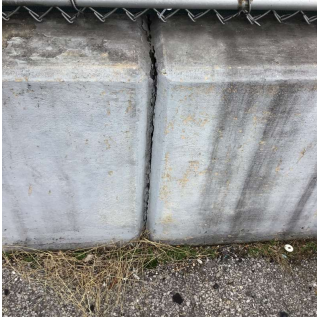
Question	Response
SITE	
RETAINING WALLS	
Deficiency Photo1

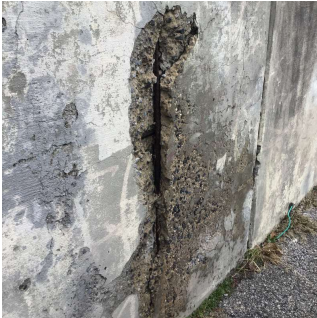
Violations	Parking Lot No violations recorded.
Deficiency	CAST IN PLACE CONCRETE: CRACKS/SPALLING - MAJOR
Deficiency Location/Instance	Parking Lot
Deficiency Quantity	150
Quantity Uom	S.F.
Potential Action	REPLACE
Urgency of Action	PRIORITY 3
Purpose of Action	LEVEL 2
Deficiency Photo1

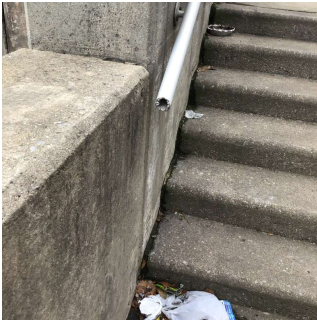
Priority Condition Exist Last Year?	Priority Category	Condition Description	Component Affected	Location Description	Person(s) Notified	Person(s) Title	PhotoImage
No	Protruding Elements	Severely damaged railing with protruding metal is a potential safety hazard.	SITE STAIRS/RAMP S: EXTERIOR Railings	Parking Lot	Philip Navetta	Custodian

Violations	Parking Lot No violations recorded.
SEATING	Does not Exist
SITE WALLS (NOT RETAINING WALLS)	Inspected
Condition	2 - Between Good and Fair
Deficiency	No deficiencies recorded
STAIRS/RAMPS: EXTERIOR	Inspected
Railings	Inspected
Condition	5 - Poor
Deficiency	DAMAGED
Deficiency Location/Instance	Parking Lot
Deficiency Quantity	15
Quantity Uom	L.F.
Potential Action	REPLACE
Urgency of Action	PRIORITY 5
Purpose of Action	LEVEL 6

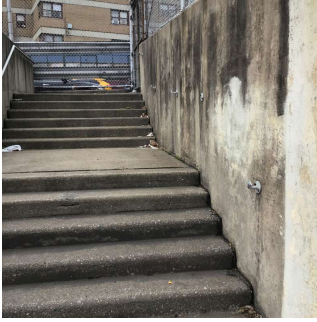
Violations	Parking Lot No violations recorded.
Deficiency	MISSING
Deficiency Location/Instance	Parking Lot
Deficiency Quantity	30
Quantity Uom	L.F.
Potential Action	REPLACE
Urgency of Action	PRIORITY 5
Purpose of Action	LEVEL 6
Deficiency Photo1
